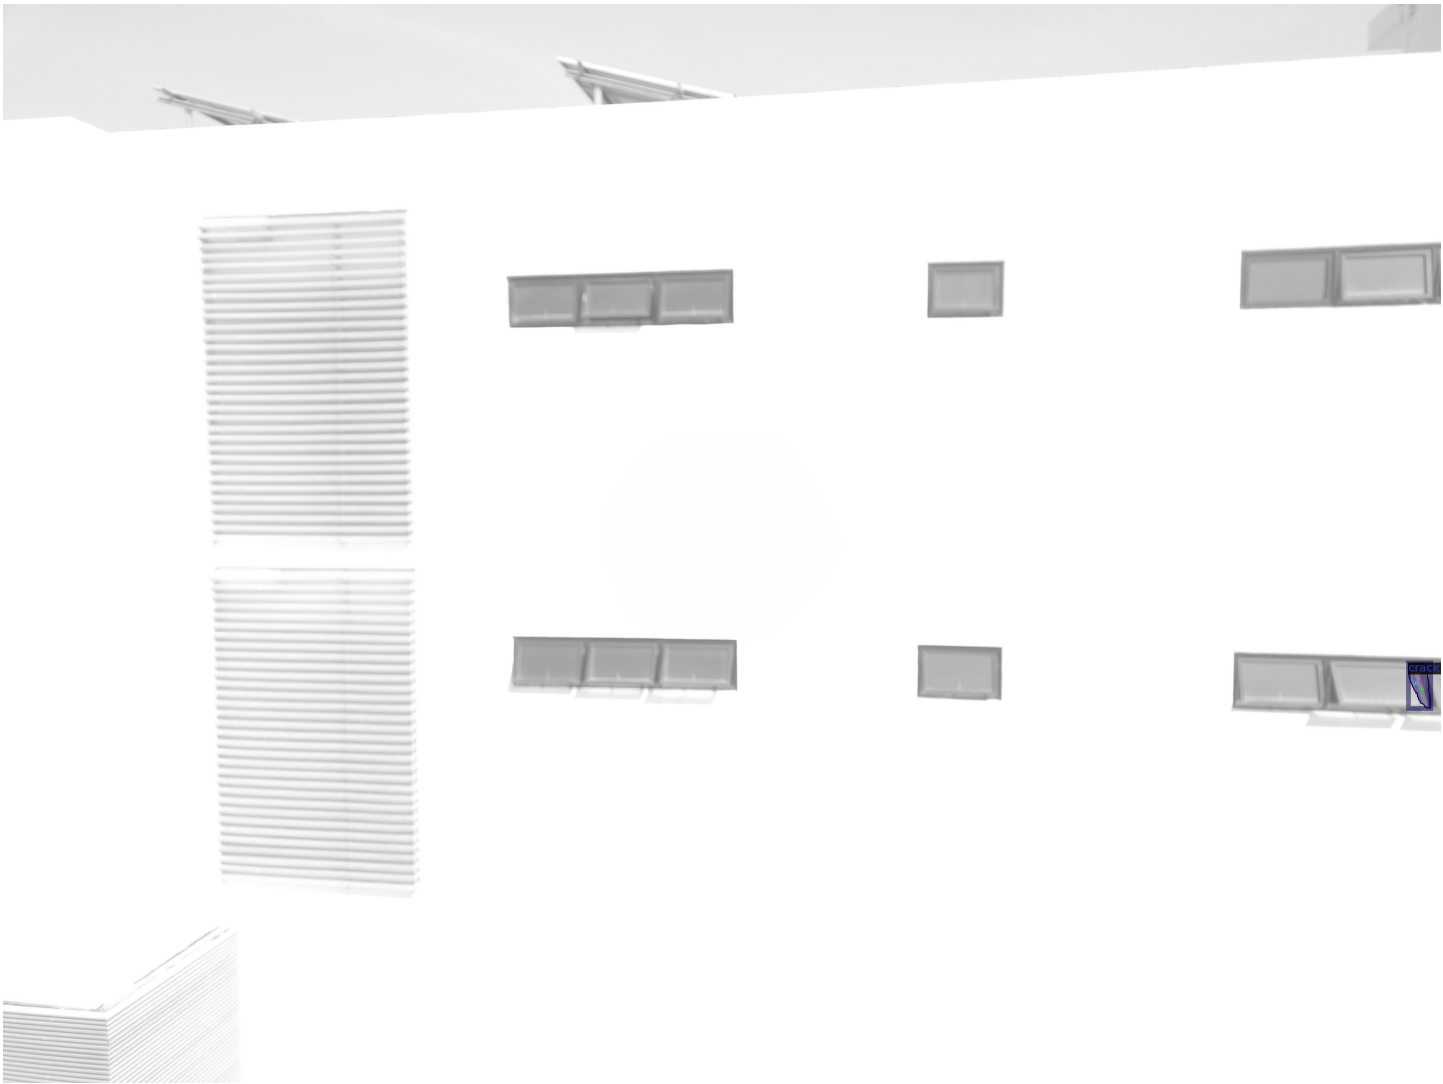
Crack number 1 (confidence score: 23.11%)
The detected crack is on wall component in this image.
Crack density: 0.05%
Crack width: 13.22 mm
Angle wrt horizontal line: -74.10 degree
Configuration: transverse
Position: Right one fourth of the wall
Severity index for this crack: 2
Suggested corrective action: General repair but no detailed investigation required
