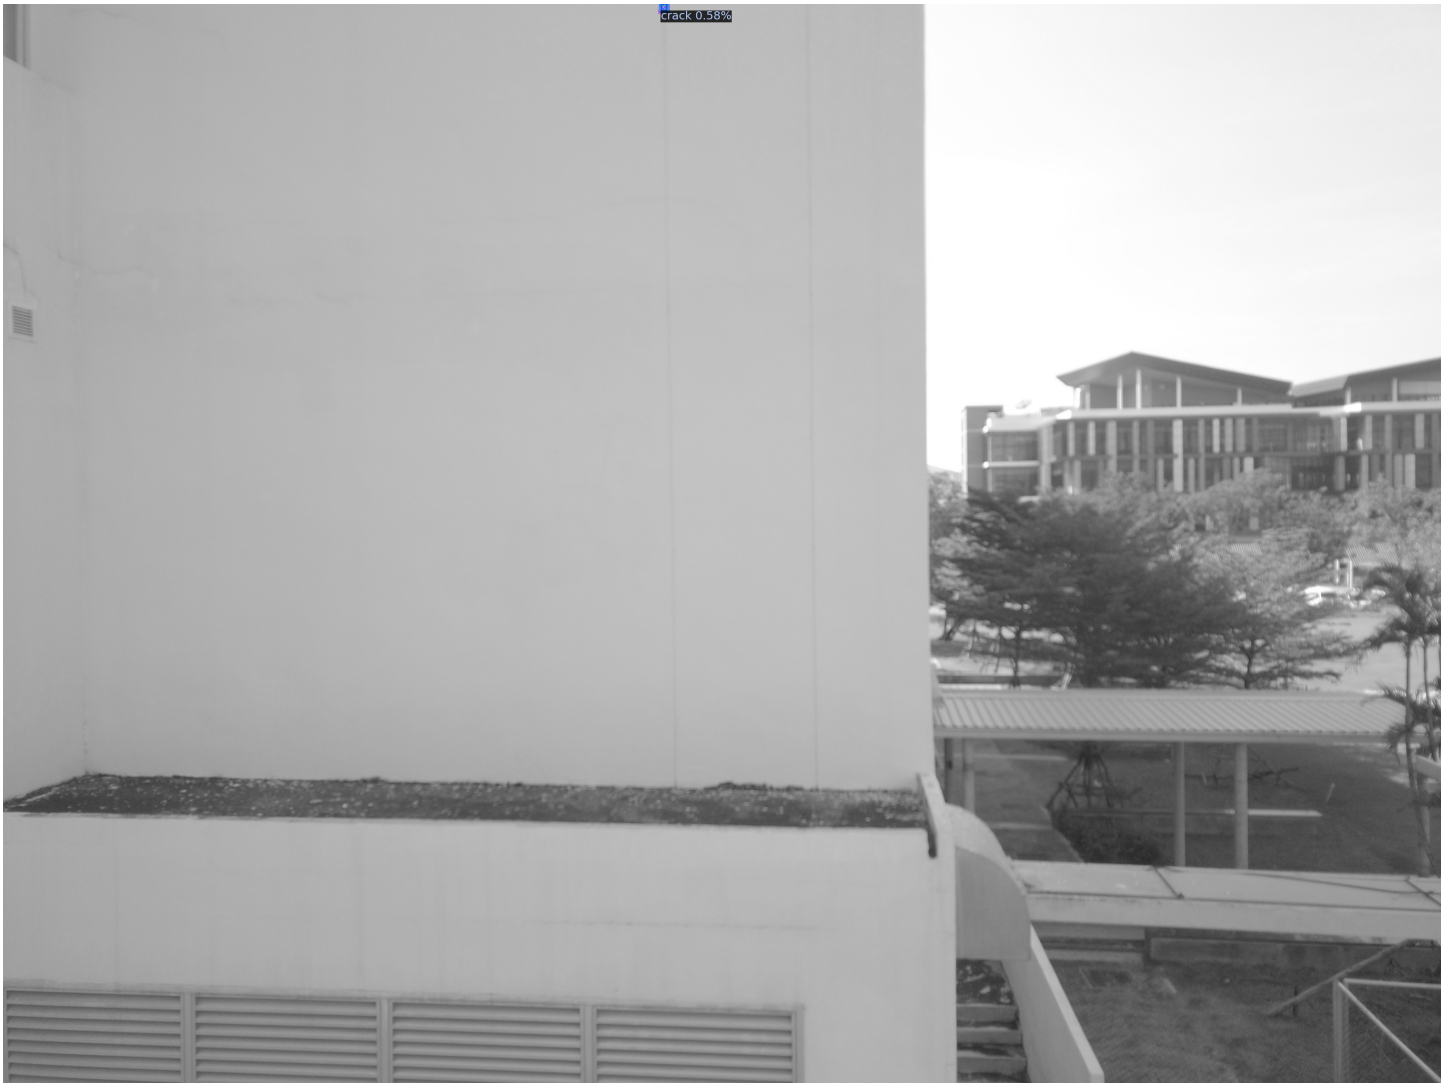
Crack number 1 (confidence score: 0.58%)
The detected crack is on wall component in this image.
Crack density: 0.01%
Crack width: 3.75 mm
Angle wrt horizontal line: -85.46 degree
Configuration: transverse
Position: Middle fourths of the wall
Severity index for this crack: 2
Suggested corrective action: General repair but no detailed investigation required
