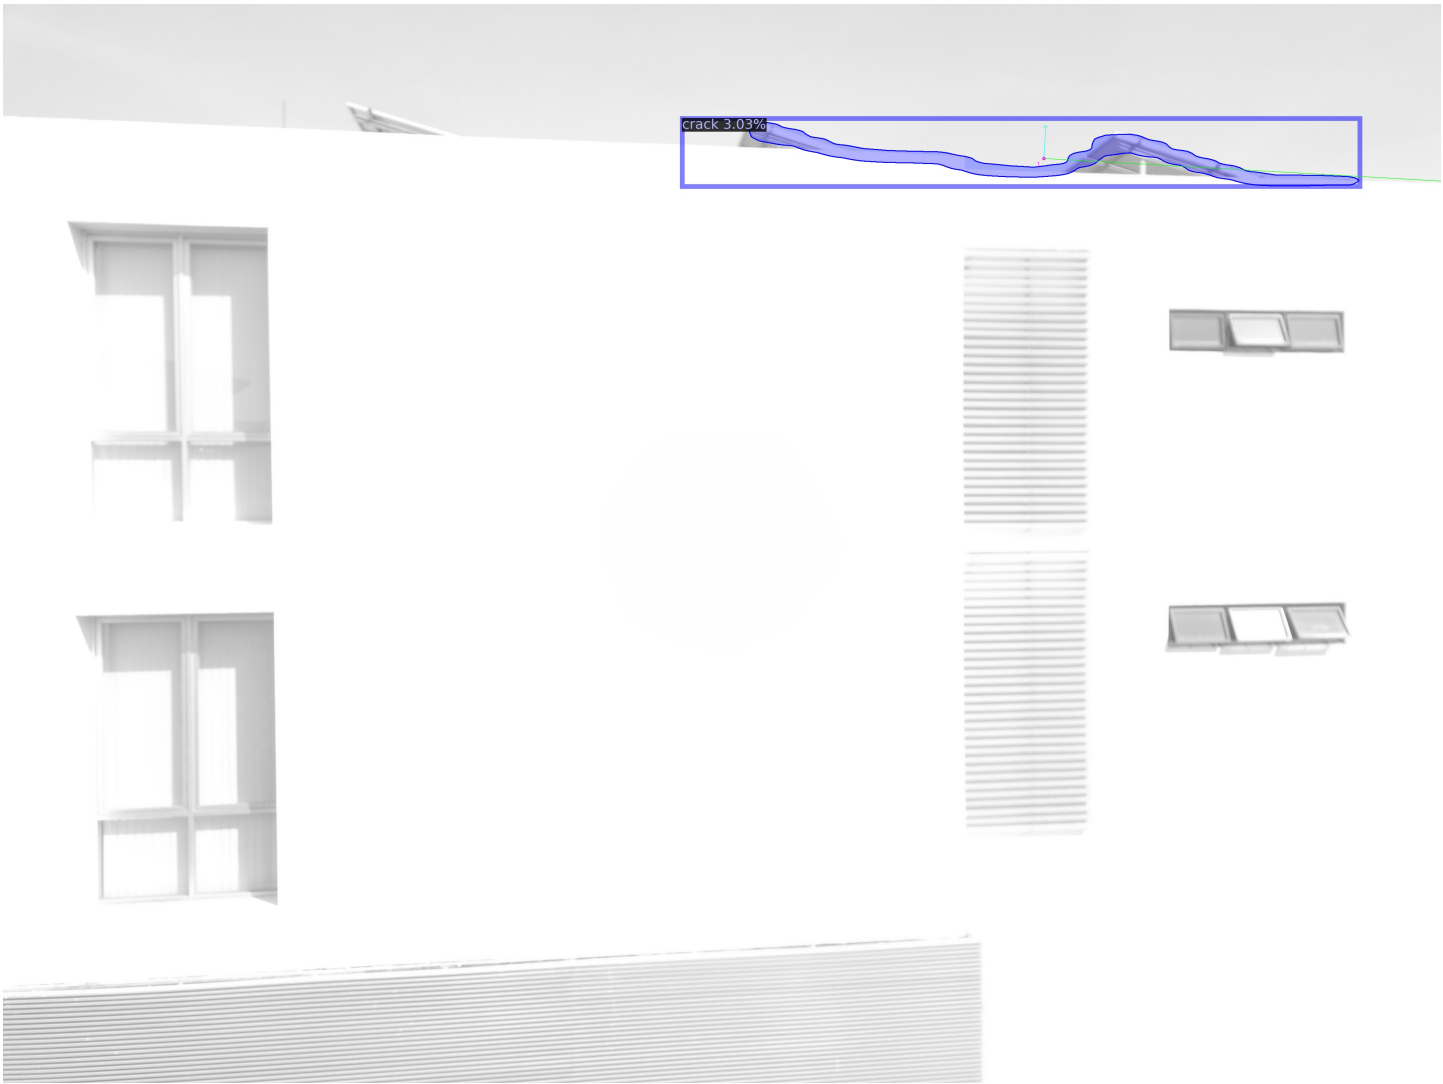
Crack number 1 (confidence score: 3.03%)  
The detected crack is on wall component in this image.  
Crack density: 0.93%  
Crack width: 13.98 mm  
Angle wrt horizontal line: -3.27 degree  
Configuration: longitudinal  
Position: Top fourths of the wall  
Severity index for this crack: 2  
Suggested corrective action: General repair but no detailed investigation required
