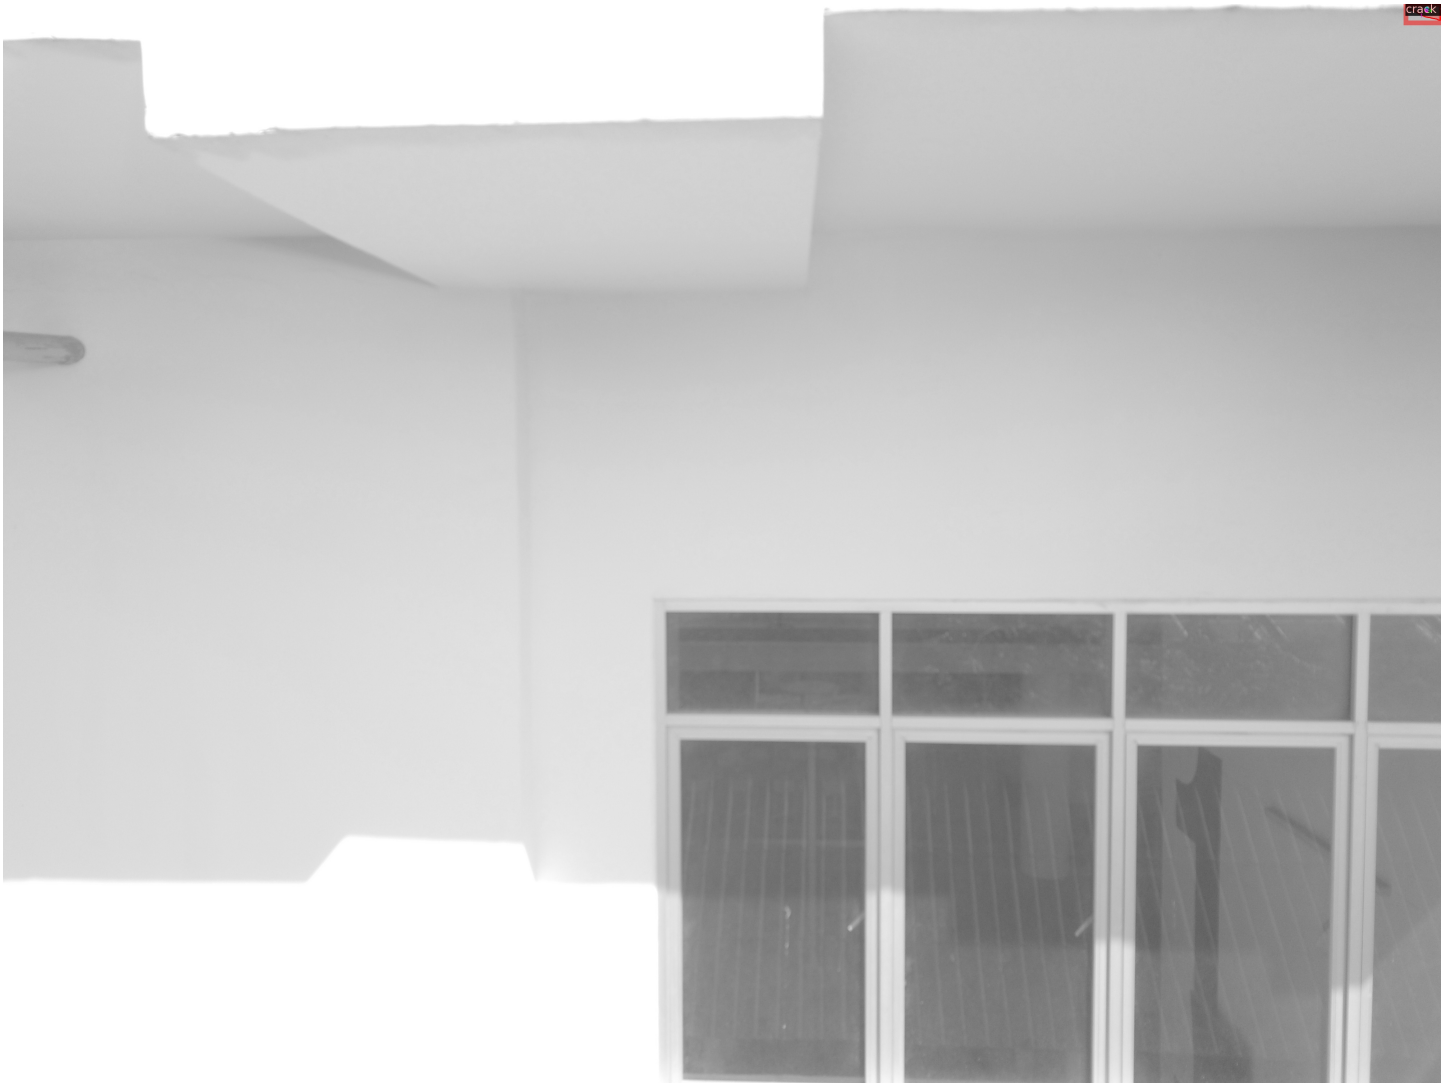
Crack number 1 (confidence score: 0.84%)  
The detected crack is on wall component in this image.  
Crack density: 0.04%  
Crack width: 8.20 mm  
Angle wrt horizontal line: -11.59 degree  
Configuration: longitudinal  
Position: Top fourths of the wall  
Severity index for this crack: 2  
Suggested corrective action: General repair but no detailed investigation required
