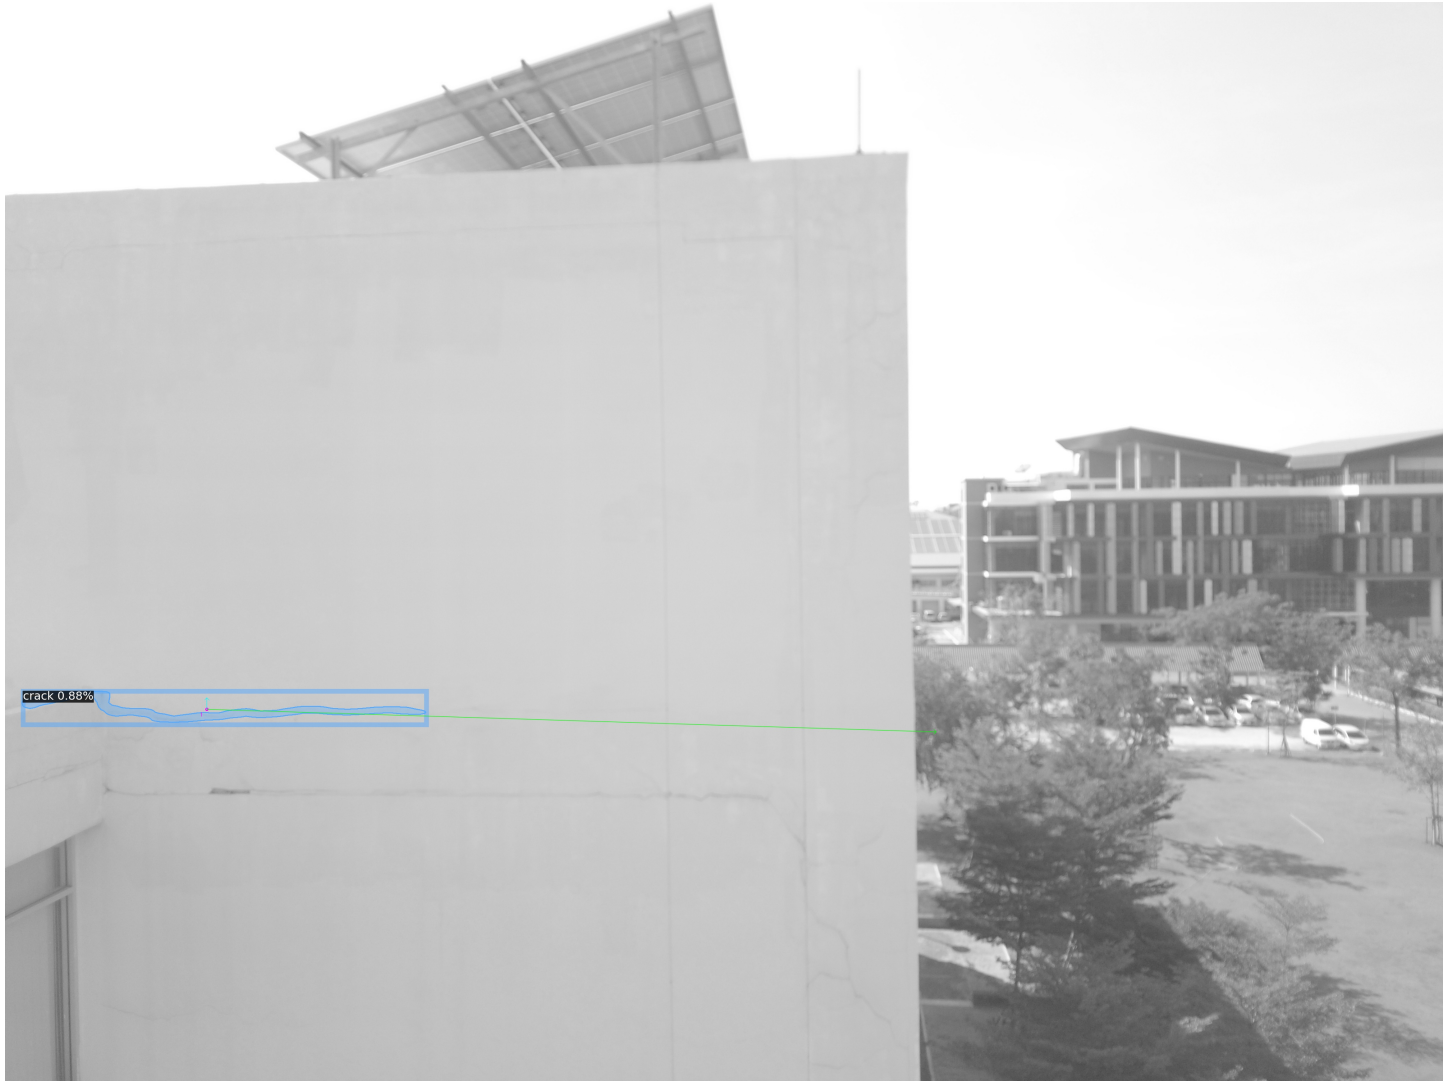
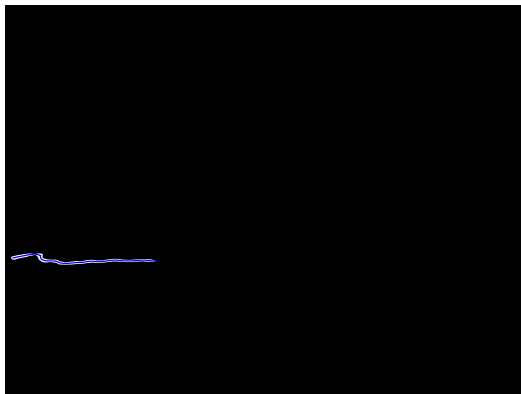
Crack number 1 (confidence score: 0.88%)  
The detected crack is on wall component in this image.  
Crack density: 1.21%  
Crack width: 7.34 mm  
Angle wrt horizontal line: -1.78 degree  
Configuration: longitudinal  
Position: Middle fourths of the wall  
Severity index for this crack: 4  
Suggested corrective action: Detailed investigation required
