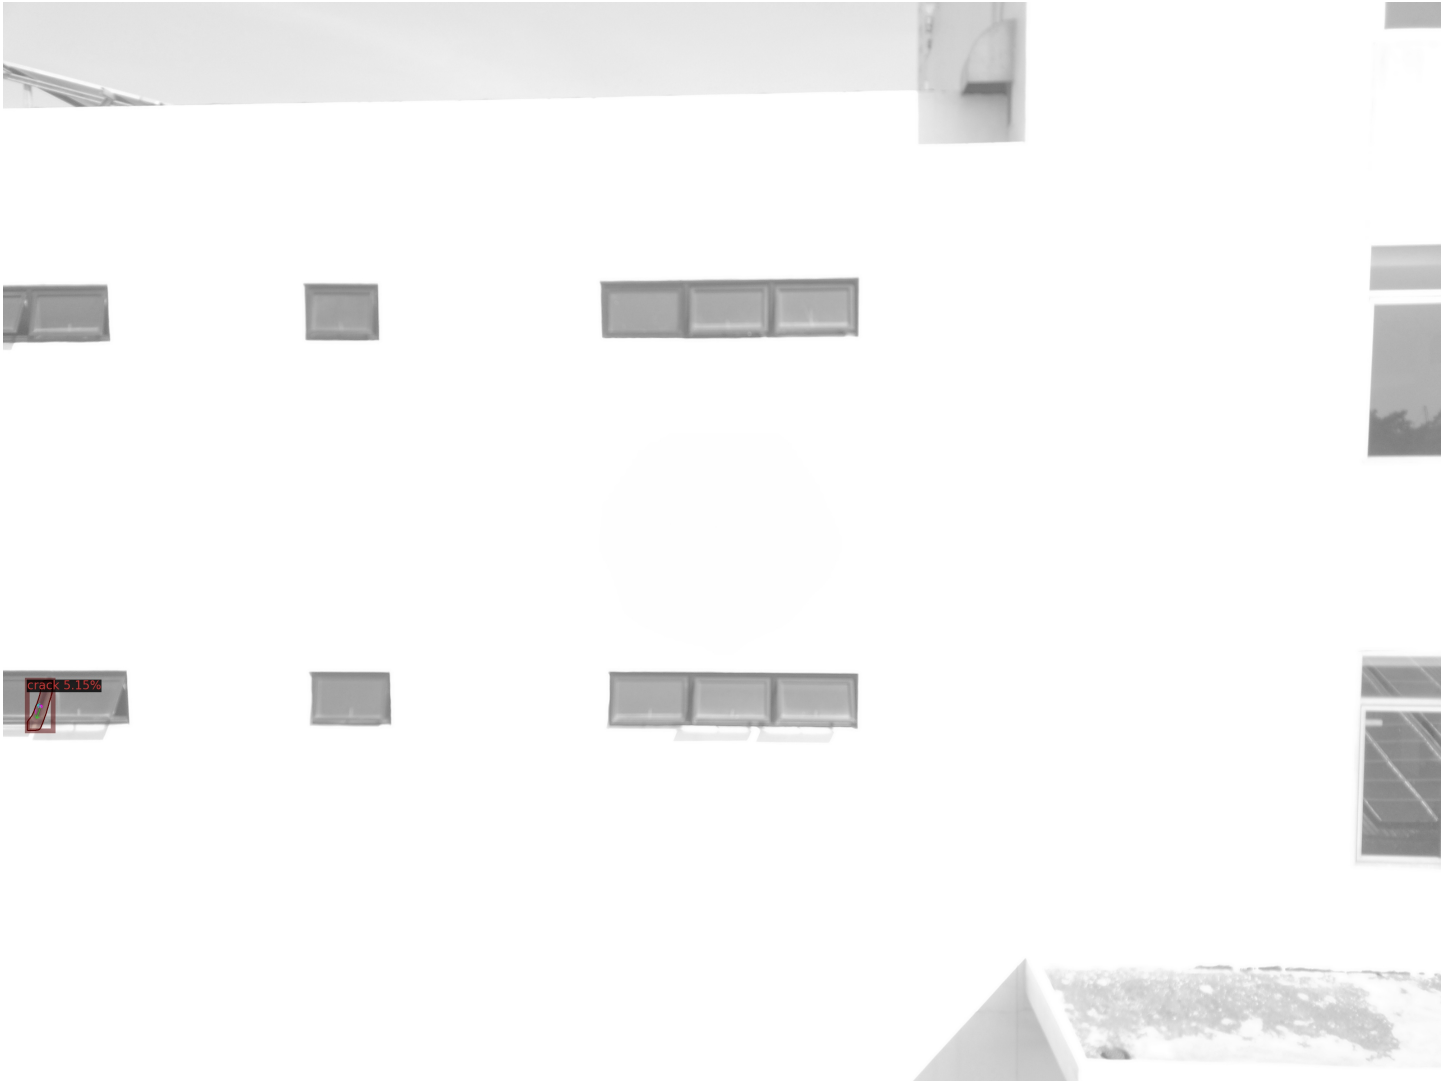
Crack number 1 (confidence score: 5.15%)
The detected crack is on wall component in this image.
Crack density: 0.07%
Crack width: 12.07 mm
Angle wrt horizontal line: -109.33 degree
Configuration: transverse
Position: Left one fourth of the wall
Severity index for this crack: 2
Suggested corrective action: General repair but no detailed investigation required
