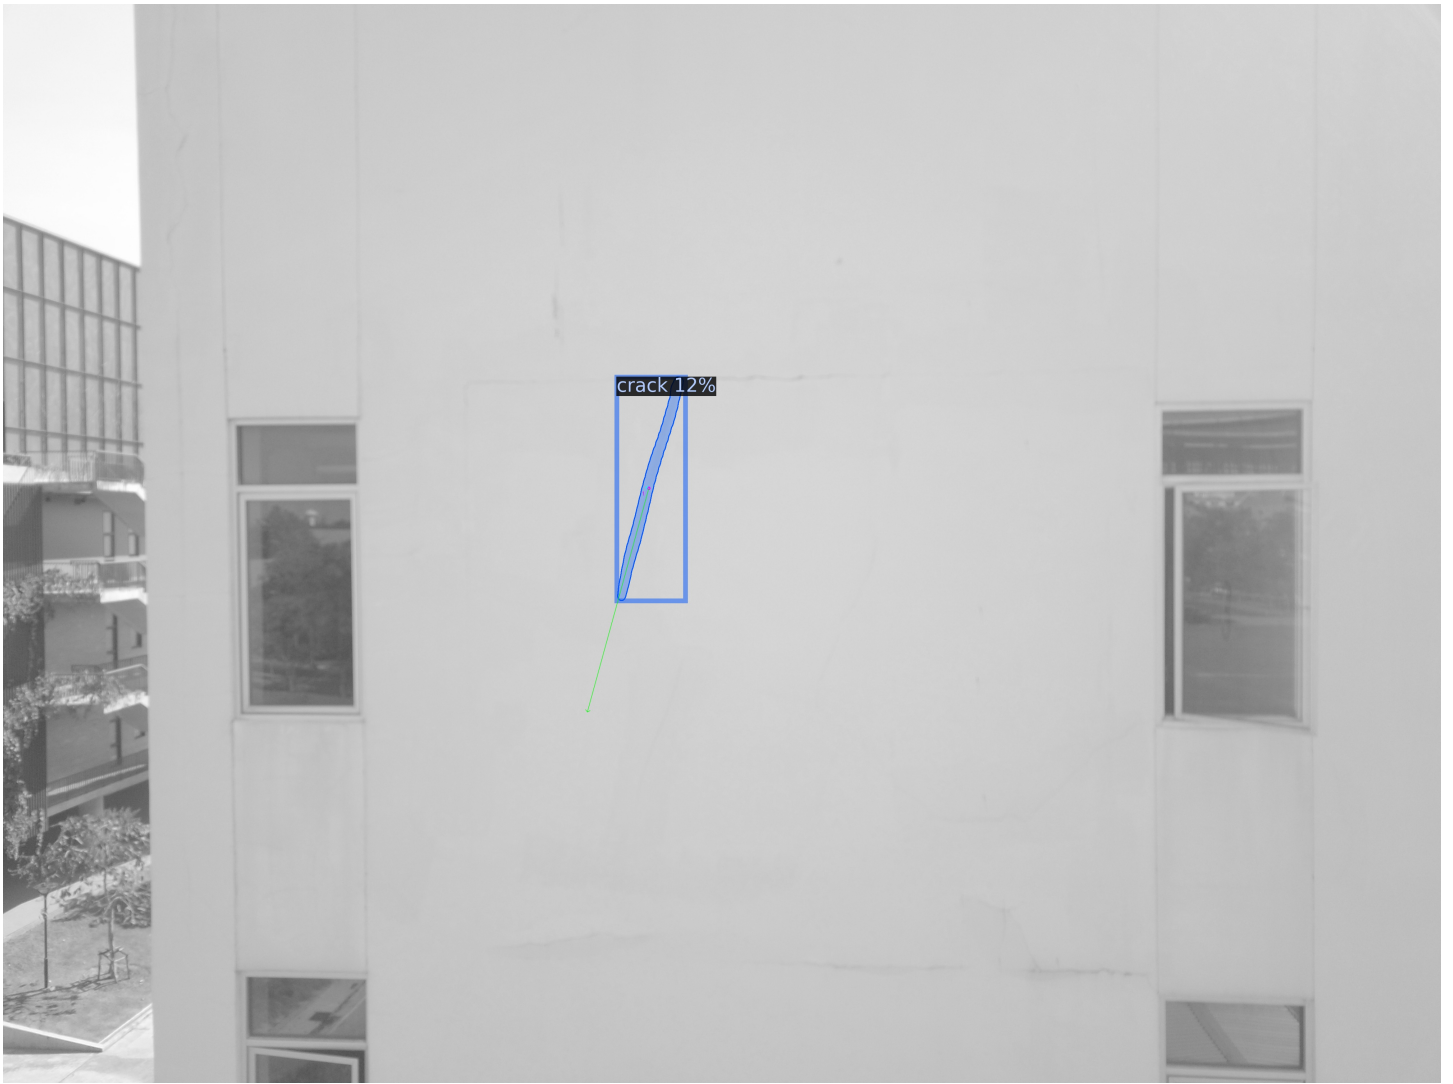
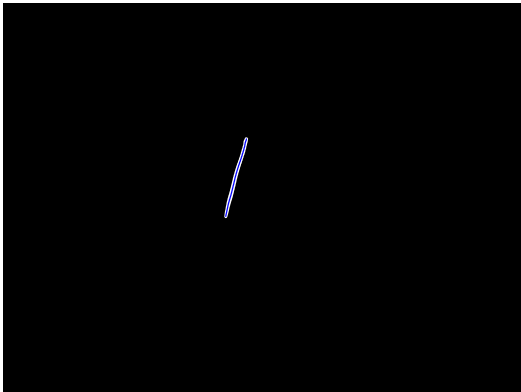
Crack number 1

The detected crack is on wall component in this image.

Crack density: 0.28%

Crack width: 10.94 mm

Angle wrt horizontal line: -105.33 degree

Configuration: transverse

Position: Middle fourths of the wall

Severity index for this crack: 2

Suggested corrective action: General repair but no detailed investigation required
