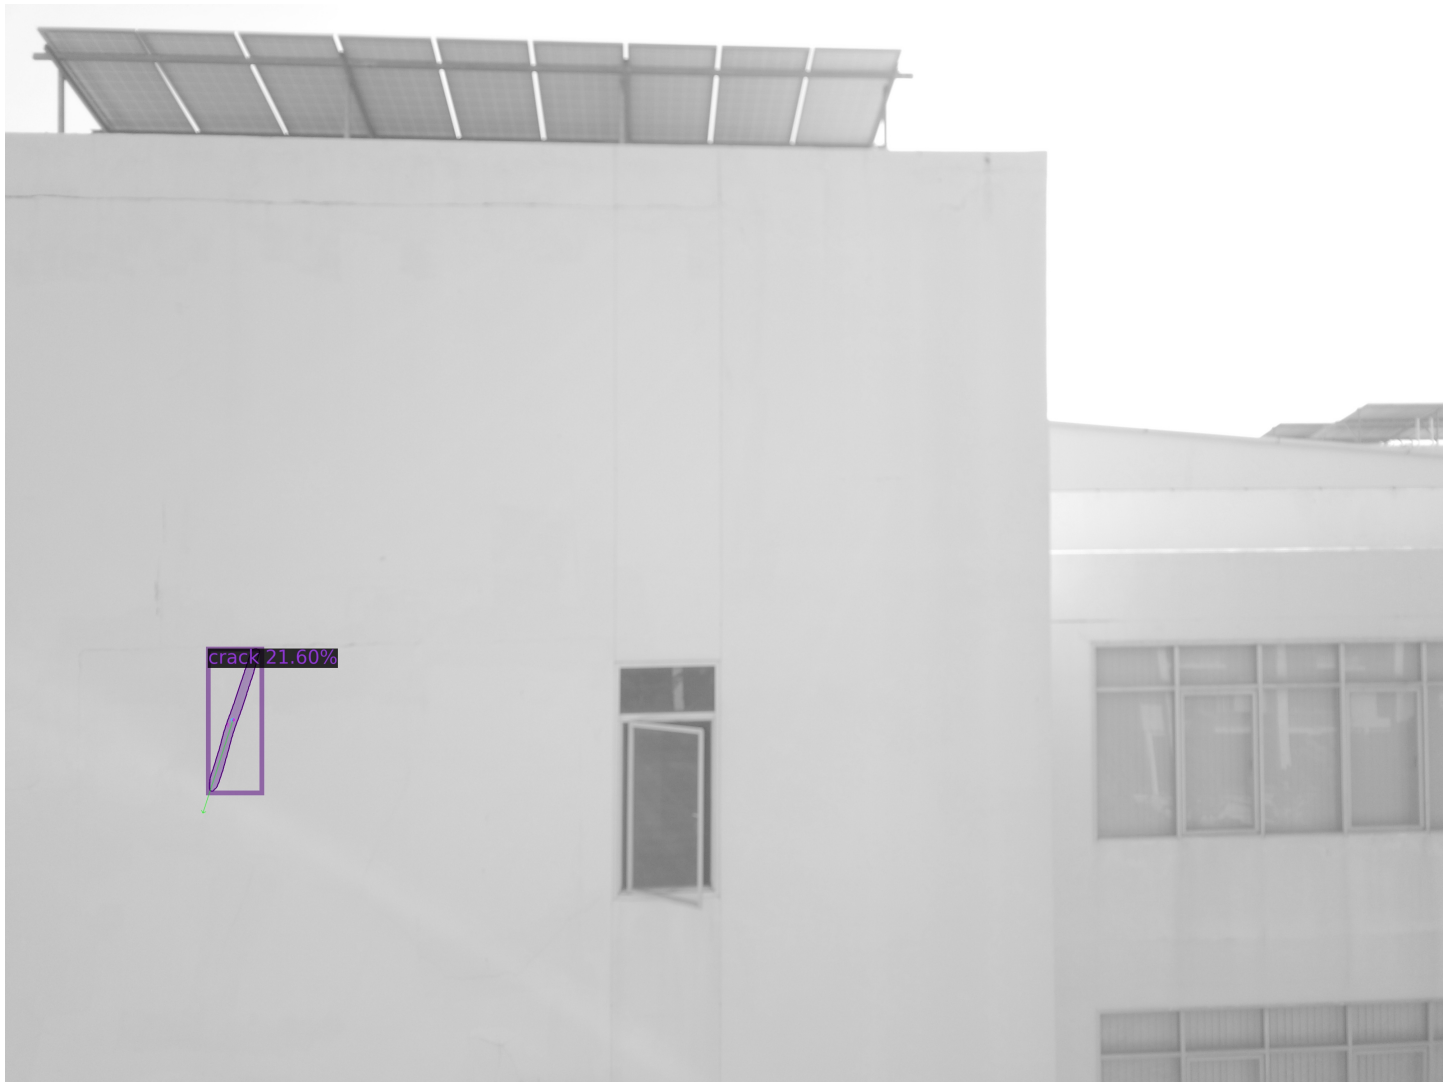
Crack number 1 (confidence score: 21.60%)

The detected crack is on wall component in this image.

Crack density: 0.17%

Crack width: 9.24 mm

Angle wrt horizontal line: -107.77 degree

Configuration: transverse

Position: Left one fourth of the wall

Severity index for this crack: 2

Suggested corrective action: General repair but no detailed investigation required
