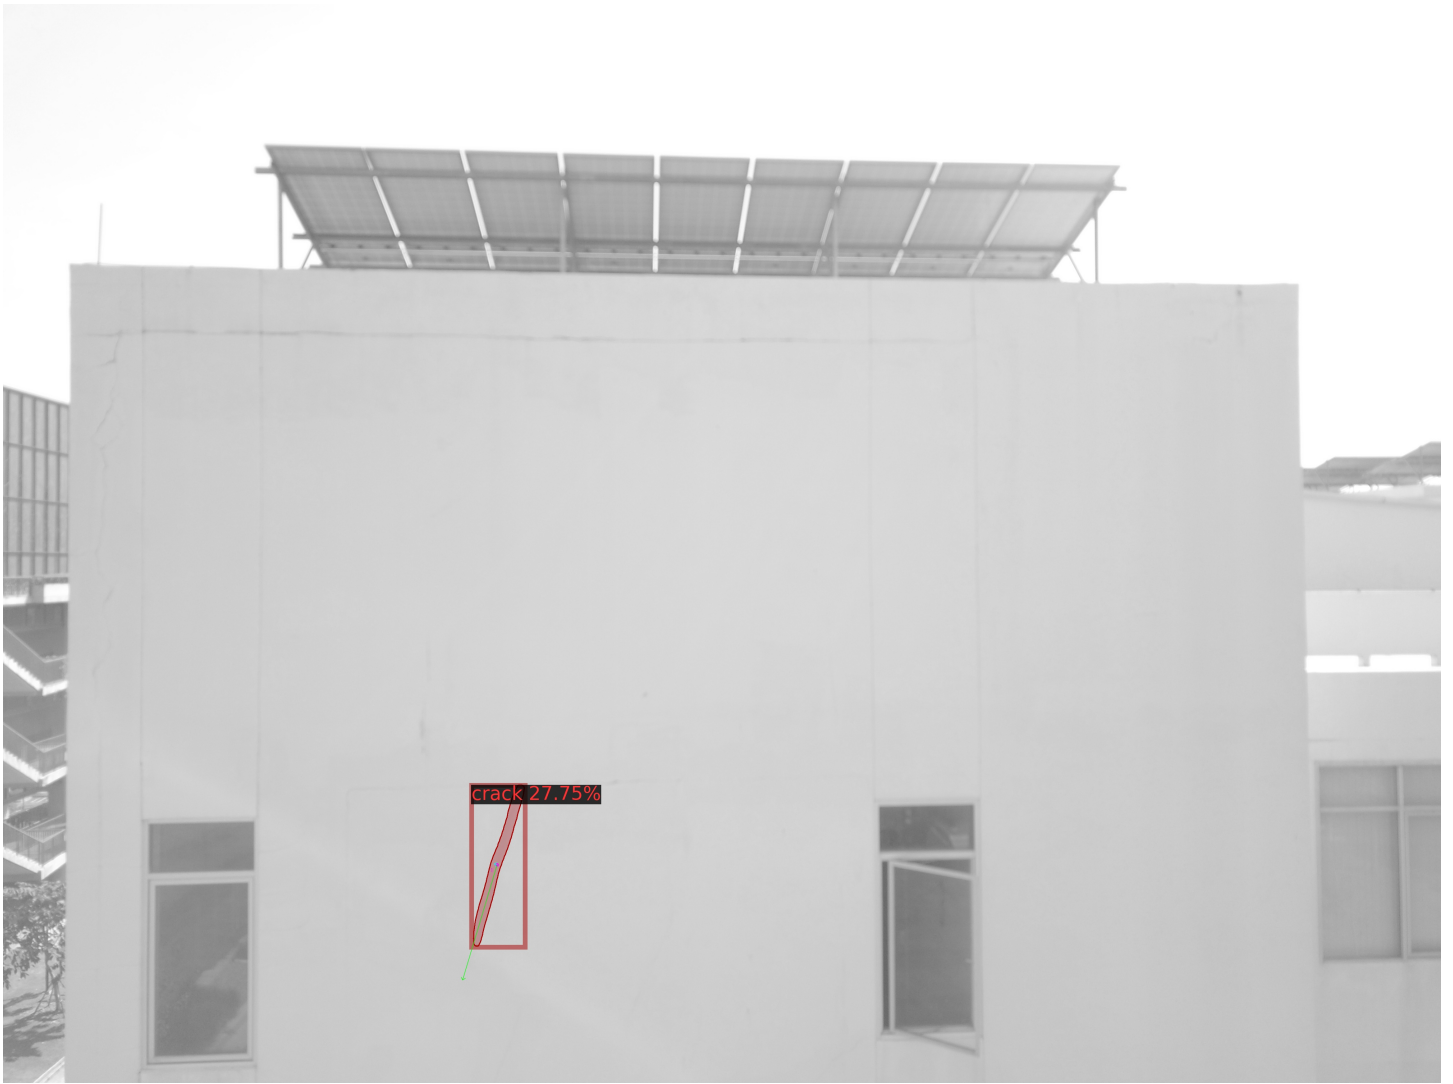
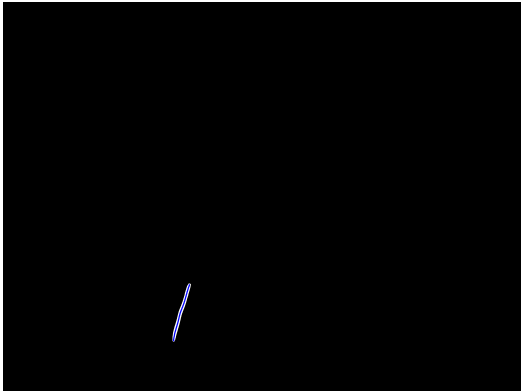
Crack number 1 (confidence score: 27.75%)  
The detected crack is on wall component in this image.  
Crack density: 0.34%  
Crack width: 10.18 mm  
Angle wrt horizontal line: -106.55 degree  
Configuration: transverse  
Position: Middle fourths of the wall  
Severity index for this crack: 2  
Suggested corrective action: General repair but no detailed investigation required
