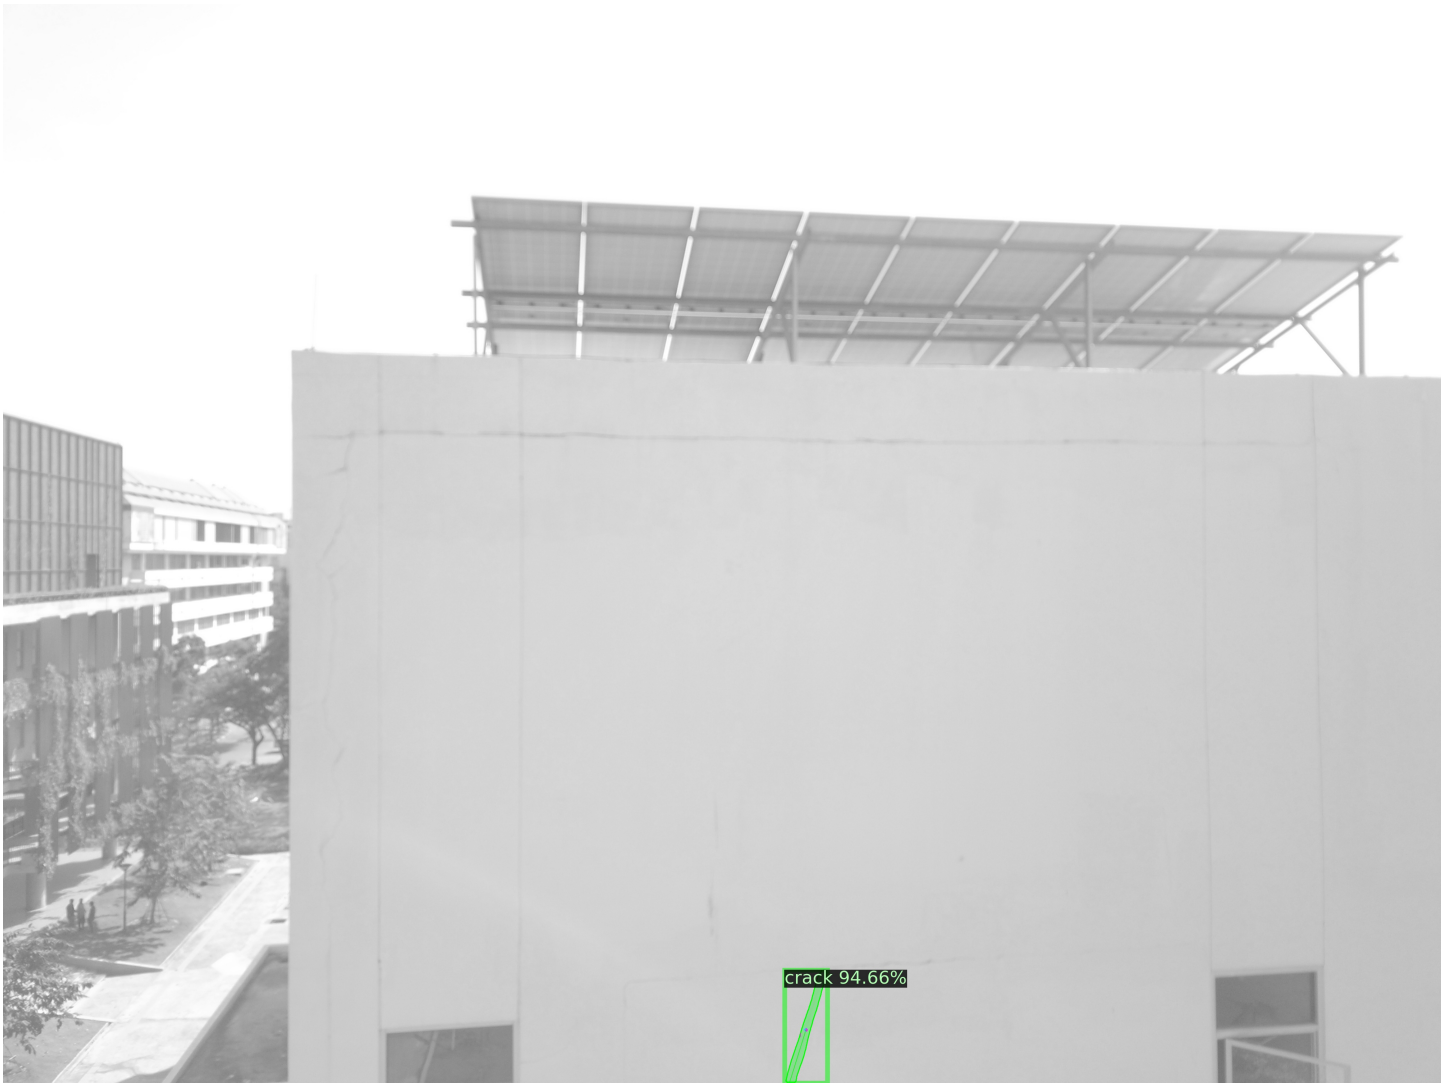
Crack number 1 (confidence score: 94.66%)  
The detected crack is on wall component in this image.  
Crack density: 0.08%  
Crack width: 8.83 mm  
Angle wrt horizontal line: -106.91 degree  
Configuration: transverse  
Position: Middle fourths of the wall  
Severity index for this crack: 2  
Suggested corrective action: General repair but no detailed investigation required
