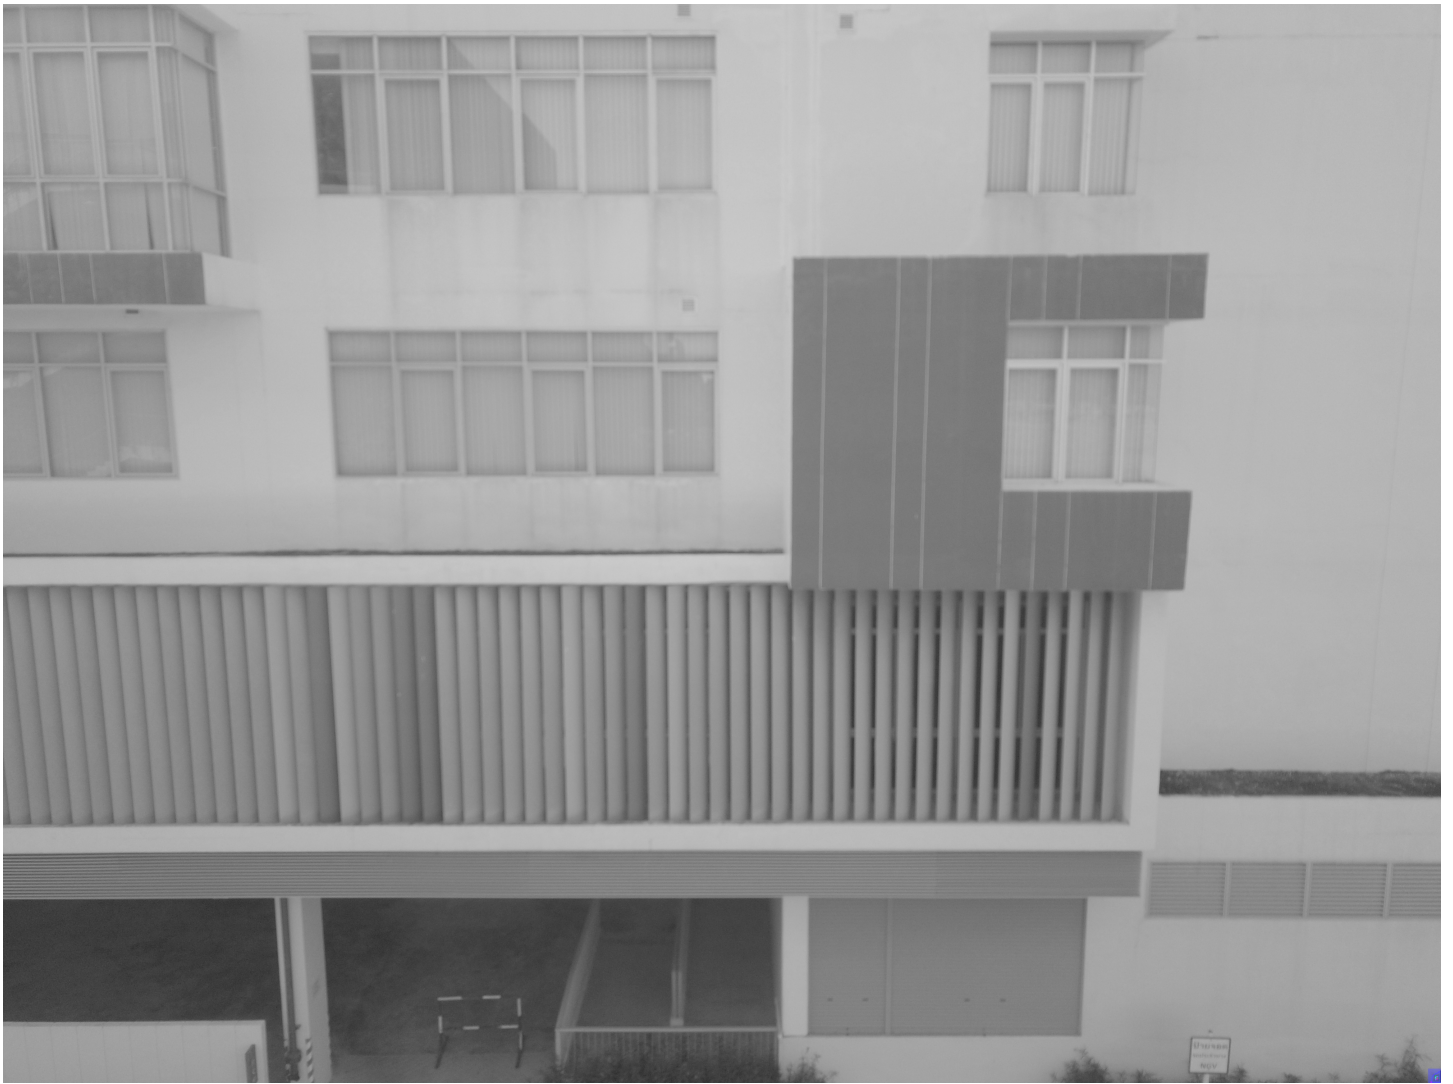
Crack number 1 (confidence score: 0.84%)

The detected crack is on wall component in this image.

Crack density: 0.01%

Crack width: 4.55 mm

Angle wrt horizontal line: -123.92 degree

Configuration: shear

Position: Right one fourth of the wall

Severity index for this crack: 2

Suggested corrective action: General repair but no detailed investigation required
