## Thrust-reverse system

## Details about the design features of the aircraft

From Frankfurt, Germany to Warsaw, Poland  
Airbus A320-211

From Pardubice, Czech Republic to Moscow, Russia  
Tupolev Tu-204-100

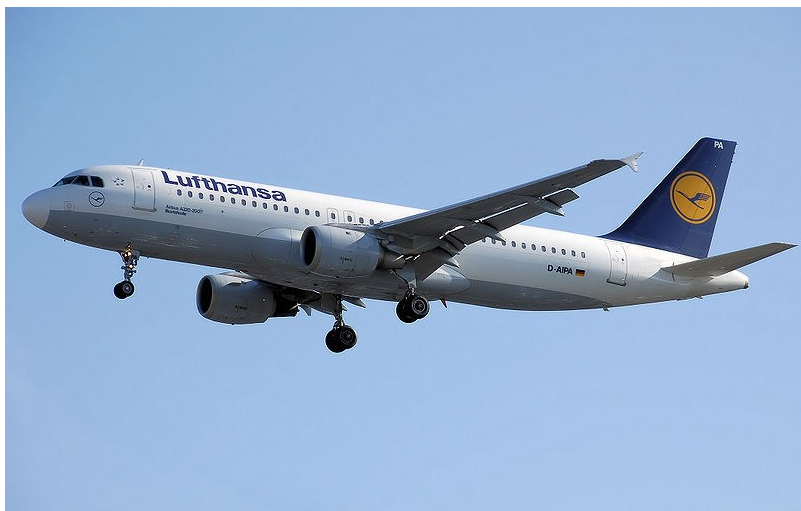
Lufthansa Flight 2904 was cleared to land at Okęcie International Airport Rwy 11 and was informed of the existence of wind shear on the approach. To compensate for the crosswind, the pilots attempted to touch down with the aircraft banked slightly to the right. Additionally they landed with a speed about 20 knots (37 km/h) faster than usual. According to the manual, this was the correct procedure for the reported weather conditions.

But the weather report was not up to date. At the moment of touch down, the assumed **crosswind** turned out to be a **tailwind**. Due to the tailwind of approximately 20 knots (37 km/h) and the increased speed the airplane hit the ground at approximately 170 knots (310 km/h) and far beyond the normal touch down point.

The aircraft's right gear touched down **770 m** from the runway 11 threshold.

The left gear touched down **9 seconds** later, **1525 m** from the threshold.

Only when the left gear touched the runway did the ground spoilers and engine thrust reversers deploy, these automatic systems depending on oleo strut (shock absorber) compression.

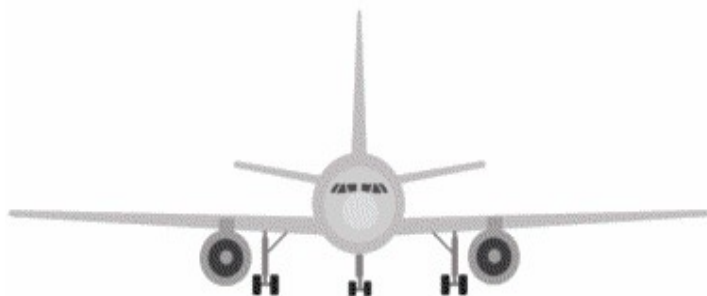
Illustration of distance relative to main strut touchdown. **The striped line** marks 1400 m, which divides the runway in half. **Red** indicates the landing gear have not touched down, **blue** indicates hydroplaning, and **green** indicates wheels on the ground.

In the case of the Warsaw accident neither of the first two conditions was fulfilled, so the most effective braking system was not activated. Point one was not fulfilled, because the plane landed inclined (to counteract the anticipated crosswind). Thus the pressure of 12 tons on both landing gears required to trigger the sensor was not reached. Point two was also not fulfilled because of a hydroplaning effect on the wet runway.

Only when the left landing gear touched the runway did the automatic aircraft systems allow the ground spoilers and engine thrust reversers to operate. Due to the braking distances in the heavy rain the aircraft could not stop before the end of the runway. The computer did not actually know the aircraft had landed until it was already 125 meters beyond the half way point of runway 11.

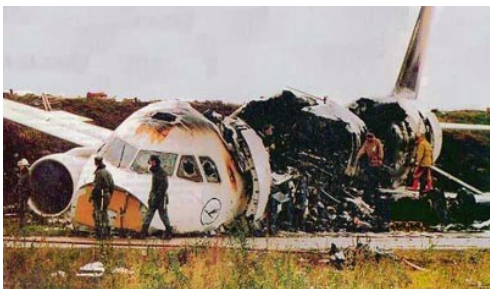
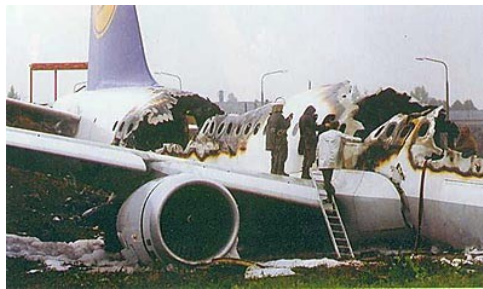
Passengers: 64, crew: 6.  
Injuries: 68, fatalities: 2, survivors: 68.

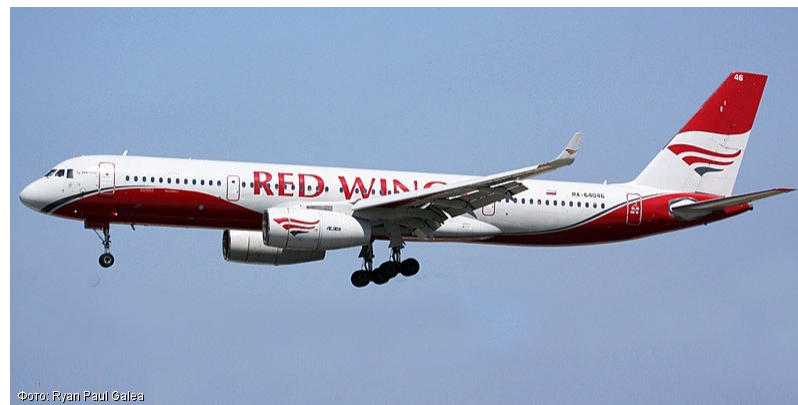
Approach was carried out on the runway 19 at Vnukovo Airport with length of 3060m. During preparation for landing the captain has determined the landing speed as 210 km/h, and specified that the speed of at least 230 km/h has to be maintained. End of the runway was passed at the height of 15 meters and airspeed of 260 km/h. 5 seconds after the throttle had been switched to the idle mode, the aircraft landed with the speed of 230 km/h, distance from the runway threshold of 900-1000m and left bank of 1... 1.5°.

At this point the signal of left gear strut compression was produced. During the landing the right side wind gusts reached up to ~11.5 m/s. The maximal value of the vertical acceleration speed during touchdown was recorded as 1.12g. About 10 seconds have passed from the moment of passing the 4m altitude point and the touchdown. 3 seconds after that the touchdown nose gear strut was compressed. At this stage the right gear strut compression signal had not yet been formed.

Almost simultaneously with the touchdown of the nose landing gear the crew moved in one motion the engine controls to the "maximum reverse" position and applied mechanical brakes. Actuation of the valves of reversing systems on both engines did not happen. Air brakes and spoilers also were not activated automatically and the crew did not attempt to activate them manually.
