Thrust-reverse system

Lufthansa Flight 2904 (September 14, 1993)

Red Wings Airlines Flight 9268 (December 29, 2012)

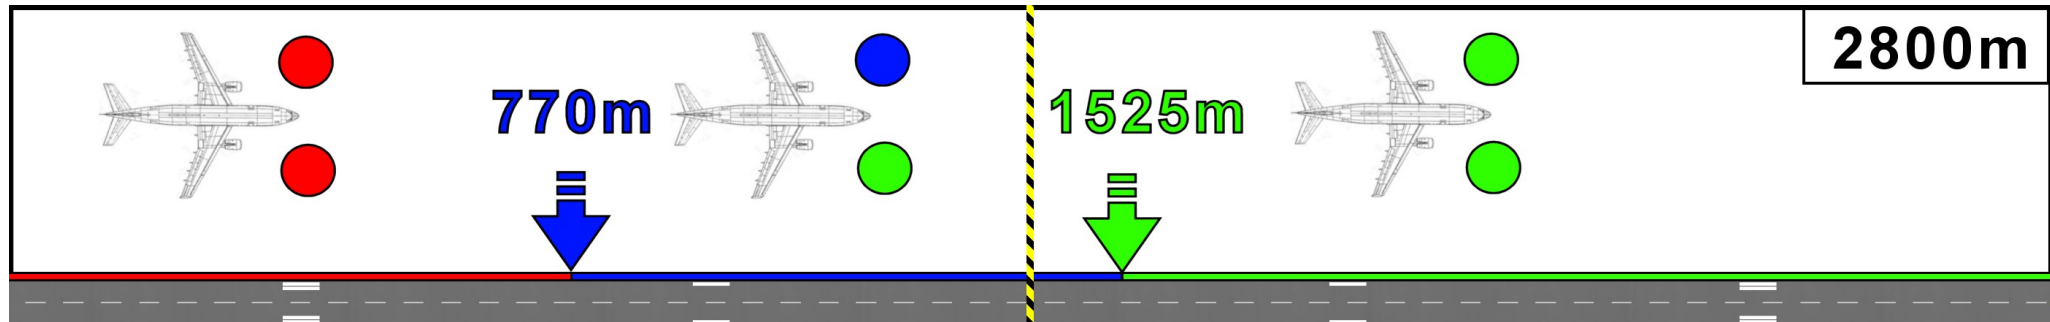
Illustration of distance relative to main strut touchdown. **The striped line** marks 1400 m, which divides the runway in half. **Red** indicates the landing gear have not touched down, **blue** indicates hydroplaning, and **green** indicates wheels on the ground.

In the case of the Warsaw accident neither of the first two conditions was fulfilled, so the most effective braking system was not activated. Point one was not fulfilled, because the plane landed inclined (to counteract the anticipated crosswind). Thus the pressure of 12 tons on both landing gears required to trigger the sensor was not reached. Point two was also not fulfilled because of a hydroplaning effect on the wet runway.

Only when the left landing gear touched the runway did the automatic aircraft systems allow the ground spoilers and engine thrust reversers to operate. Due to the braking distances in the heavy rain the aircraft could not stop before the end of the runway. The computer did not actually know the aircraft had landed until it was already 125 meters beyond the half way point of runway 11.

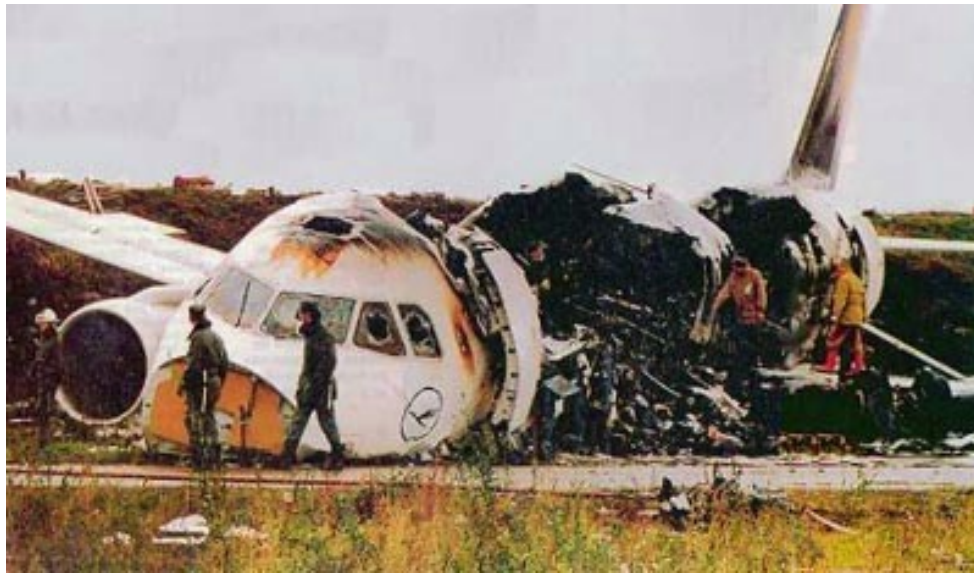
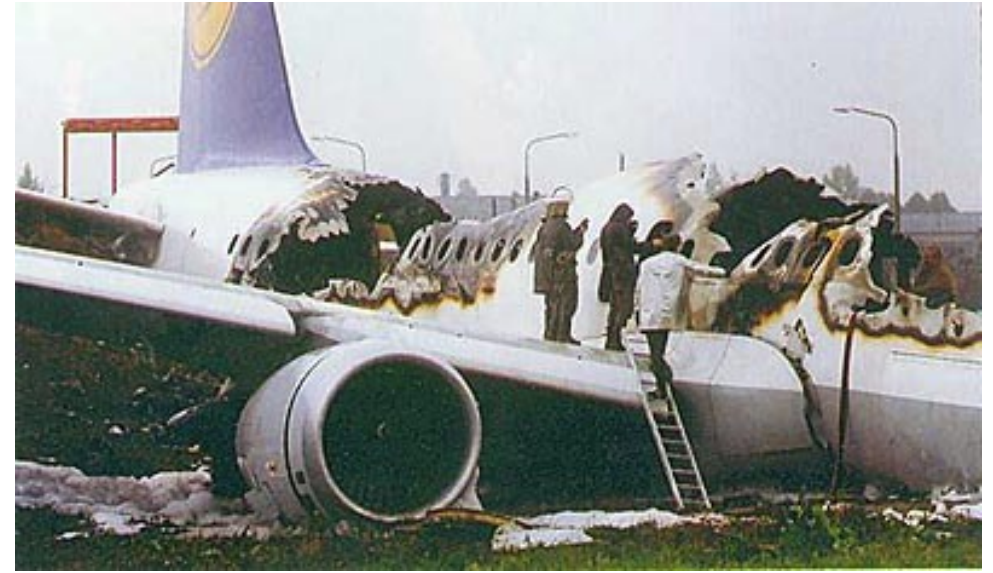
Accident summary:

Passengers: 64, crew: 6.

Injuries: 68, fatalities: 2, survivors: 68.

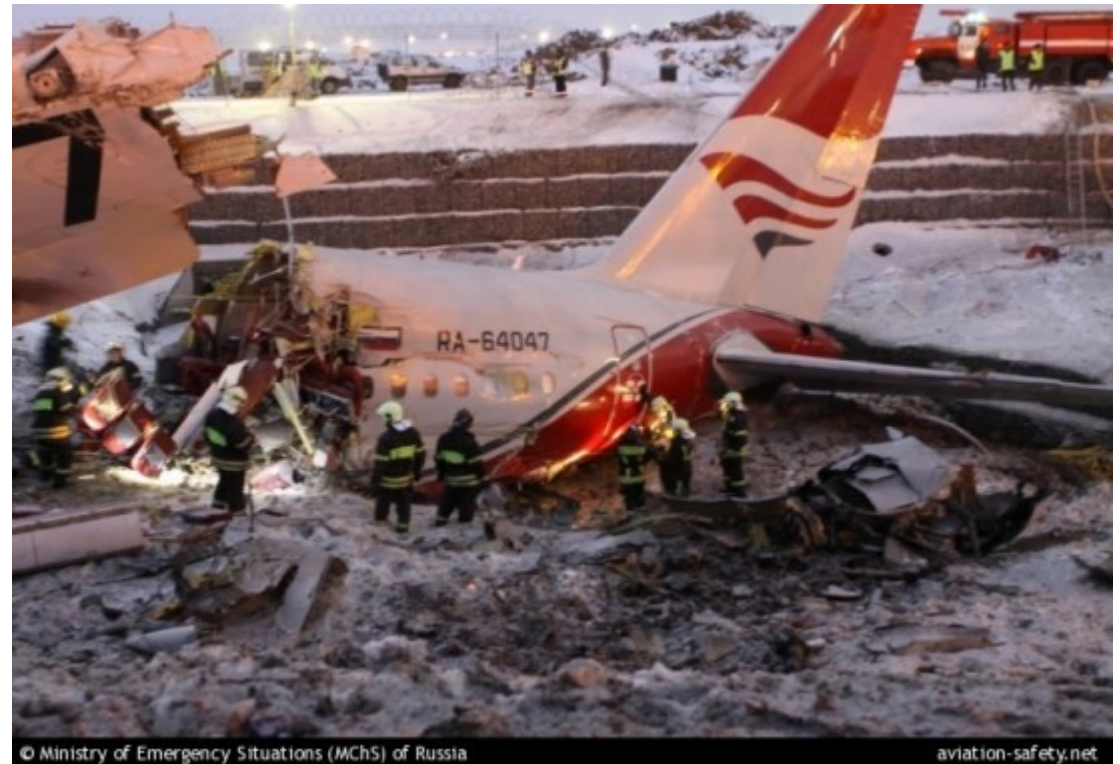
Accident summary:

Passengers: 0, crew: 8.

Injuries: 3, fatalities: 5, survivors: 3.
