Thrust-reverse system

From Frankfurt, Germany to Warsaw, Poland
Airbus A320-211

Red Wings Airlines Flight 9268 (December 29, 2012)

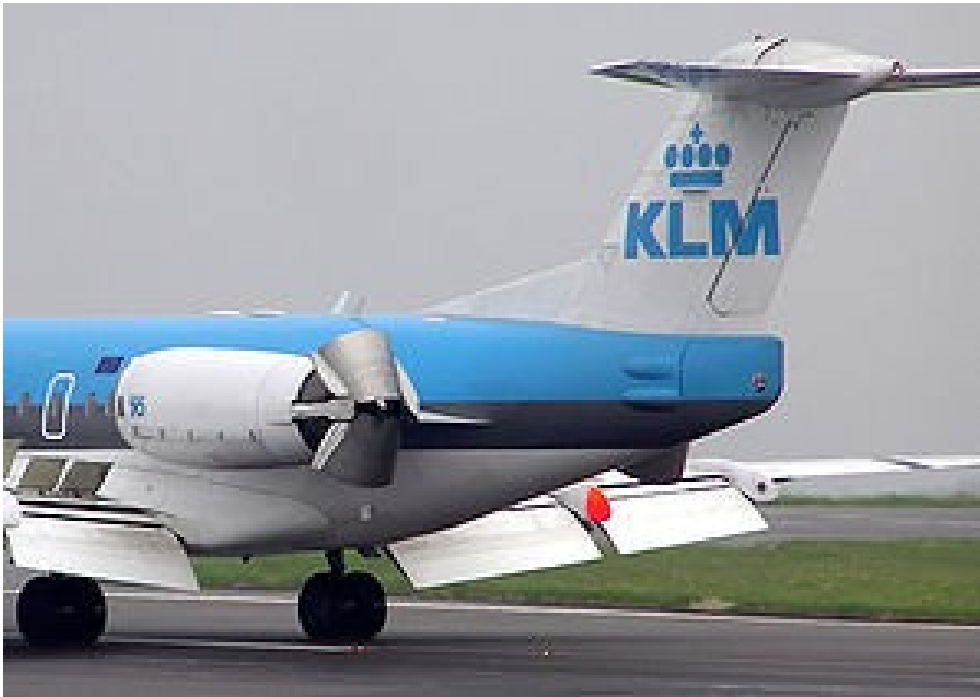
A KLM Fokker 70 rolling out with **flaps** fully extended, **spoilers** raised, and **reverse thrust** selected. The two reverse thrust buckets behind each engine can be seen in the deployed position, diverting the engine exhaust gases forward.

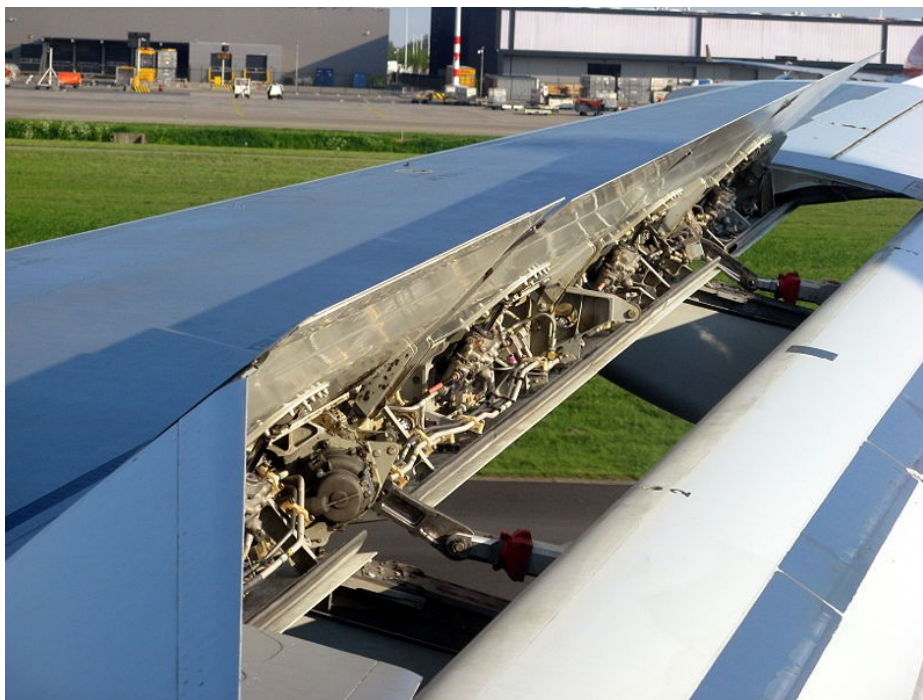
A close look at the inner workings of spoilers in lift dump deployment during the landing of an Airbus A320.

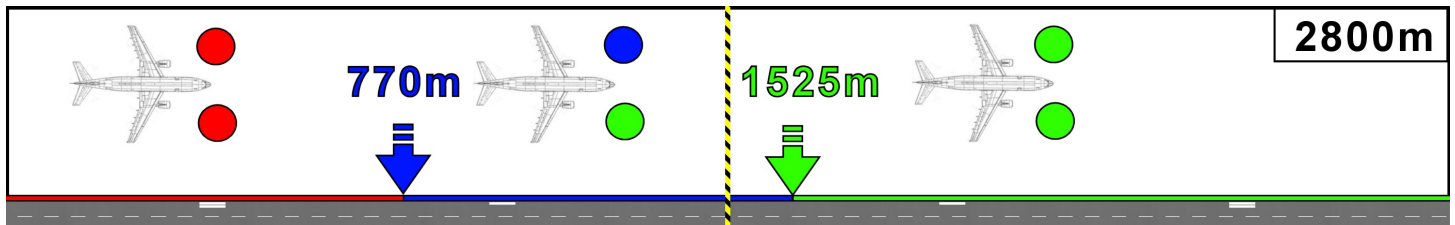
Illustration of distance relative to main strut touchdown. **The striped line** marks 1400 m, which divides the runway in half. **Red** indicates the landing gear have not touched down, **blue** indicates hydroplaning, and **green** indicates wheels on the ground.

In the case of the Warsaw accident neither of the first two conditions was fulfilled, so the most effective braking system was not activated. Point one was not fulfilled, because the plane landed inclined (to counteract the anticipated crosswind). Thus the pressure of 12 tons on both landing gears required to trigger the sensor was not reached. Point two was also not fulfilled because of a hydroplaning effect on the wet runway.

Only when the left landing gear touched the runway did the automatic aircraft systems allow the ground spoilers and engine thrust reversers to operate. Due to the braking distances in the heavy rain the aircraft could not stop before the end of the runway. The computer did not actually know the aircraft had landed until it was already 125 meters beyond the half way point of runway 11.
