QUALITY REPORT

LFM-0122-200-166

ReportNumber:	01	ProjectNumber:	LFM-0122-200-166
PartNumber:	LFM-0122-200-166	InquiryNumber:	LFM-0122-200-166.001
Requirements:	DO-01	DrawingNumber:	LFM-0122-200-166.idw
PartTitle:	Turbine blade	Visual testing date:	04.05.2022

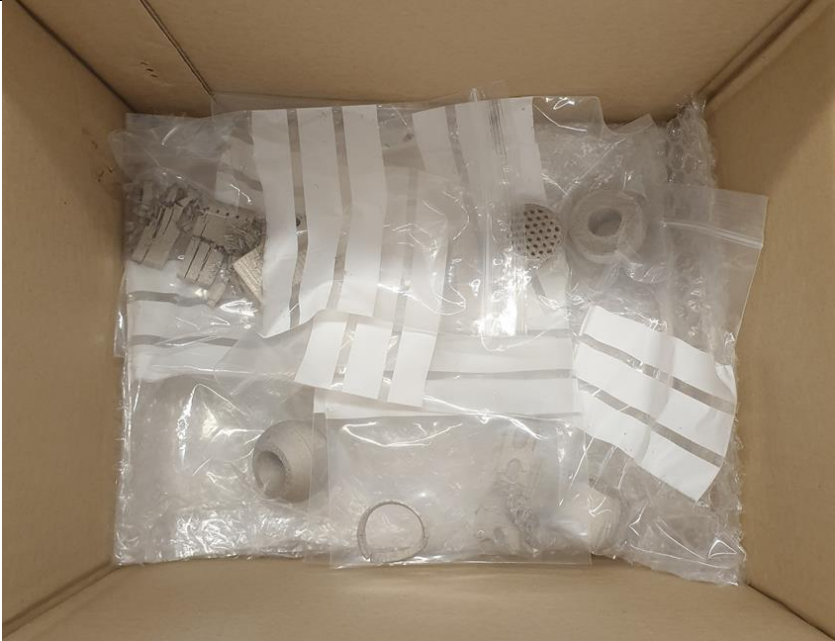
Appendix <input checked="" type="checkbox"/> YES / <input type="checkbox"/> NO (Description/Pages)	General test instructions, acceptance rule, part properties/ 3 pages
Remarks:	<ul style="list-style-type: none"> Parts were safely packed Part completely broke apart during sintering. Further processing of defective parts for validation of the documentation process
