PRINT REPORT

LFM-0122-100-001

ReportNumber:	01	ProjectNumber:	LFM-0122-100-001
PartNumber:	LFM-0122-100-001	InquiryNumber:	LFM-0122-100-001.001
Requirements:	DO-01	DrawingNumber:	LFM-0122-100-001.idw
PartTitle:	Femoral head 32mm	Visual testing date:	04.04.2022

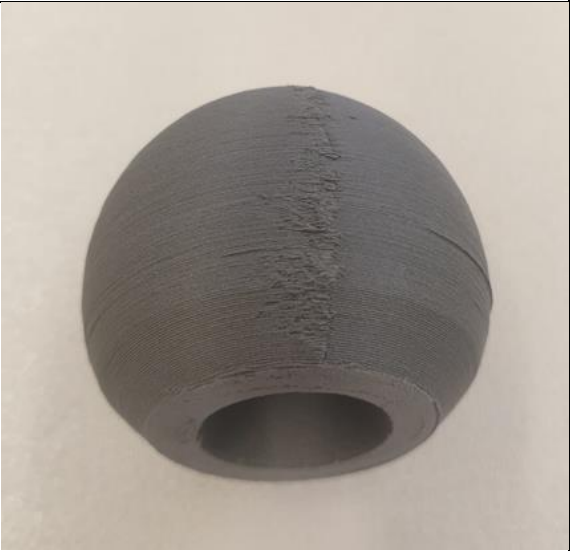
View of the defects (if occurred)		
z-seam on surface

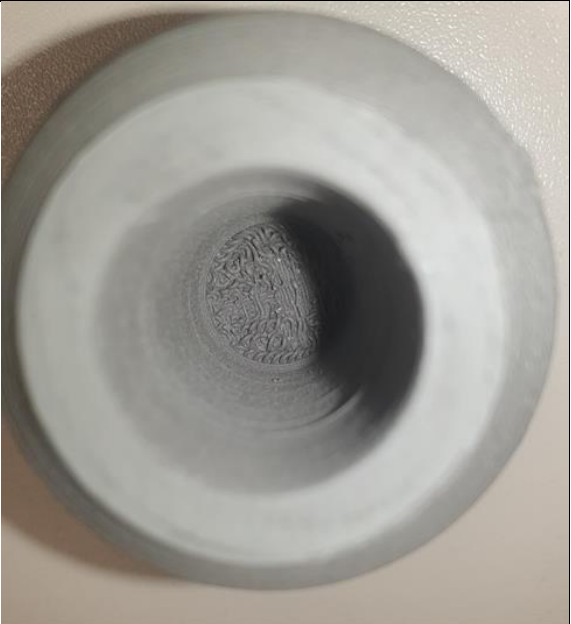
Bad overhangs at the end of the hole
