PRINT REPORT

LFM-0122-200-166

ReportNumber:	01	ProjectNumber:	LFM-0122-200-166
PartNumber:	LFM-0122-200-166	InquiryNumber:	LFM-0122-200-166.001
Requirements:	DO-01	DrawingNumber:	LFM-0122-200-166.idw
PartTitle:	Turbine blade	Visual testing date:	05.04.2022

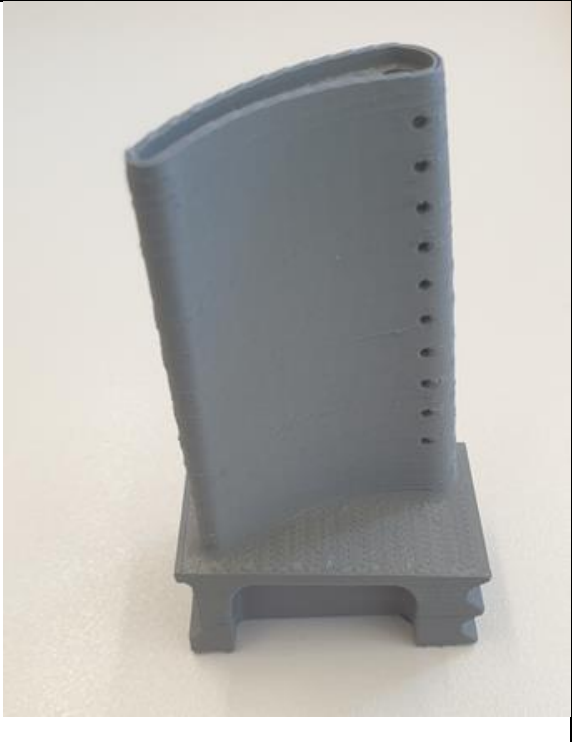
<p>View under test conditions</p>

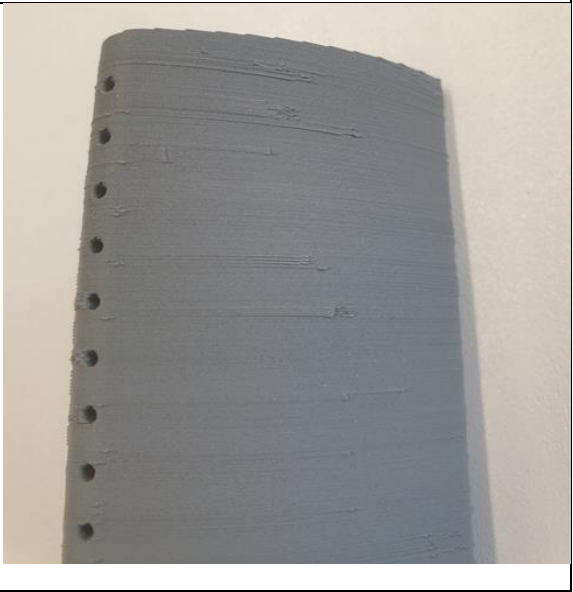
<p>View of the defects (if occurred)</p>		
<p>Blobs</p>

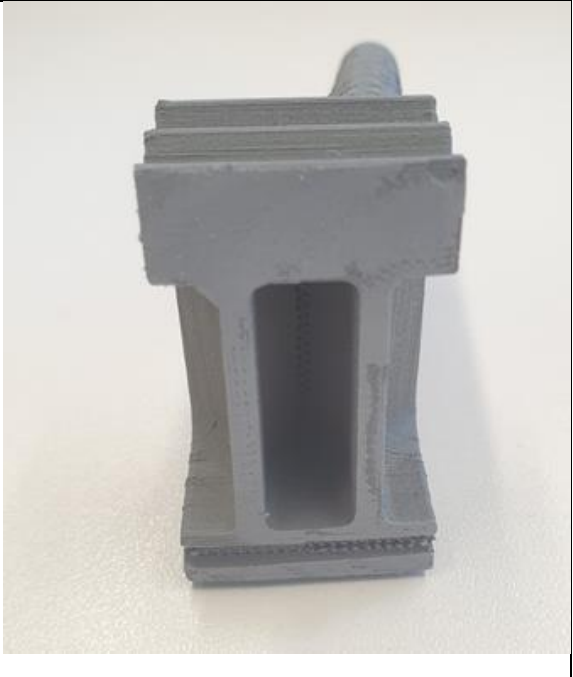
Appendix <input checked="" type="checkbox"/> YES / <input type="checkbox"/> NO (Description/Pages)	General test instructions, acceptance rule, printing properties/ 3 pages
Remarks:	<ul style="list-style-type: none"> Good printing parameters Raft difficult to remove

<p>Bad initial layer due to difficult raft removal</p>
