# QUALITY REPORT

LFM-0122-100-001

ReportNumber:	01	ProjectNumber:	LFM-0122-100-001
PartNumber:	LFM-0122-100-001	InquiryNumber:	LFM-0122-100-001.001
Requirements:	DO-01	DrawingNumber:	LFM-0122-100-001.idw
PartTitle:	Femoral head 32mm	Visual testing date:	04.05.2022

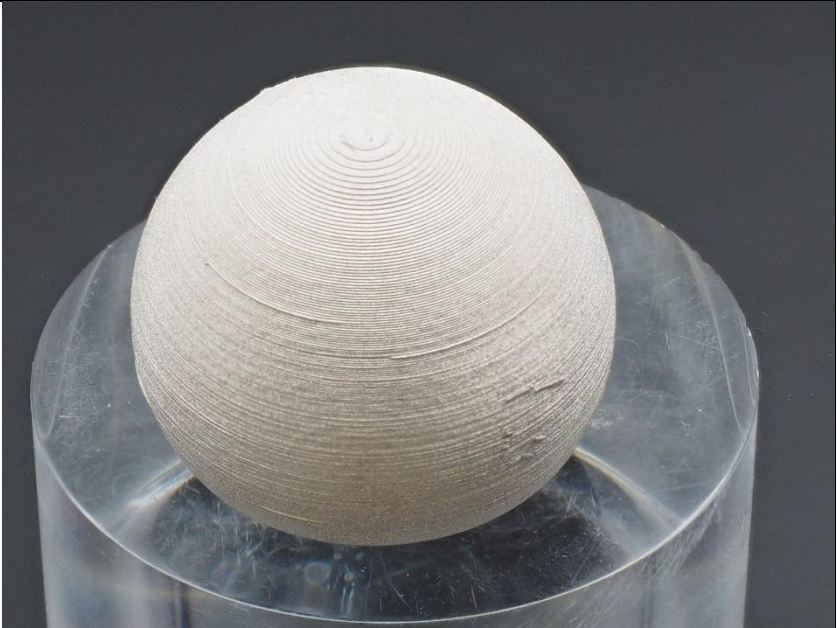
<p>View of the defects (if occurred)</p>	
<p>Rough initial surface</p>

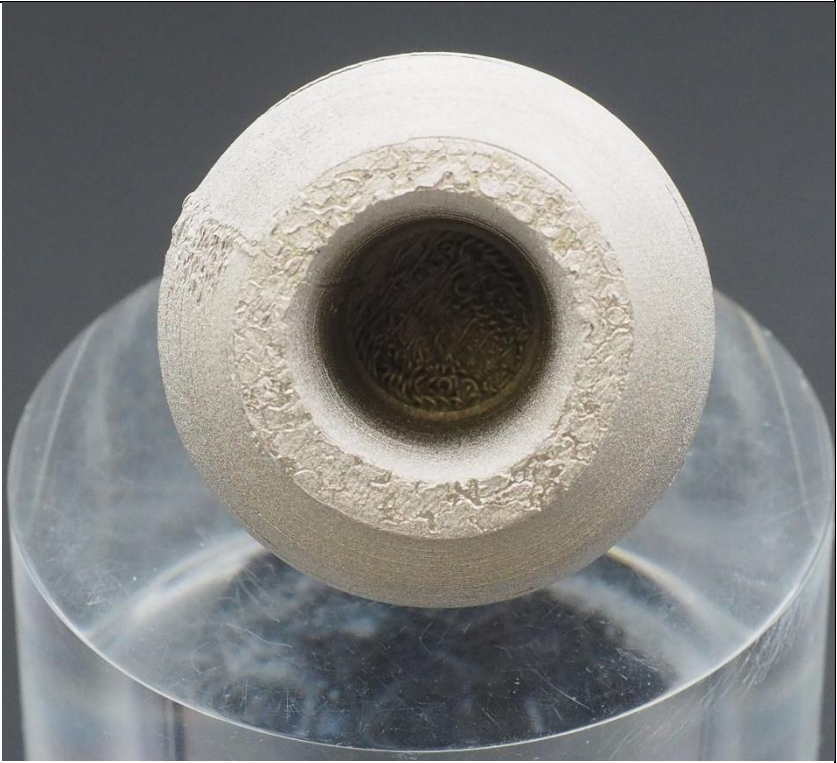
<p>Z-seam on outer sur- face</p>	 
--------------------------------------	--
