**ProLiant DL380 Gen10 - Embedded ALOM HPE Eth 10/25Gb 2p 640FLR-
SFP28 Adptr shows Unknow in ILO 5**

- Embedded ALOM HPE Eth 10/25Gb 2p 640FLR-SFP28 Adptr shows Unknow in ILO 5

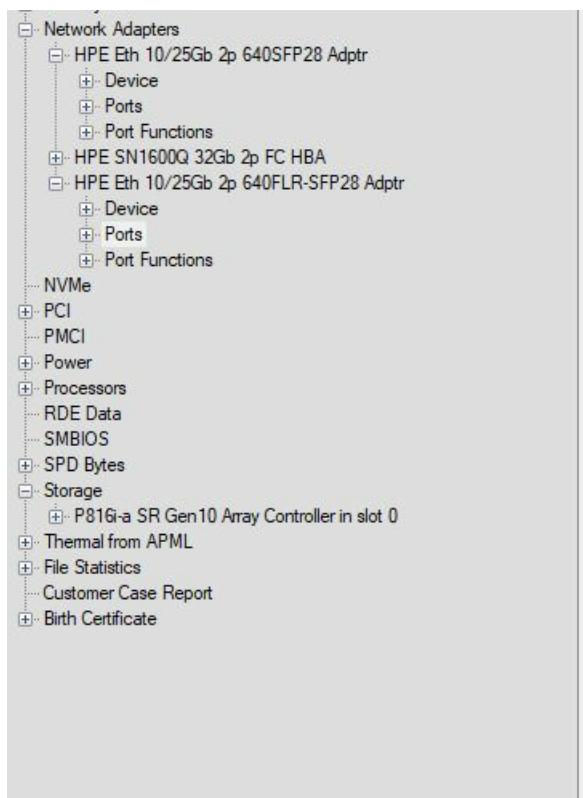
- Unsupported SFP ((Small form factor Pluggable transceiver)

- Verified in AHS for the card details and found different Part number for installed SFP (Small form factor Pluggable transceiver)
- Embedded ALOM Port Details and Installed SFP Part number in AHS Logs :-

- Change the Supported SFP with spare part no # 455885-001 after which Ports are showing OK in ILO 5 and up in Operating System.
- To verify the Supported SFP (Small form factor Pluggable transceiver) please refer the link
 :- <https://h20195.www2.hpe.com/v2/gethtml.aspx?docname=c04815215>

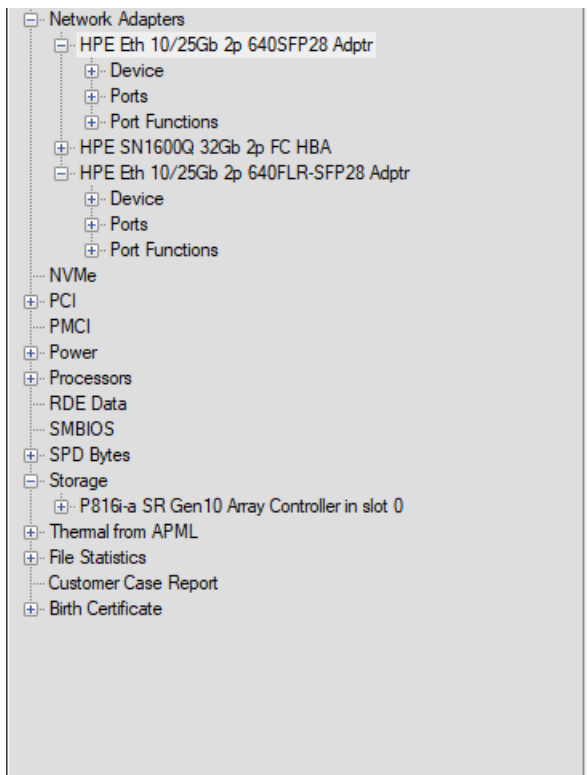
- Slot 1 HPE Eth 10/25Gb 2p 640SFP28 Adptr details and Installed SFP Part number in AHS :-
