**HPE ProLiant Gen10 Server - Qlogic FC HBA Ports may disappear from UEFI
boot order on system with Multiple FC HBAs installed with iLO FW version 2.65
or below**

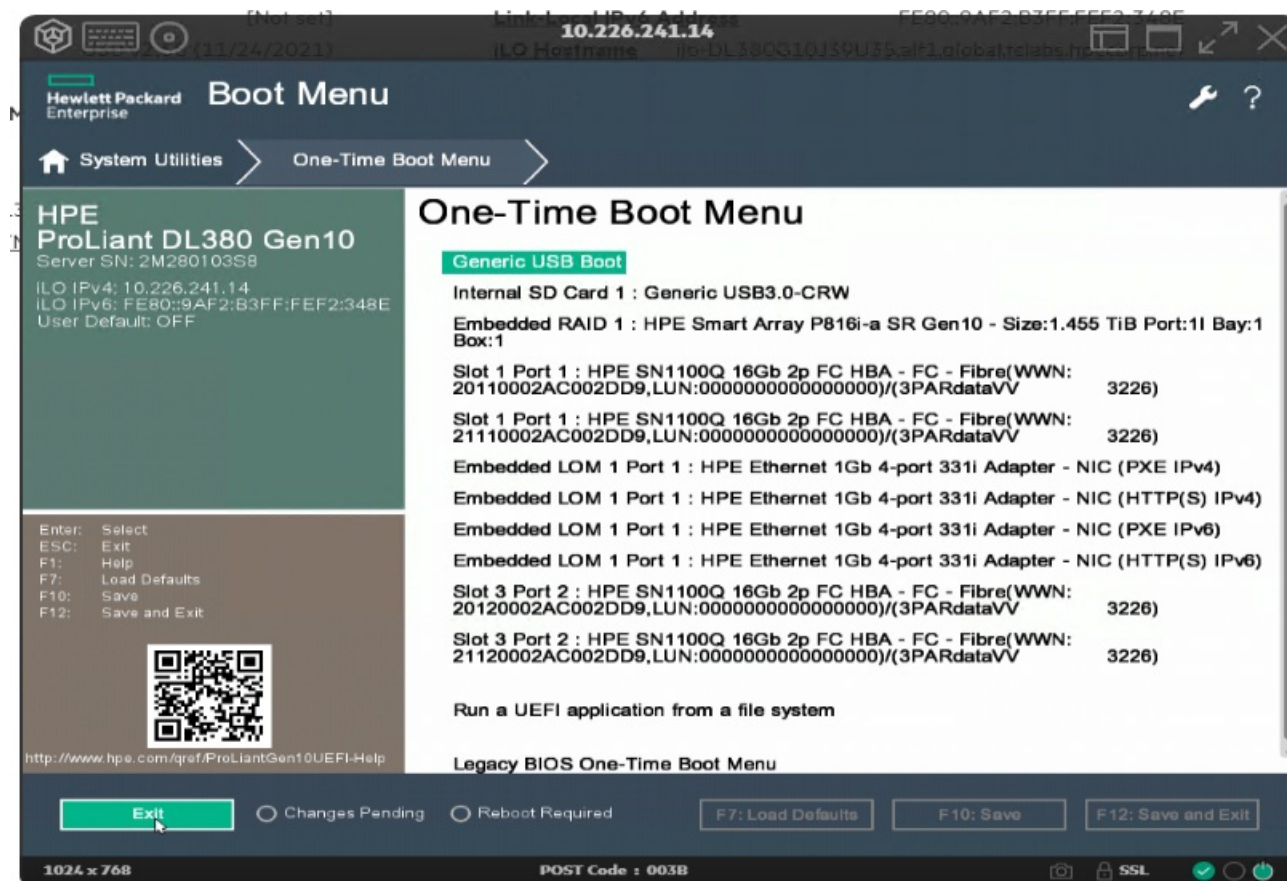
When system is configured with Multiple FC HBA [Slot 1 and Slot 3 in below example] and LUNS are mapped with Adapter Driver - "Enabled" in FC HBA BIOS, the BIOS boot order should have following entries -

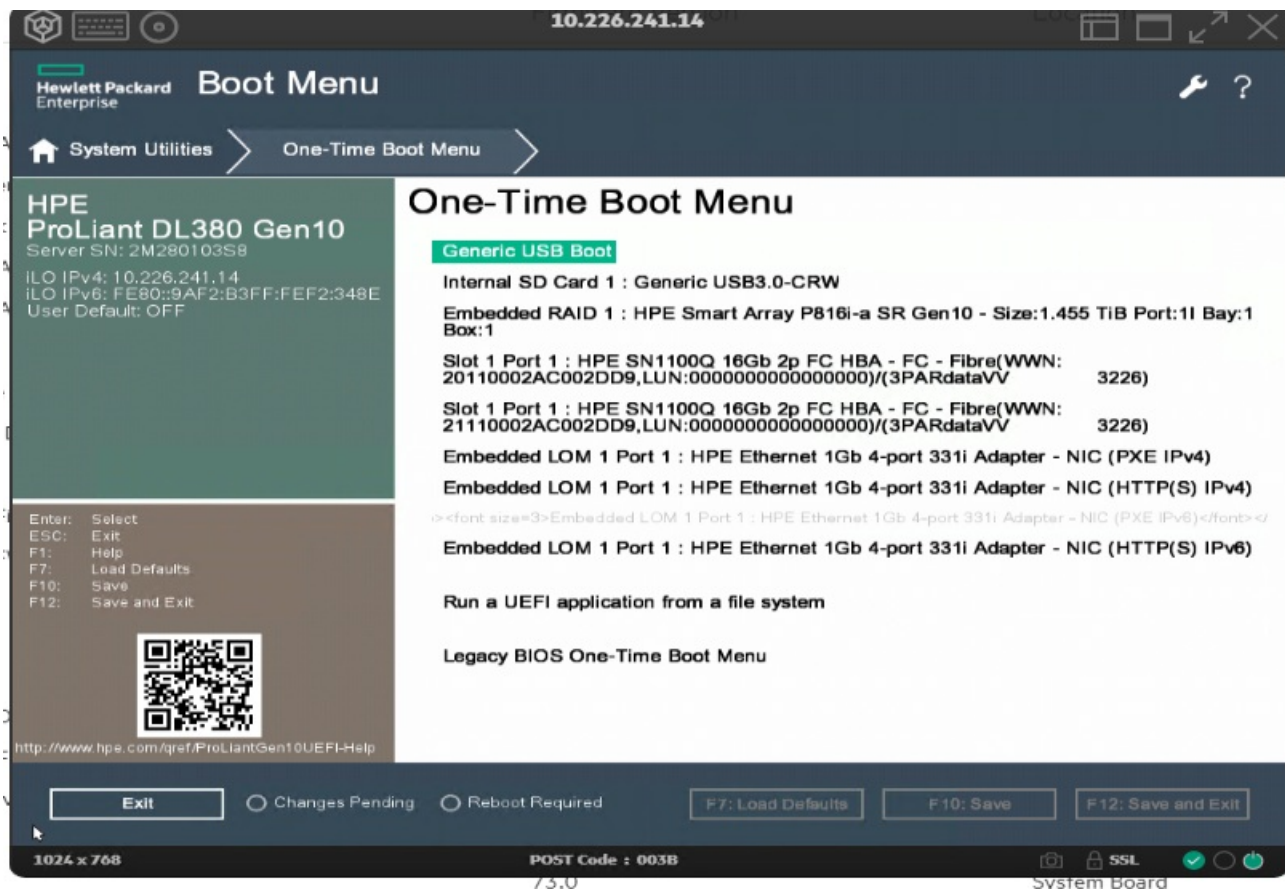
After the reboot, the FC HBA in Slot 3 disappears and Adapter Driver in FC HBA BIOS may change to "Disabled" and we can see the following entries -

Update the iLO Firmware to latest version v2.70

Also ensure that Adapter Driver is Enabled in FC HBA BIOS for ports configured with LUNs -

1. During system boot press the F9 key to enter the system configuration menu.
2. Select System Configuration and then press the Enter key.
3. Navigate to one of the desired adapter ports and then press Enter
4. The HBAs HII configuration menu should appear Select Boot Settings and then press Enter
5. Select Adapter Driver and then press Enter --> Set it to Enabled and then press Enter

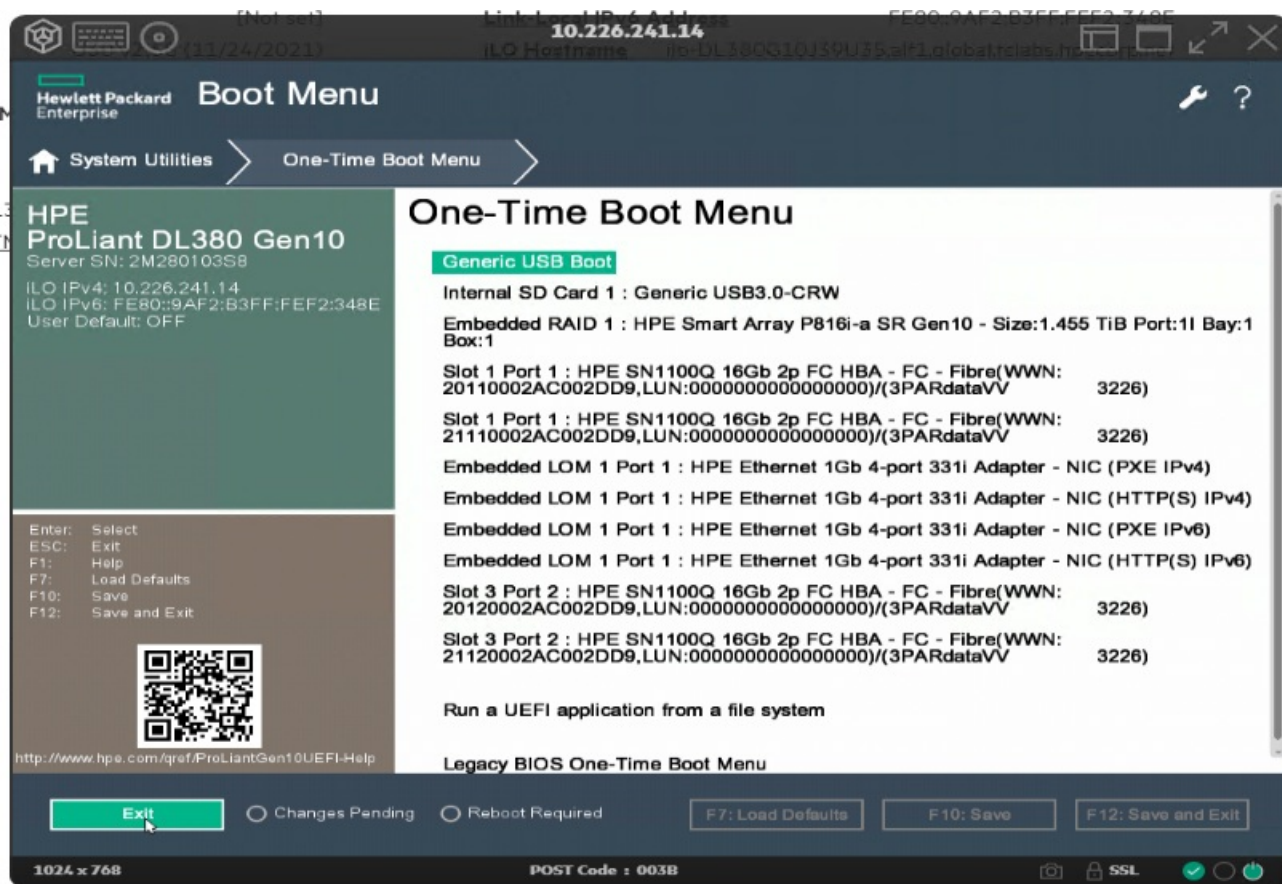
When system is configured with Multiple FC HBA [Slot 1 and Slot 3 in below example] and LUNS are mapped with Adapter Driver - "Enabled" in FC HBA BIOS, the BIOS boot order should have following entries -

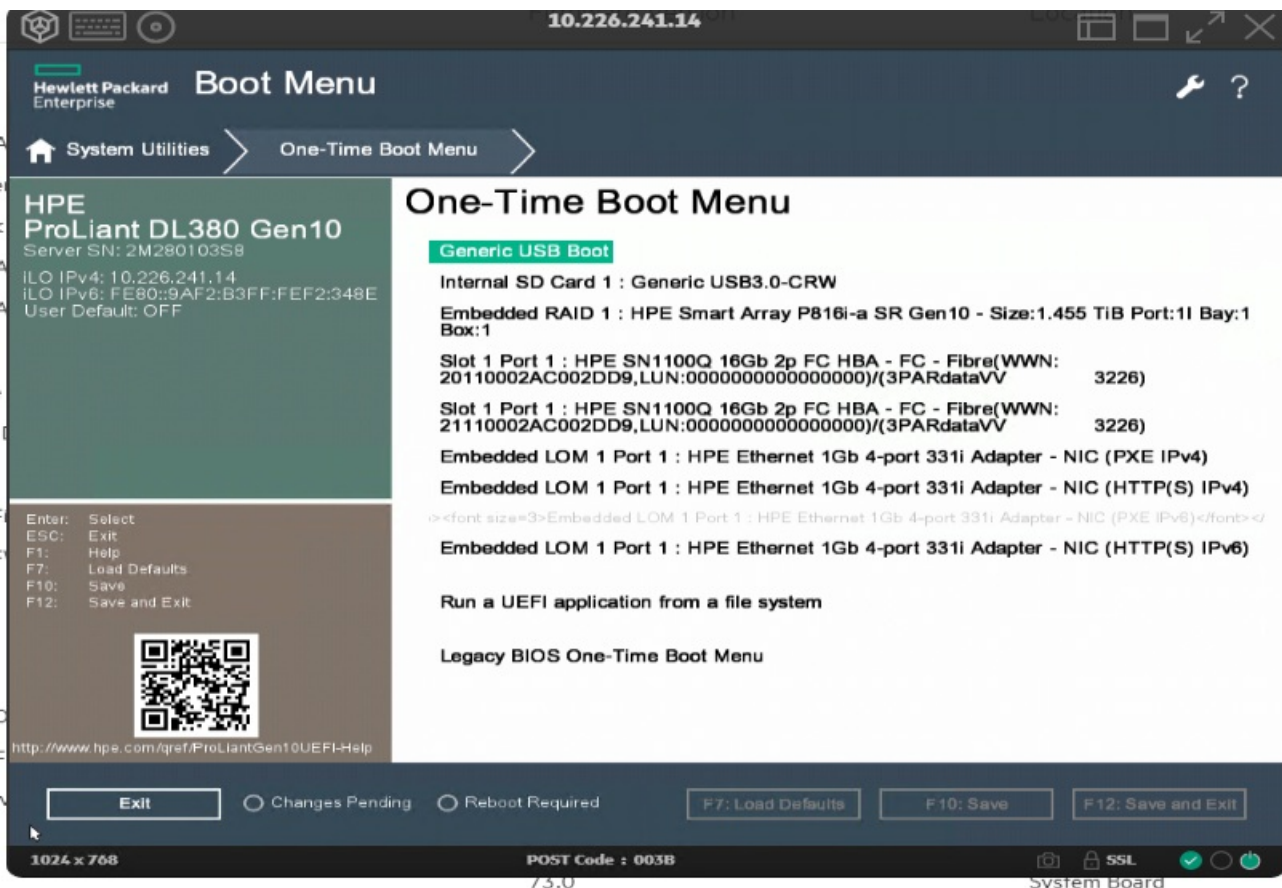
After the reboot, the FC HBA in Slot 3 disappears and Adapter Driver in FC HBA BIOS may change to "Disabled" and we can see the following entries -
