## PROPERTY CONDITION ASSESSMENT REPORT

27214 Fraser Hwy, Aldergrove, BC

DATE OF INSPECTION: June 12, 2020

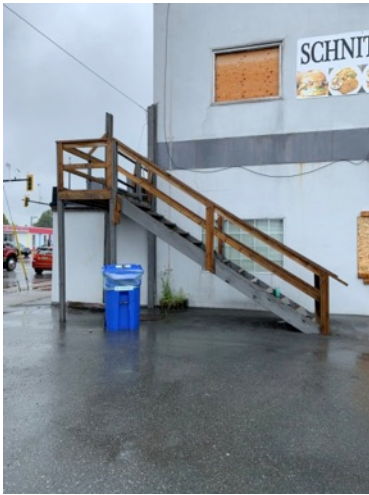
Significant deterioration and structural deficiencies were noted to the exterior rear wood stair structures.

*Photo 1.* View of the exterior wood stairs located at the southwest.

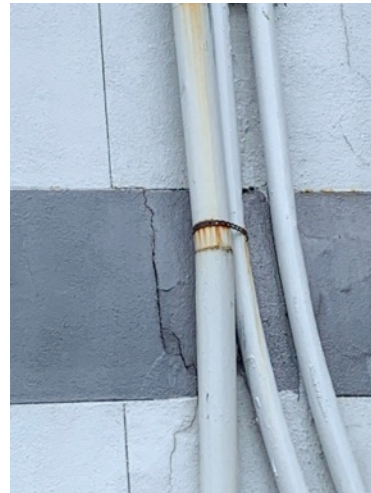
Many deficiencies were noted with the wall cladding systems including leakage and wood rot visible at a number of locations.

*Photo 4.* Close-up view of the stucco cracks and damage noted at the centre of the south exterior wall.

We recommend a building envelope review with invasive testing by a building envelope specialist to determine the extent of damage and anticipate significant cost to repair.

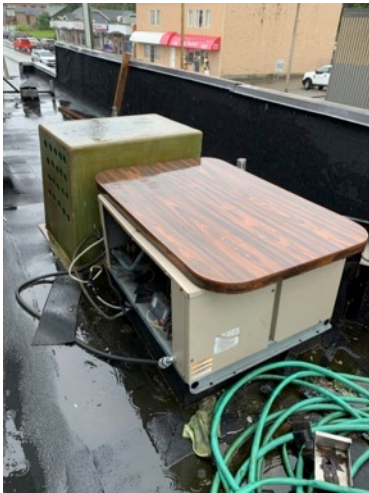
- 4.2.4** There are rooftop units located at the west and south lower roofs. The units appear to be quite old and inoperative at the time of the site visit. The economic service lifespan of the equipment is considered to be 20 years. As such, the rooftop equipment will need to be replaced in the short term and the supply ducting may also need to be repaired or reconfigured depending on future tenant improvements. Similar to the recommendations above, a qualified heating contractor should be engaged to provide possible remediation methods.

*Photo 9.* View of the air conditioning units at the lower west side roof.

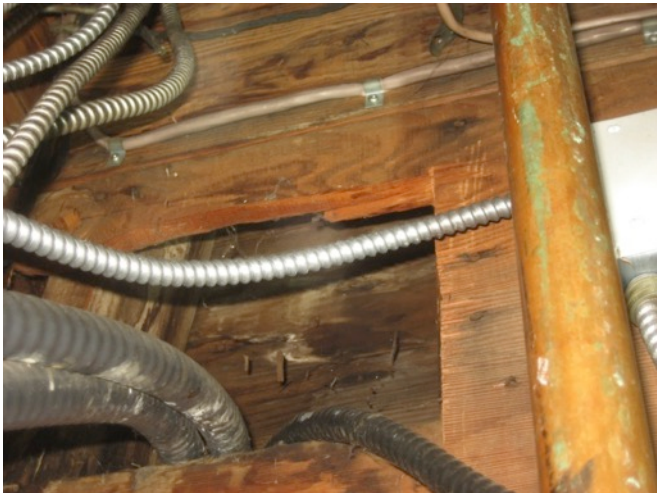
*Photo 15.* Close-up view of the exterior wall opening above the electrical room. Note the water staining.

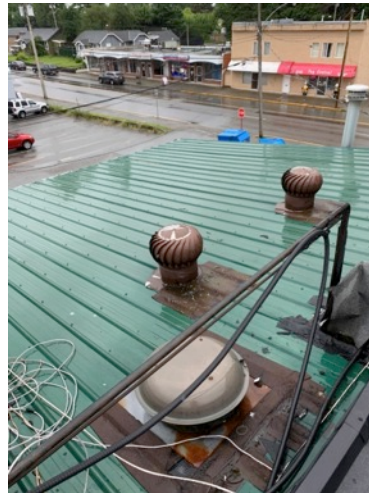
*Photo 16.* View of the sloped metal roof at the south side of the building. Noted the patching at the roof venting.

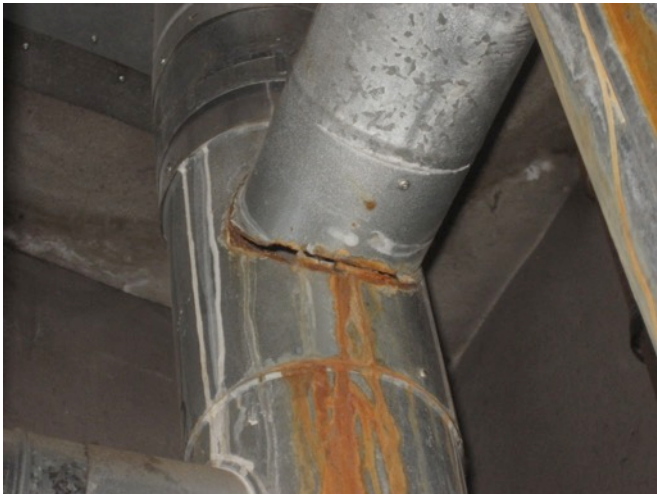
- 4.2.9** The metal exhaust chimney is cracked and corroded in the boiler room and should be replaced as required.

*Photo 19.* Close-up view of the corroded and damage metal exhaust vent located in the boiler room.

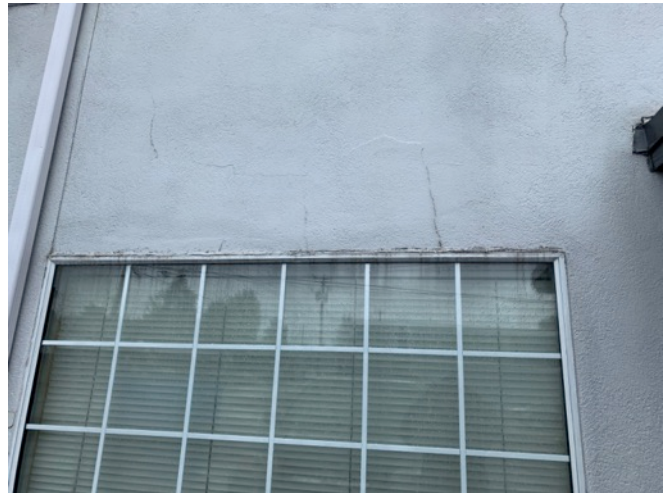
Many deficiencies were noted with the building windows and doors. The head and sill metal flashing detail are inadequate and missing. These areas should be addressed as part of the building envelope assessment.

*Photo 28.* Example view of the windows at the building. Noted at lack of head flashing and corrosion along the window frame.

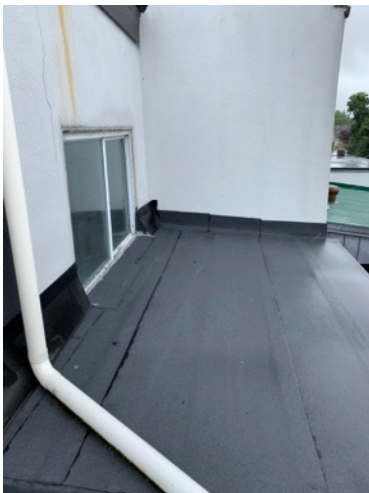
*Photo 29.* View of the second floor modified bitumen membrane against the southwest window. Note the poor threshold between the window and the flat roof.

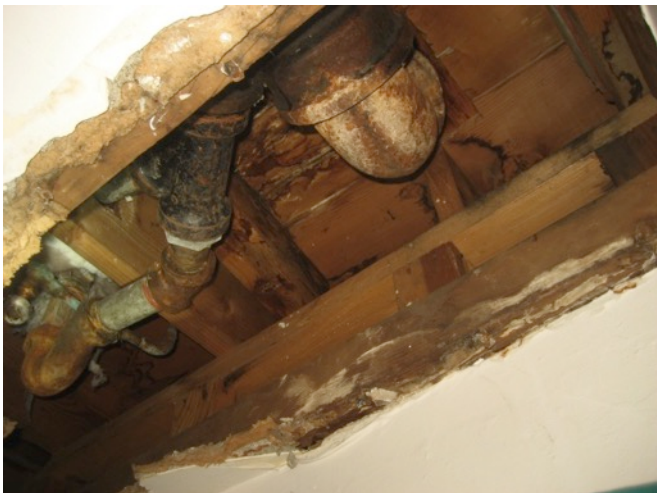
Significant deterioration was noted to the plumbing system. Replacement of the older waste piping and older copper supply piping should be anticipated in the short term including repairing some of the bathroom fixtures and bathtub enclosures at the same time. Anticipates significant cost to repair.

*Photo 35.* Example view of the older waste piping located at a ceiling opening.

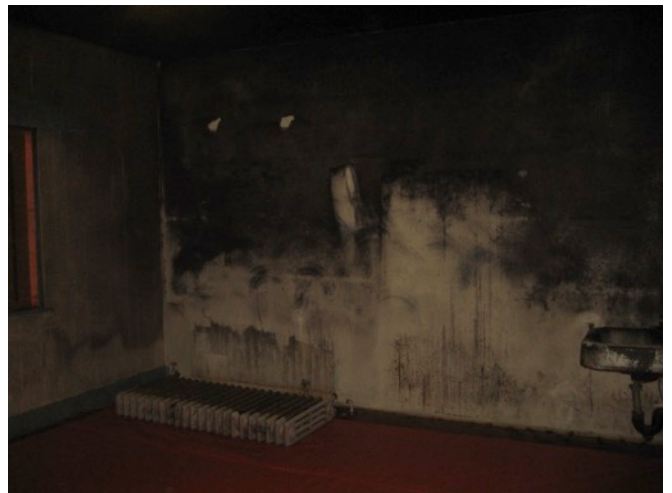
*Photo 36.* View of the room with a recent fire incident at the second floor hotel suite.

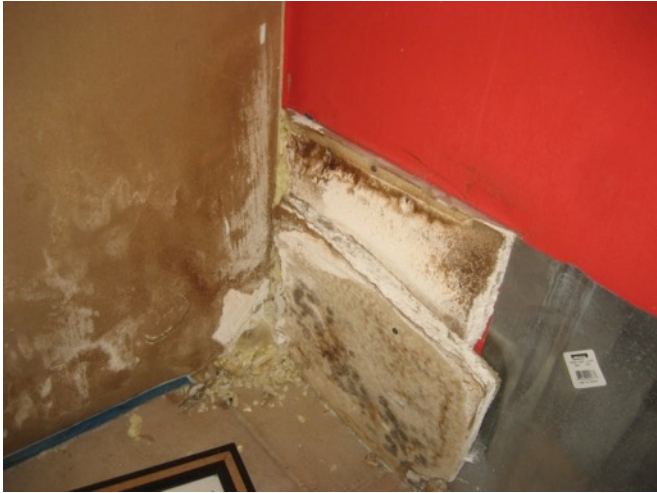
*Photo 43.* View of the water stains/leakage noted at the north, west exterior wall of the restaurant.

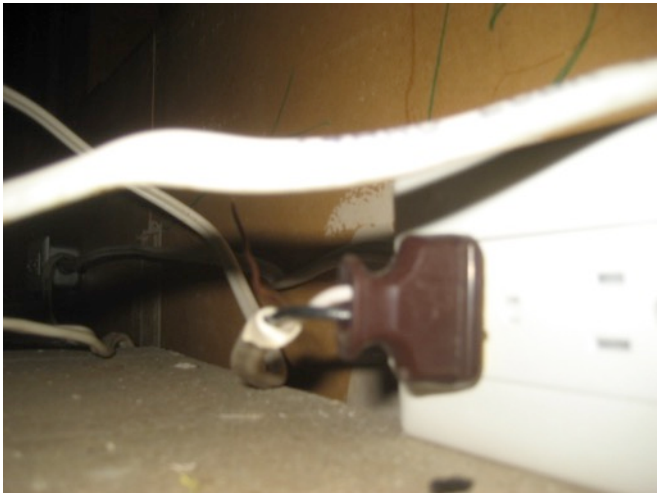
- Wires connected outside of a box were noted. All electrical connections should be made within approved junction boxes, complete with covers.
- Several examples of unprofessional workmanship were noted. There is an increased probability of hidden defects.

*Photo 45.* Close-up view of a unprofessional electrical wiring.

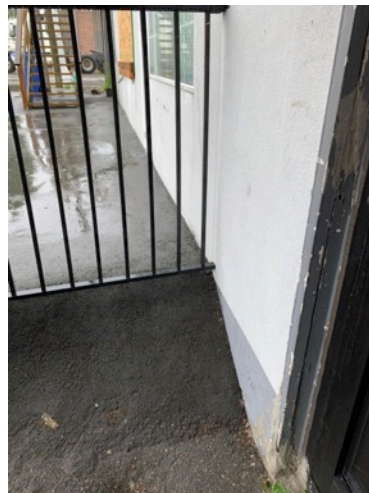
*Photo 48.* View of the recently elevated asphalt pavement against the south, west exterior wall of the building.

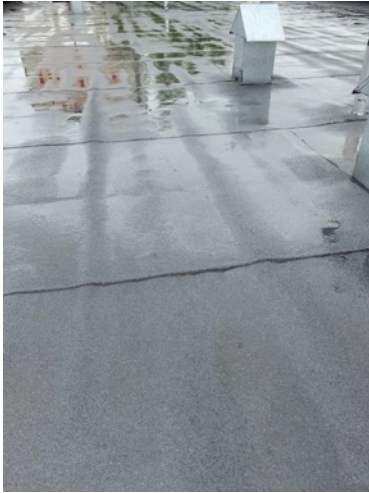
*Photo 49.* Close-up view of the blistering of the roof membrane located at the east side of the second floor flat roof.

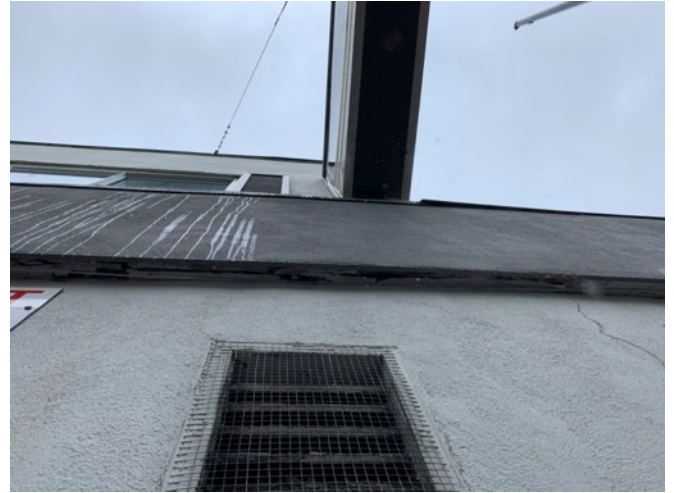
*Photo 50.* Close-up view of the rot noted at the underside wall edge on the north side of the building.

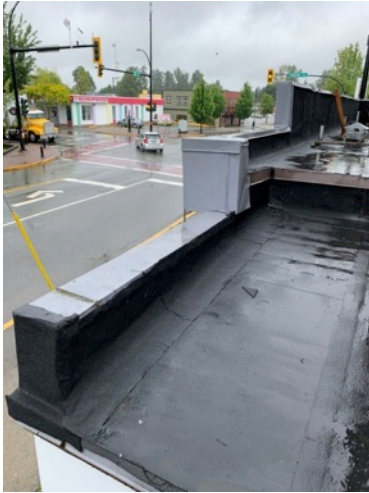
*Photo 53.* View of the modified bitumen membrane located at the southwest corner of the building. Note the poor practice of overlapping the metal cap flashing.

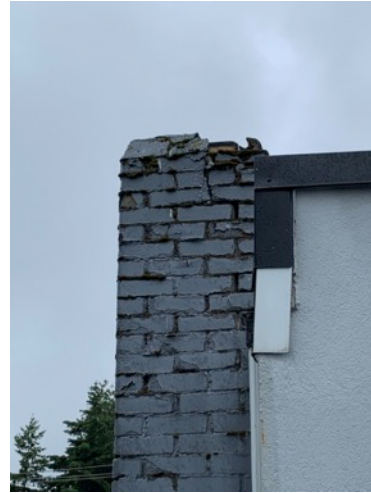
*Photo 54.* View of the deteriorated masonry chimney at the centre south wall.
