ENGINEERING REPORT

**Preliminary Report of Noticeable
4.84G in Vertical Acceleration of
PK-WGS, Registered MSN 1134, at
Sumbawa Besar (SWQ) Airport
on 20 April 2015**

No.	: ATR72-ER-05-034
Date	: May 4, 2015
Reference	: <i>See References</i>
A/C Type	: ATR72-212A
Effectivity	: PK-WGS
Attention	: QA, LM, SM, SSQ, OEM

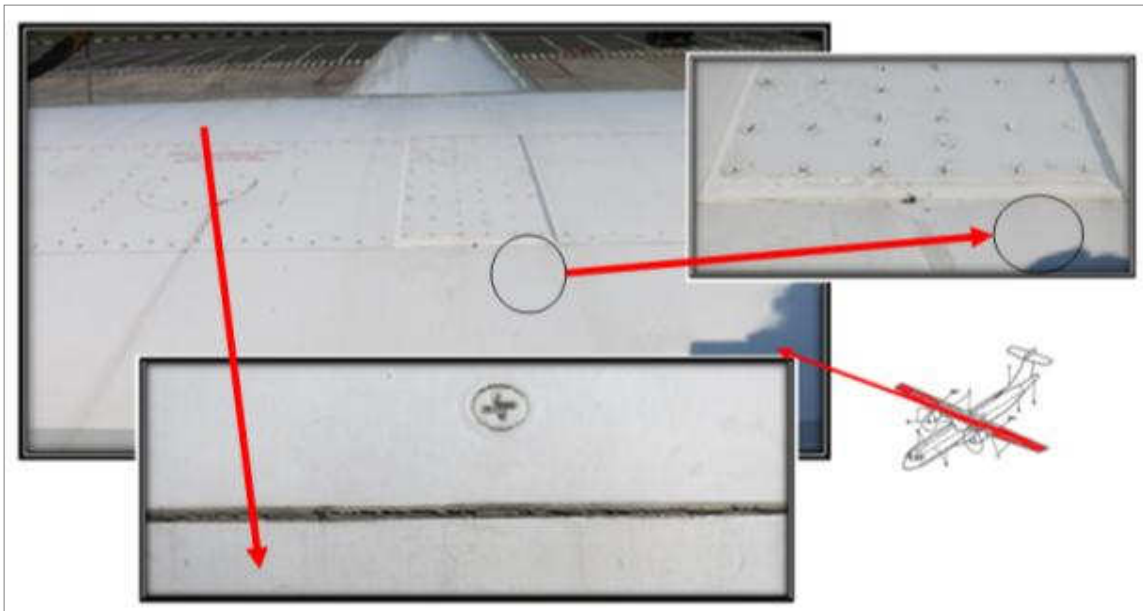
Wing - Upper Surface

1. No damage (wrinkle, loose screws, loose rivets) observed on the upper surface.
2. Sealant broke out in the middle of center wing.

Structure	Normal	Abnormal
Upper Surface	<input checked="" type="checkbox"/>	<input type="checkbox"/>
Sealant	<input type="checkbox"/>	<input checked="" type="checkbox"/>

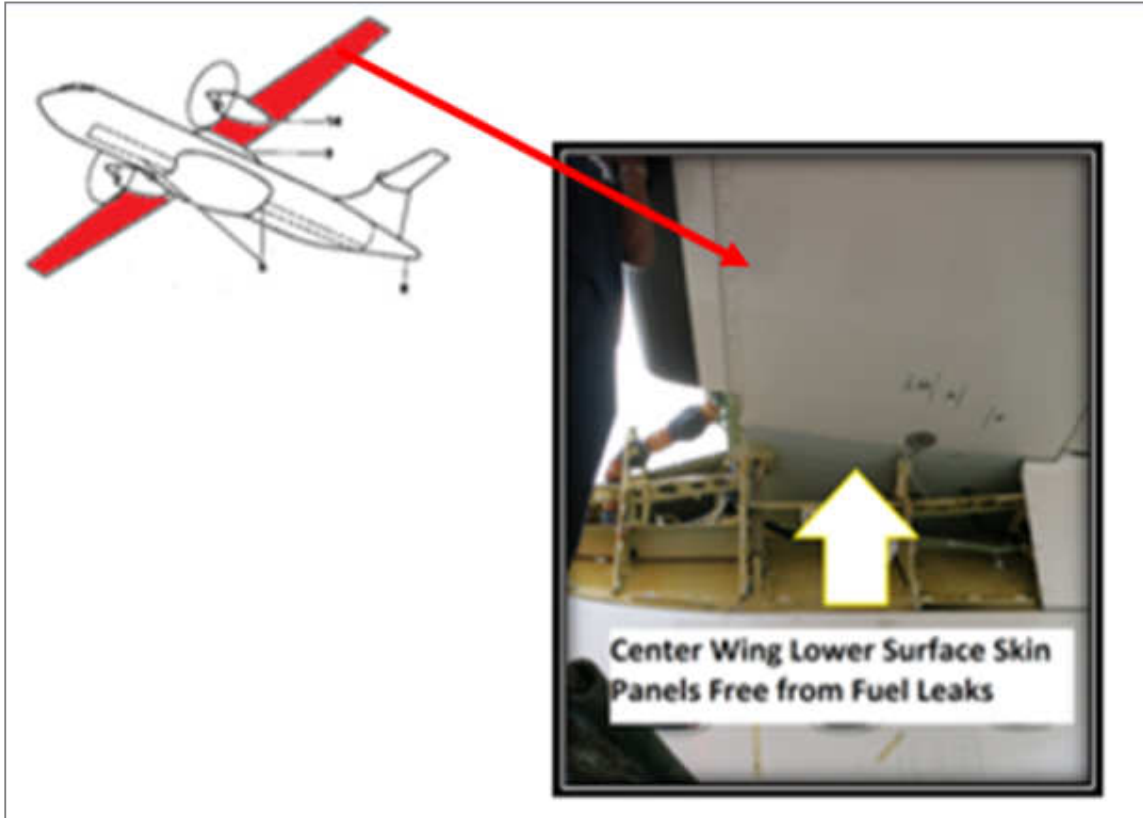
Wing - Lower Surface

1. No damage (wrinkle, loose screws, loose rivets and fuel leaks) observed on the lower surface.

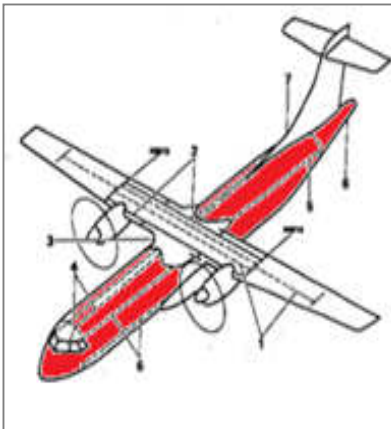
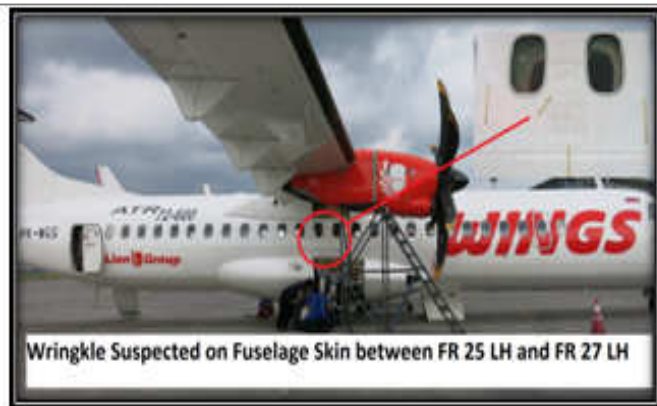
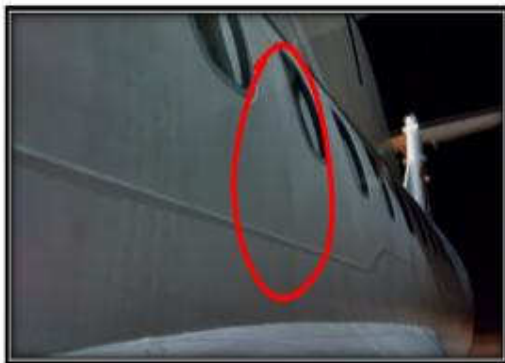
Fuselage Skin Wrinkle (before Check)

1. No found damage, good condition.
2. Suspected wrinkle is to be compared with other aircraft and it was normal condition when the aircraft on ground (with no pressurization).

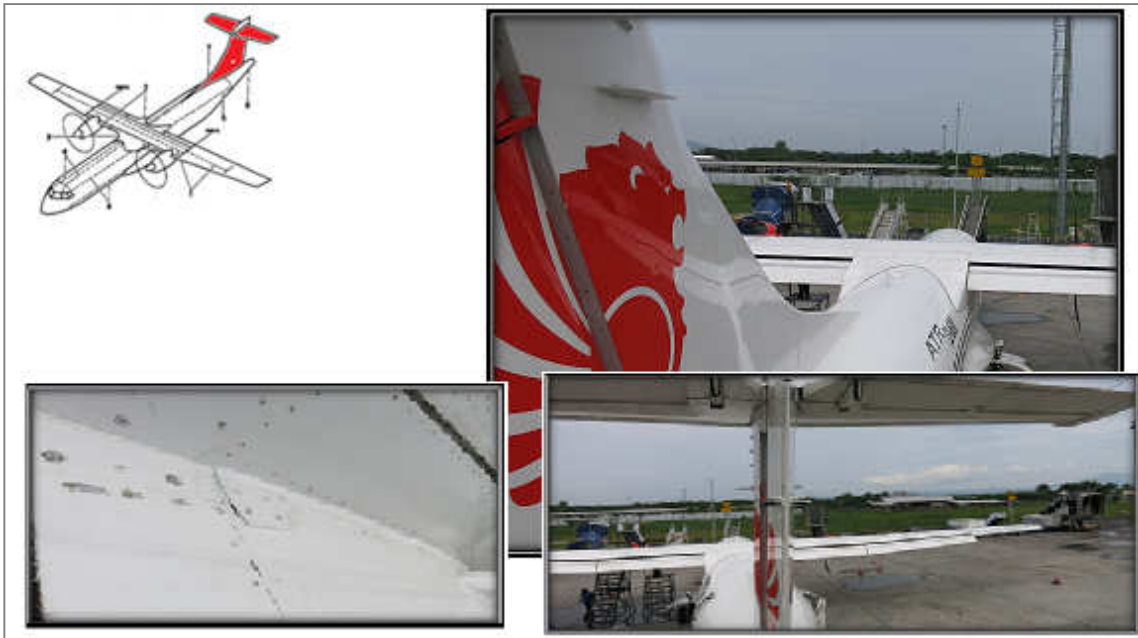
S t a b i l i z e r

1. No found damage on observed stabilizer; good condition.

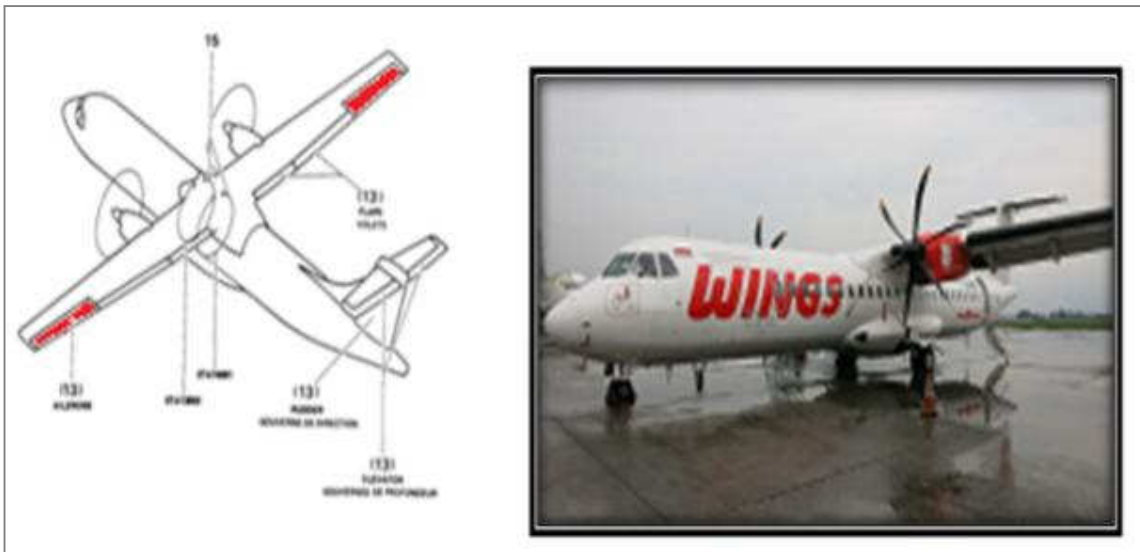
Control Surfaces

1. No found damage, no friction, no binding and no jamming. Good Condition.

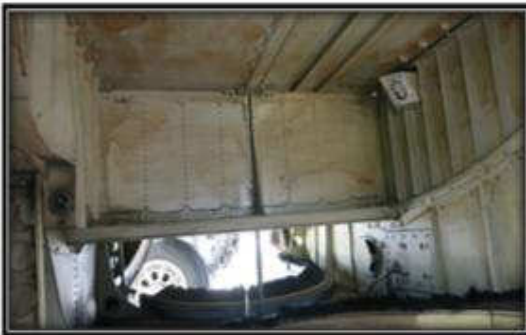
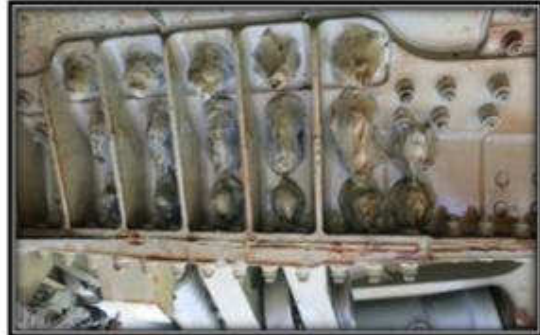
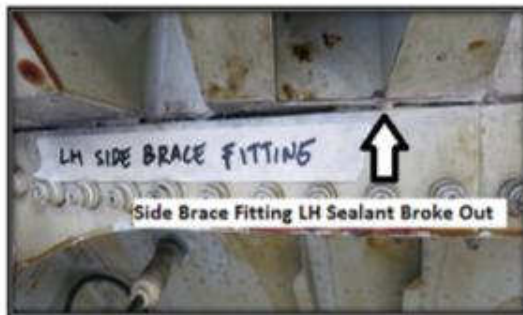
Sealant Broke Out (L/H Side Brace Fitting)

1. No found damage. Overall is on good condition except Sealant broke out found in Main Landing Gear Wheel Well.

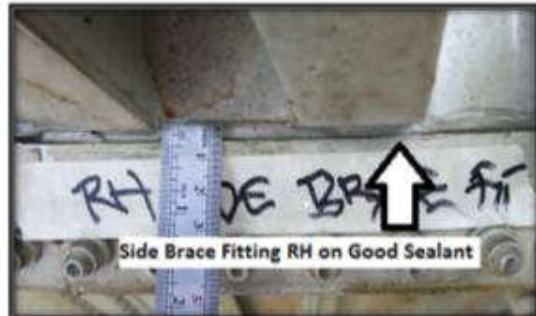
Good Sealant (R/H Side Brace Fitting)

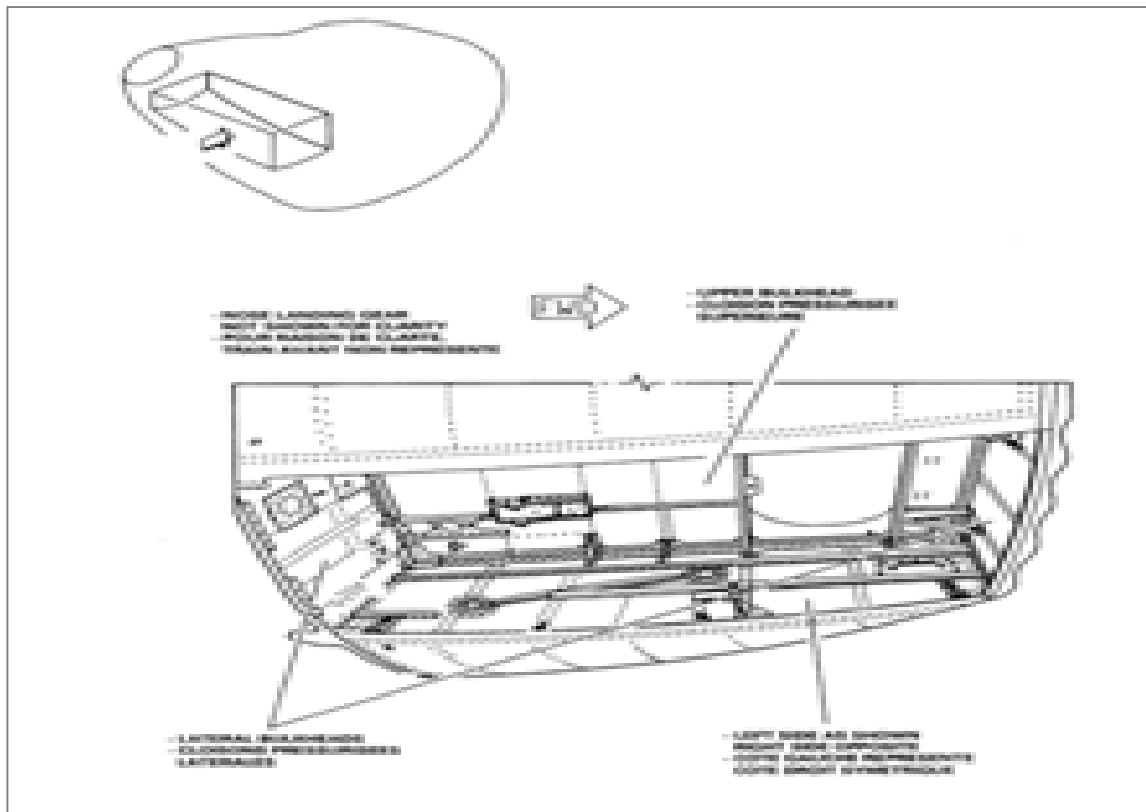
1. No found damage; good condition.

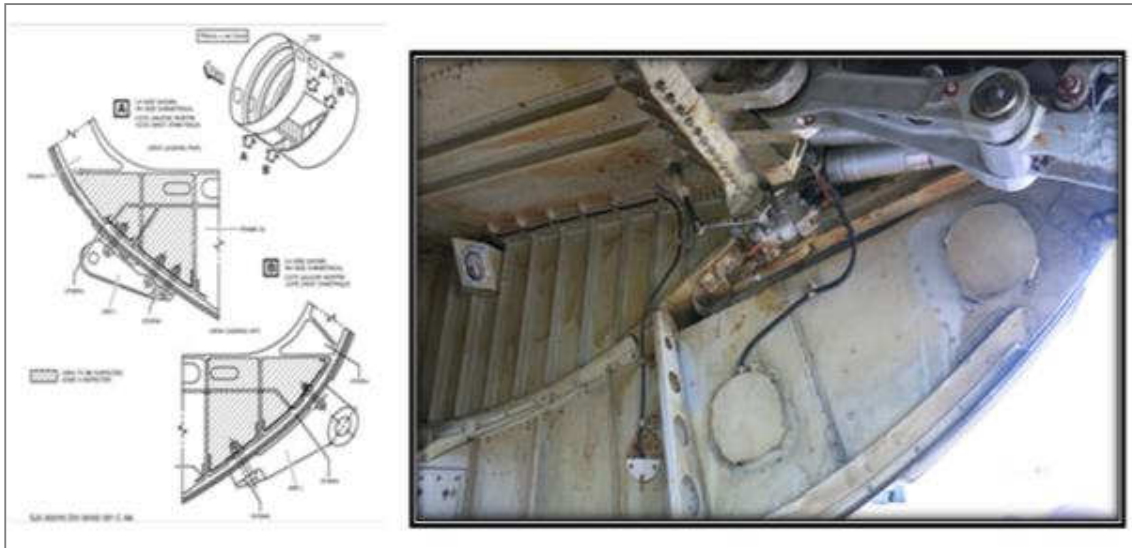
MLG Wheel Well

No found damage; good condition.

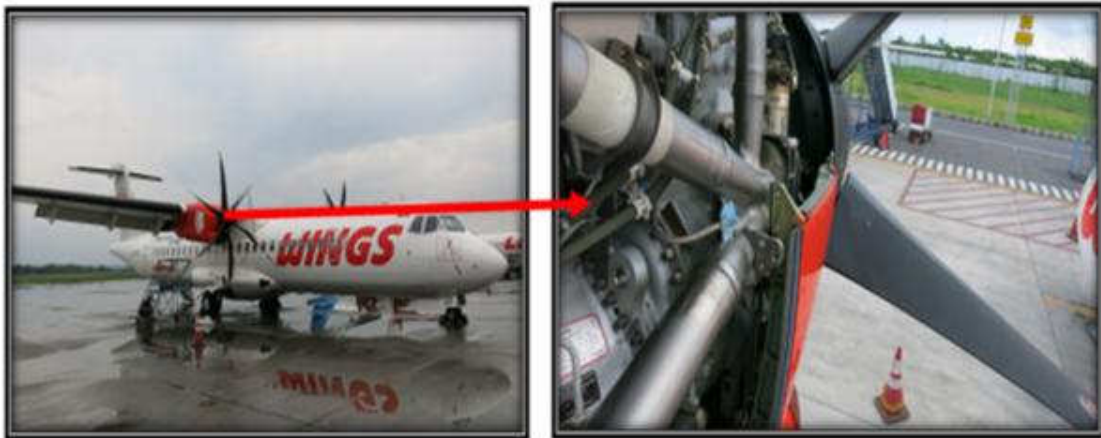
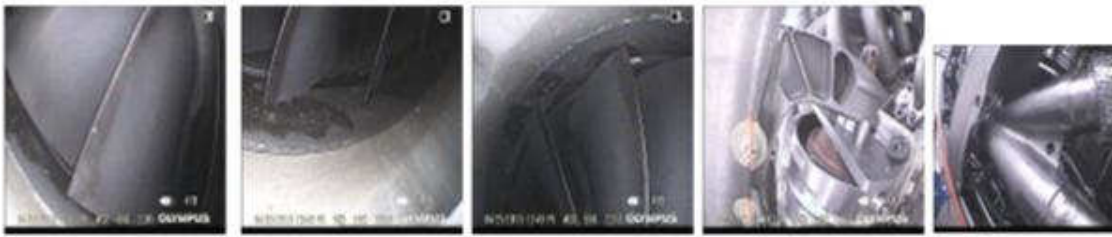
Engine Boroscope Inspection

No found damage; good condition.

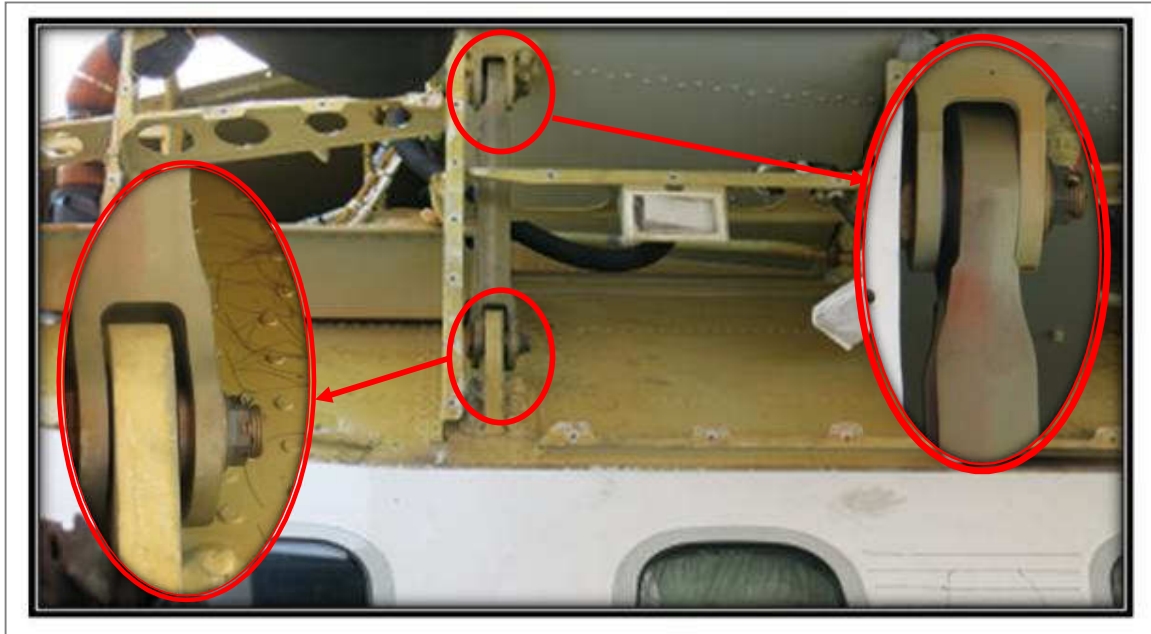
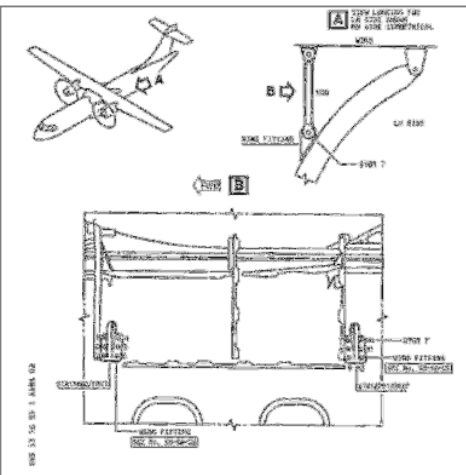
W i n g R o d

The attached position of wing rod is not aligned.

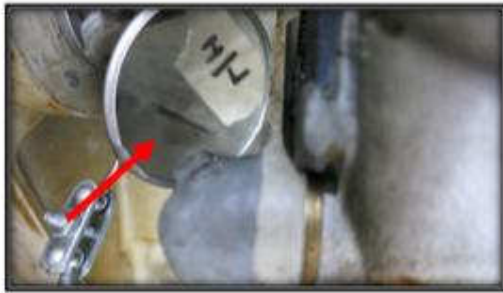
N°1 Fitting Crack Suspected

Several suspicious scratches on L/H MLG Wheel Well (Frame 25 - 27) have been investigated with NDT-Eddy Current.

Has been stated on NDT Report No.141/IV/15/NDT those suspected crossing cut is not a crack.

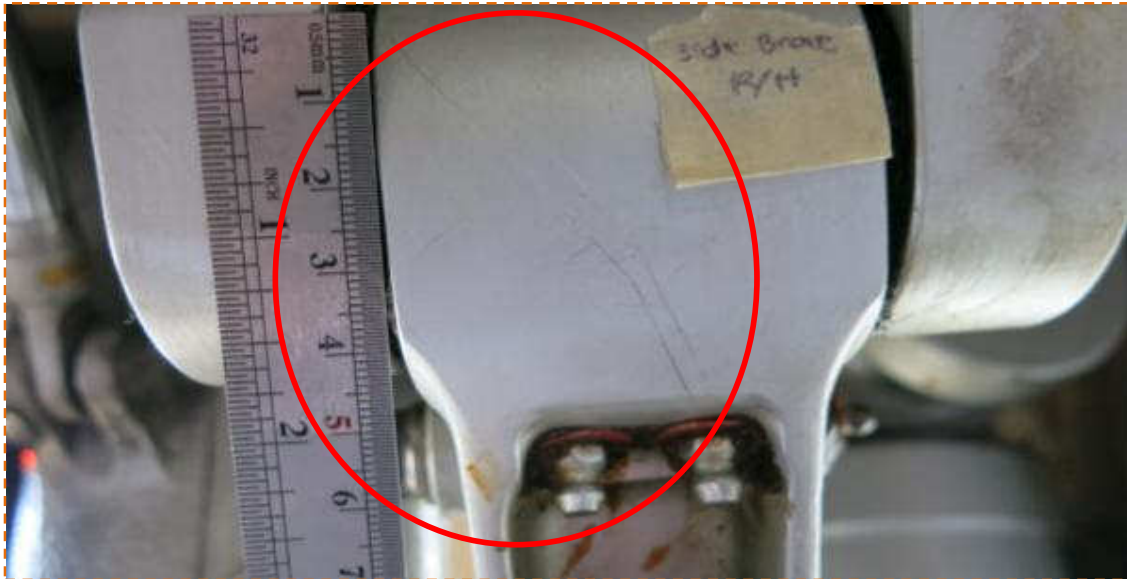
General Visual Inspection of Landing Gears — Side Brace

After performed NDT-Eddy Current inspection insisting on R/H Side Brace by NDT Level II Certified Inspector no crack found. Reference: NDT Report No. 142/IV/15/NDT.

No improper clearance between Side Brace connection.

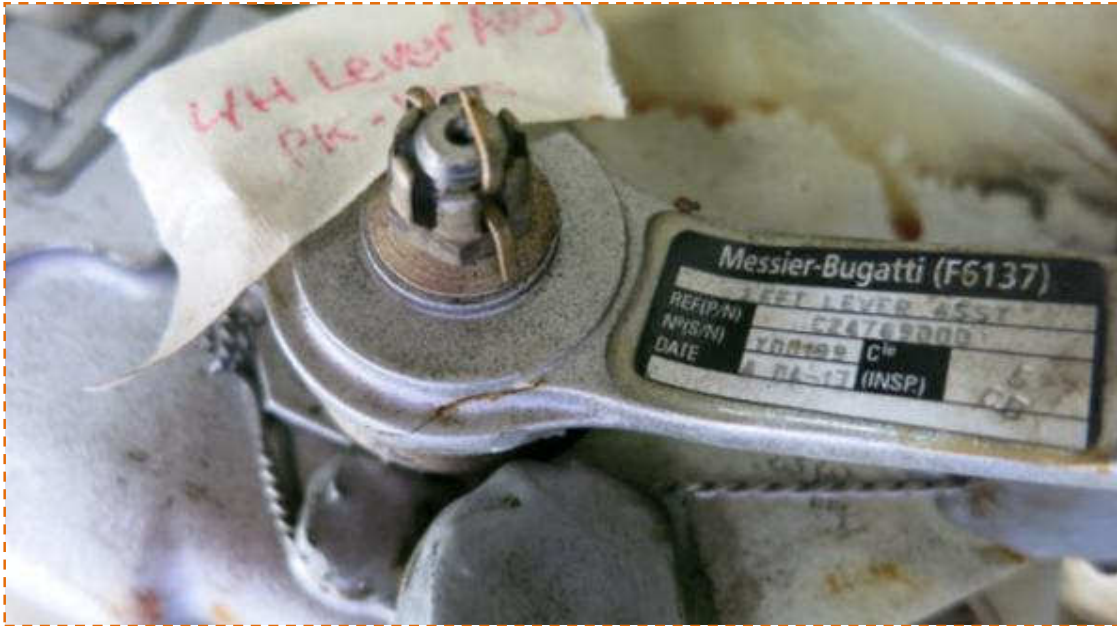
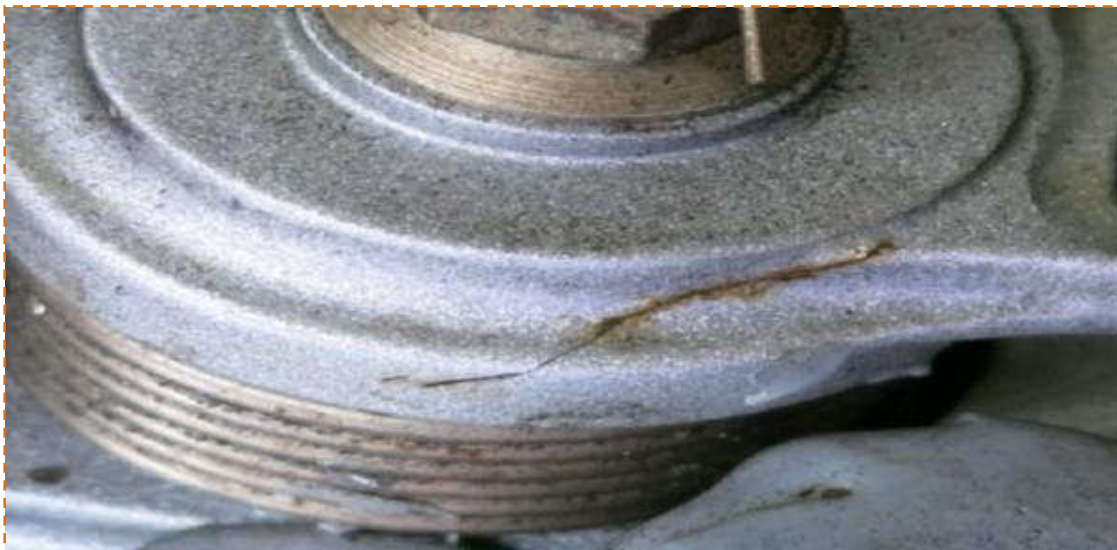
General Visual Inspection of Landing Gears — Lever Assy

After performed NDT-Eddy Current inspection insisting on L/H Lever Assy by NDT Level II Certified Inspector no crack found.
Reference: NDT Report No. 143/IV/15/NDT.

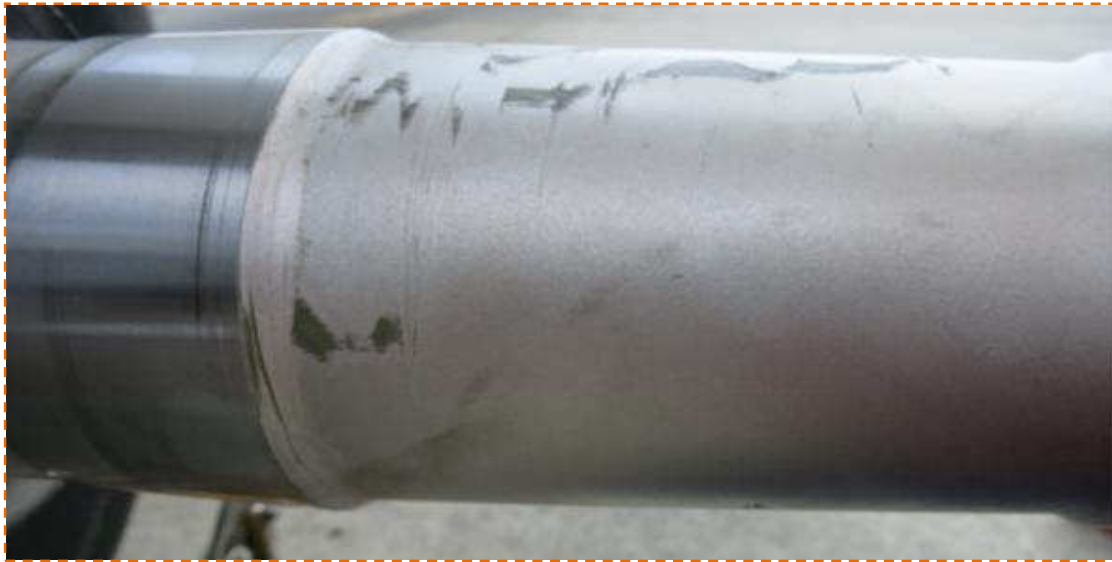
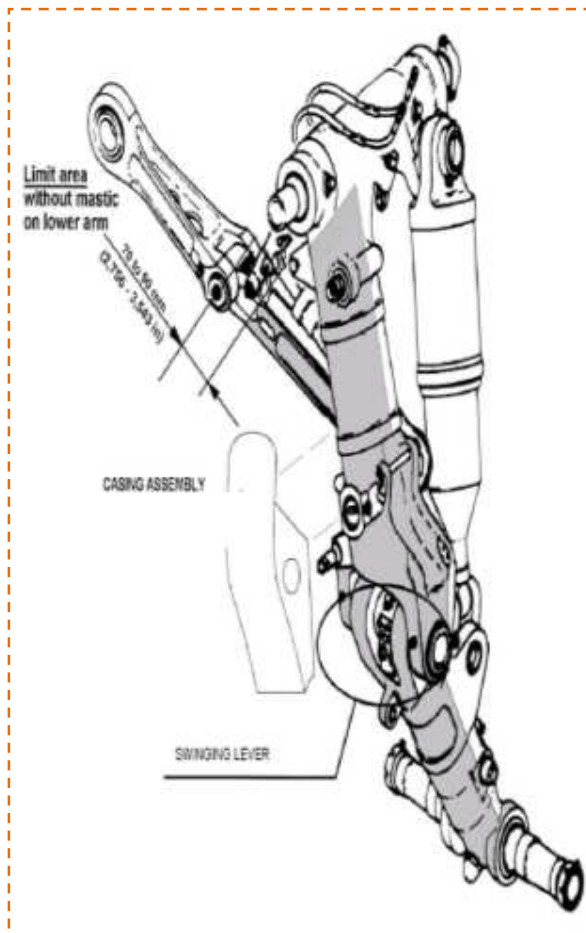
General Visual Inspection of Landing Gears — Wheel Axle

After performed NDT-Dye Penetrant inspection insisting on L/H and R/H Main Wheel Axle by NDT Level II Certified Inspector no crack found. Reference: NDT Report No. 143/IV/15/NDT.

No corrosion in area of wheel axle/jacking pad of the swinging lever.

Rubber sealing compound PR1826B2 of Swinging Lever was still in good condition.

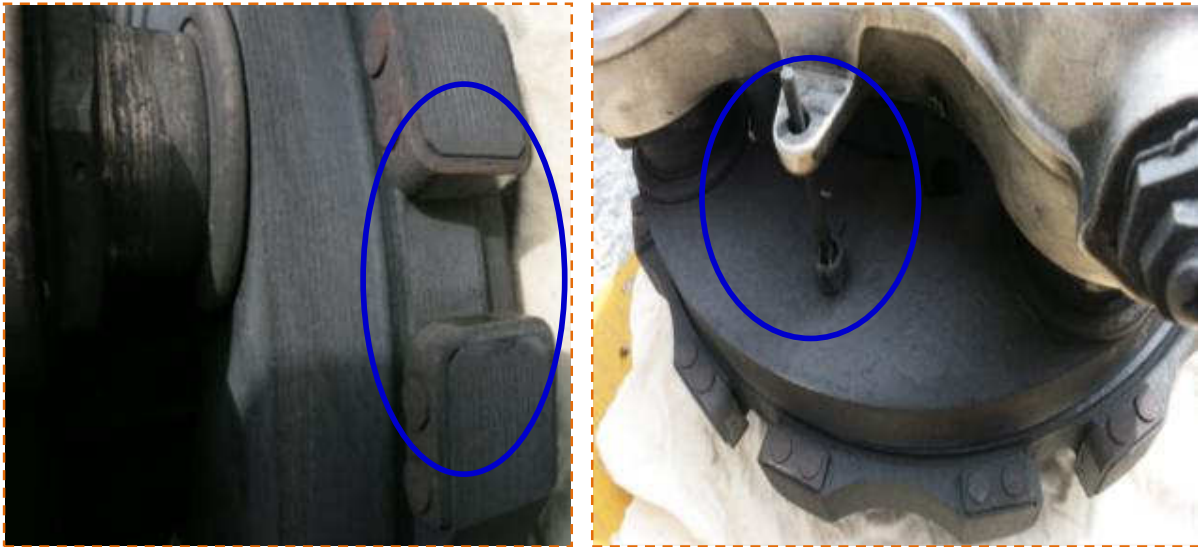
General Visual Inspection of Brake Assembly

After performed the inspection of Brake Assembly inboard and outboard no defective screw was found, no major signs of overheating on piston housing, no warping was found on piston housing, no signs of overheating on carbon brake material, no brittle effect on carbon brake material, no flush indication on wearing pin. Minor signs of overheating on L/H and R/H rotor clip of brake assembly.

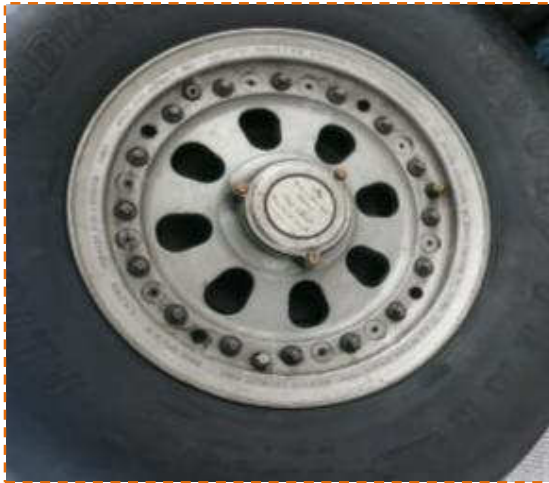
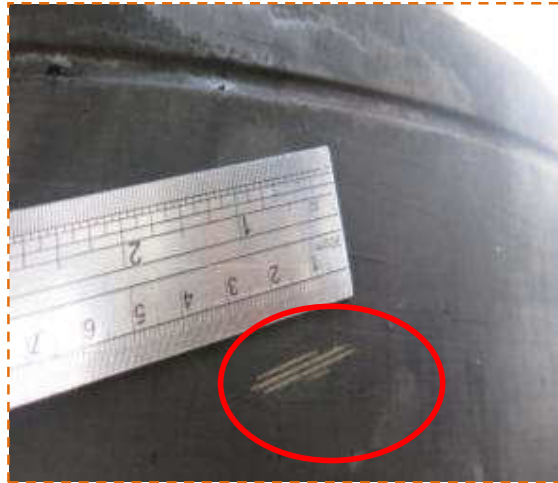
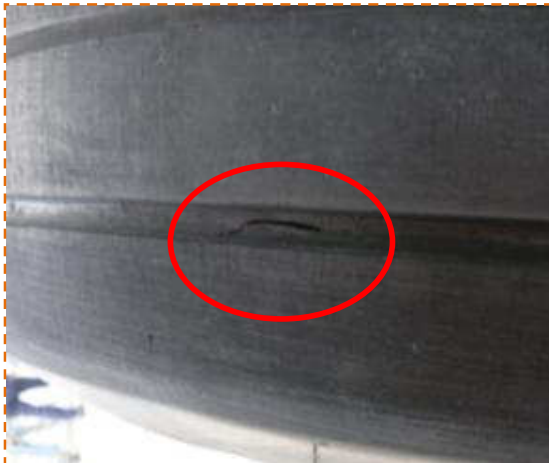
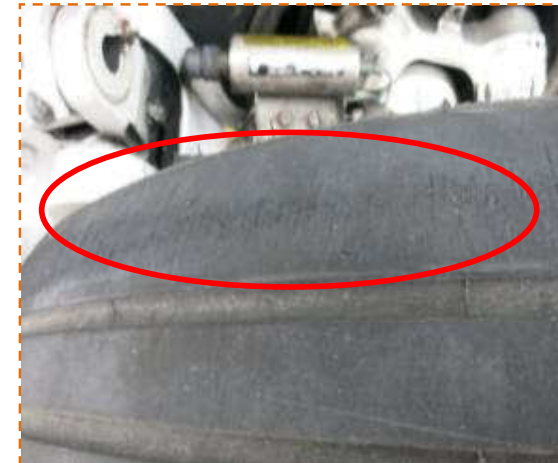
- After performed NDT-Eddy Current inspection insisting on L/H and R/H Main Wheel Rim Bead, no found crack was confirmed.
- L/H Tire N° 1 outboard was found chevron marking and blister.
- L/H Tire N° 2 inboard was found chevron marking and blister.
- R/H Tire N° 3 inboard was found thread damage.
- R/H Tire N° 4 outboard was found deep cut.
