# Aviation Investigation Final Report

<b>Location:</b>	Canadensis, Pennsylvania	<b>Accident Number:</b>	ERA16FA143
<b>Date &amp; Time:</b>	March 27, 2016, 11:47 Local	<b>Registration:</b>	N776JM
<b>Aircraft:</b>	Robinson R44	<b>Aircraft Damage:</b>	Destroyed
<b>Defining Event:</b>	Loss of visual reference	<b>Injuries:</b>	1 Fatal
<b>Flight Conducted Under:</b>	Part 91: General aviation - Personal

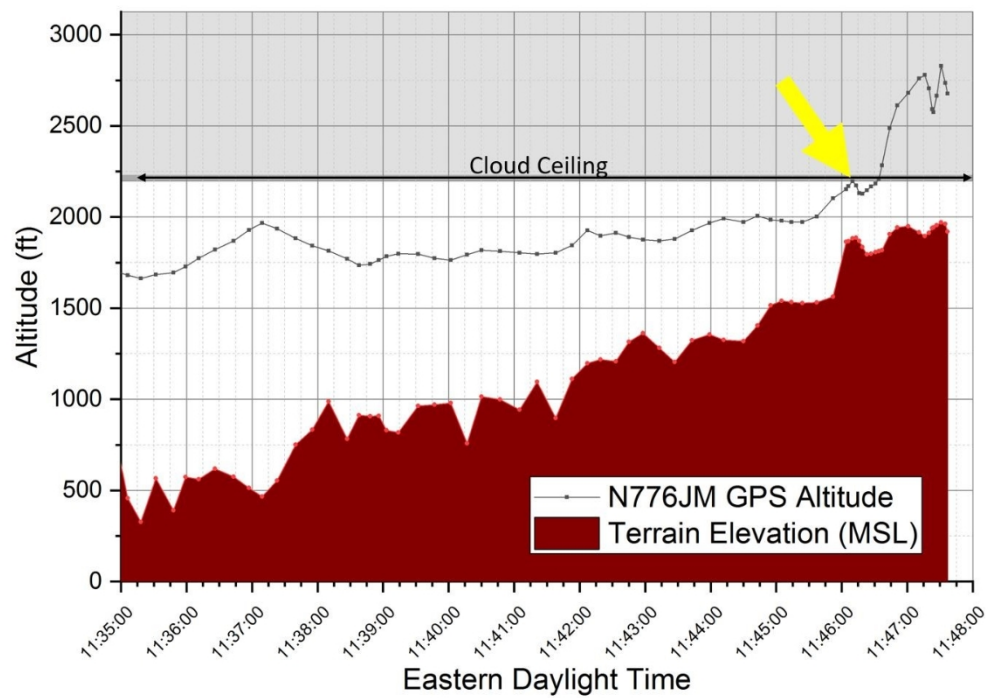
Figure 1. Altitude and Terrain Elevation

The helicopter was equipped with an on-board GPS; review of the recorded data revealed that, over the last 10 minutes of flight, the helicopter's altitude gradually increased. The increase in altitude corresponded with rising terrain. As the helicopter approached the crest of a ridge, the GPS altitude increased sharply to about 2,200 ft mean sea level (msl), or about 200-300 ft above ground level (agl) in the area of the ridge. At the time, the reported cloud ceiling was also about 2,200 ft msl. The yellow arrows in Figures 1 and 2 indicate the climb and location of the ridge.

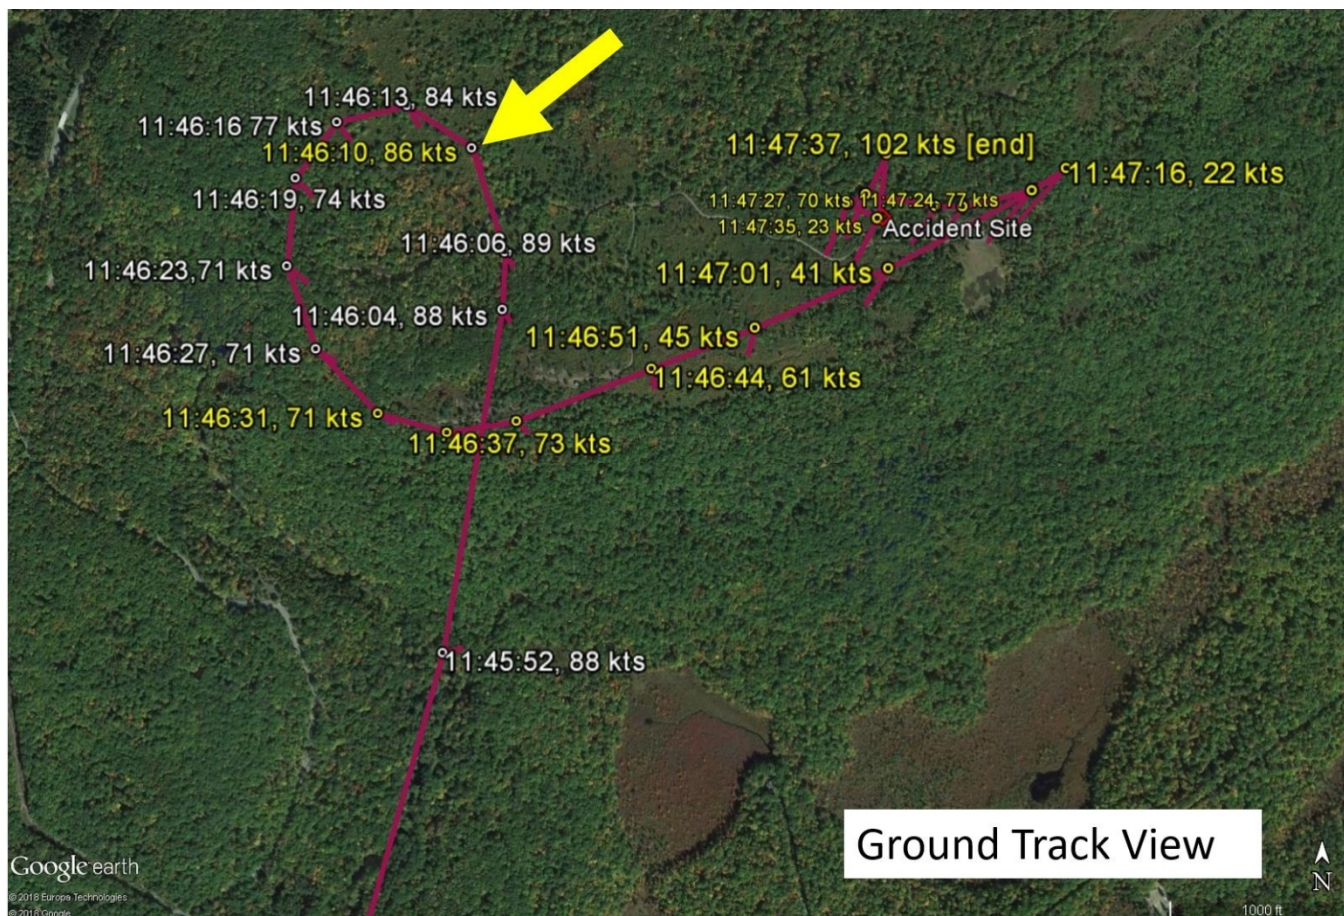
Figure 2. Ground Track

The helicopter then descended slightly as it began a left 330° turn, then climbed again; the GPS altitude indicated that the helicopter was above the cloud ceiling (as depicted by the yellow data points in Figure 2). The helicopter then flew northwest for about 40 seconds as it continued to climb, while the ground speed decreased from about 70 knots to about 20 knots. The helicopter then reversed course briefly, and then made several changes in track direction and altitude, before making a left 270° turn just before the last data point, which was about 135 ft north of the accident site at a GPS altitude of 2,678 ft msl, which was about 800 ft agl.
