Aviation Investigation Final Report

Location:	Monticello, Georgia	Accident Number:	ERA21FA362
Date & Time:	September 15, 2021, 20:46 Local	Registration:	N888DV
Aircraft:	ROBINSON HELICOPTER CO R66	Aircraft Damage:	Destroyed
Defining Event:	VFR encounter with IMC	Injuries:	3 Fatal
Flight Conducted Under:	Part 135: Air taxi & commuter - Non-scheduled

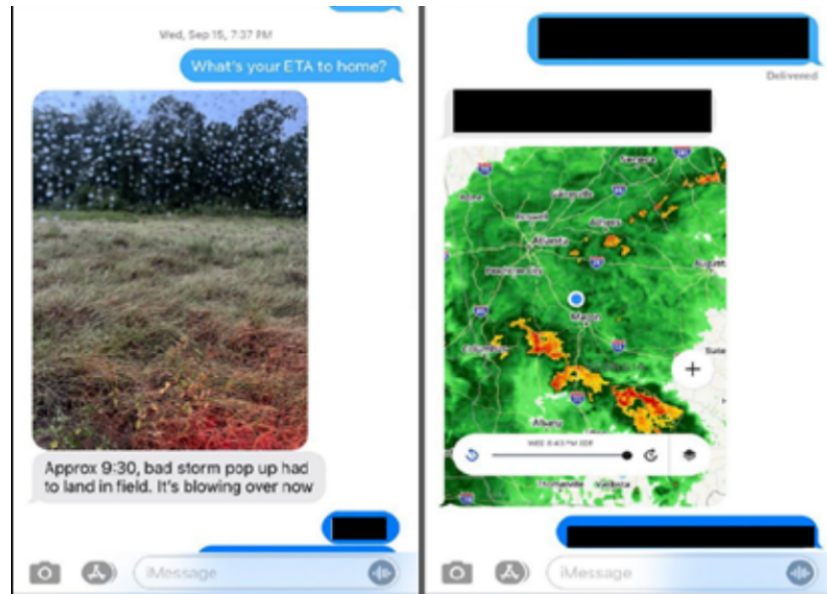
During the return trip, they landed at Thomasville Regional Airport (TVI), Thomasville, Georgia, where they refueled with 40 gallons of fuel. Automatic dependent surveillance–broadcast (ADS–B) data indicated the flight departed TVI at 1840, then proceeded on a northerly track for about 80 nautical miles near the town of Andersonville, Georgia. At 1937, the passenger’s spouse sent a text message her husband and asked him, “What’s your ETA to home?” He responded with a photograph taken with his mobile device and stated “Approx 9:30, bad storm pop up had to land in field. It’s blowing over now.” The photograph showed a grass field, gray skies and rain on the helicopter’s window (figure 1).

later passed about 2 miles east of a large powerplant shortly before entering the Piedmont National Wildlife Refuge, a remote area covered with dense forest. The passenger sent a second series of text messages to his spouse during this en route portion of the flight and included a screen shot of the weather radar and their location (figure 1).

Figure 1 – Screen captures of mobile telephone messages from the passenger. These included a photo of the weather about 1937 and a weather radar composite image (right).

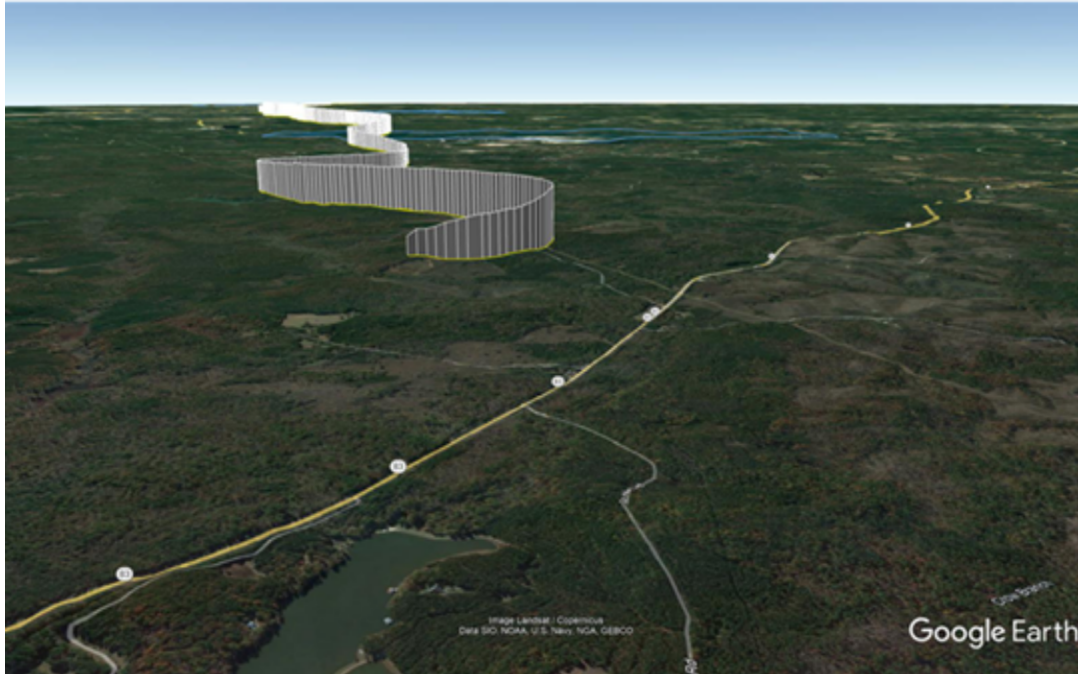
About 2043, the helicopter made a series of left and right track changes (figure 2), then during the last 25 seconds of the flight, when the helicopter was at 1,650 ft above mean sea level , it entered a rapidly descending right turn where the vertical speed decreased steadily from level flight to a nearly 4,000 ft per minute descent; at 2046, the ADS-B signal was lost. The helicopter collided with trees and hilly terrain at an elevation of 570 ft. A witness south of the accident site reported hearing a low-flying helicopter and stated that at the time it was “very rainy.”

Figure 2 - Orthographic image of helicopter flight path (white overlay), looking south.

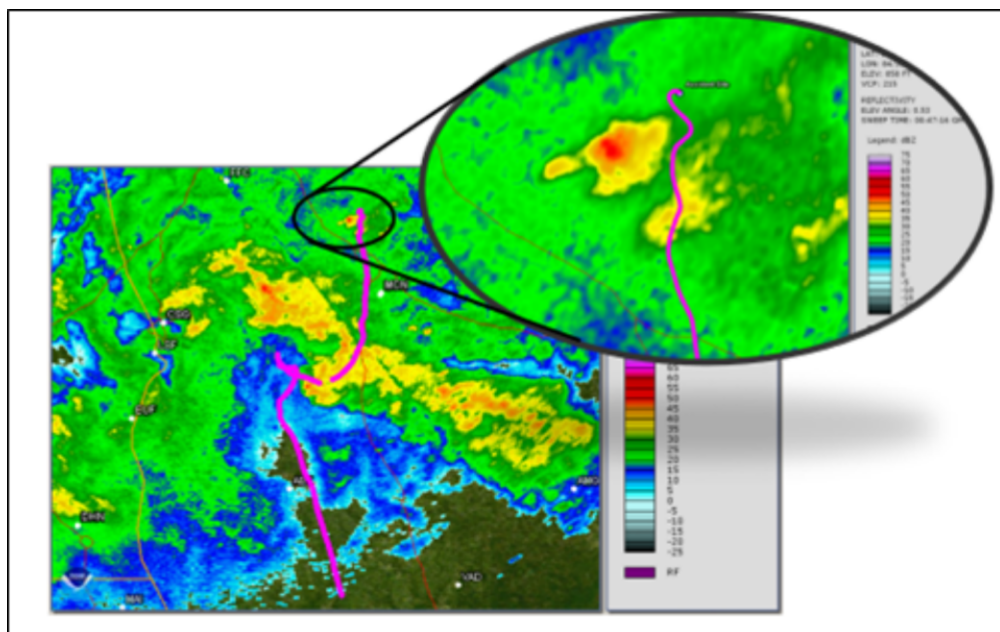
The closest National Weather Service (NWS) Weather Surveillance Doppler Radar (WSR-88D) was located at Atlanta Regional Airport-Falcon Field (FFC) Atlanta, Georgia about 42 miles north-northwest of the accident site. The FFC 0.5° base reflectivity image for 2047 with the flight track overlaid is included as figure 3. The base reflectivity inset image depicted echoes of 20 to 37 dBZ along the flight track, and the accident site located about 4 miles from an isolated cell with maximum echo intensity of 53 dBZ. The echo was moving northward at a velocity of around 15 knots. No lightning was depicted with the echo or within 25 miles of the accident site between 2000 and 2100.

Figure 3 - Doppler radar base reflectivity image for 2047 with flight track overlaid (magenta).
