# Aviation Investigation Final Report

<b>Location:</b>	McDougal, Arkansas	<b>Accident Number:</b>	CEN19FA020
<b>Date &amp; Time:</b>	November 2, 2018, 13:15 Local	<b>Registration:</b>	N5187S
<b>Aircraft:</b>	Hughes 369	<b>Aircraft Damage:</b>	Destroyed
<b>Defining Event:</b>	Collision with terr/obj (non-CFIT)	<b>Injuries:</b>	1 Fatal, 2 Minor
<b>Flight Conducted Under:</b>	Part 133: Rotorcraft ext. load

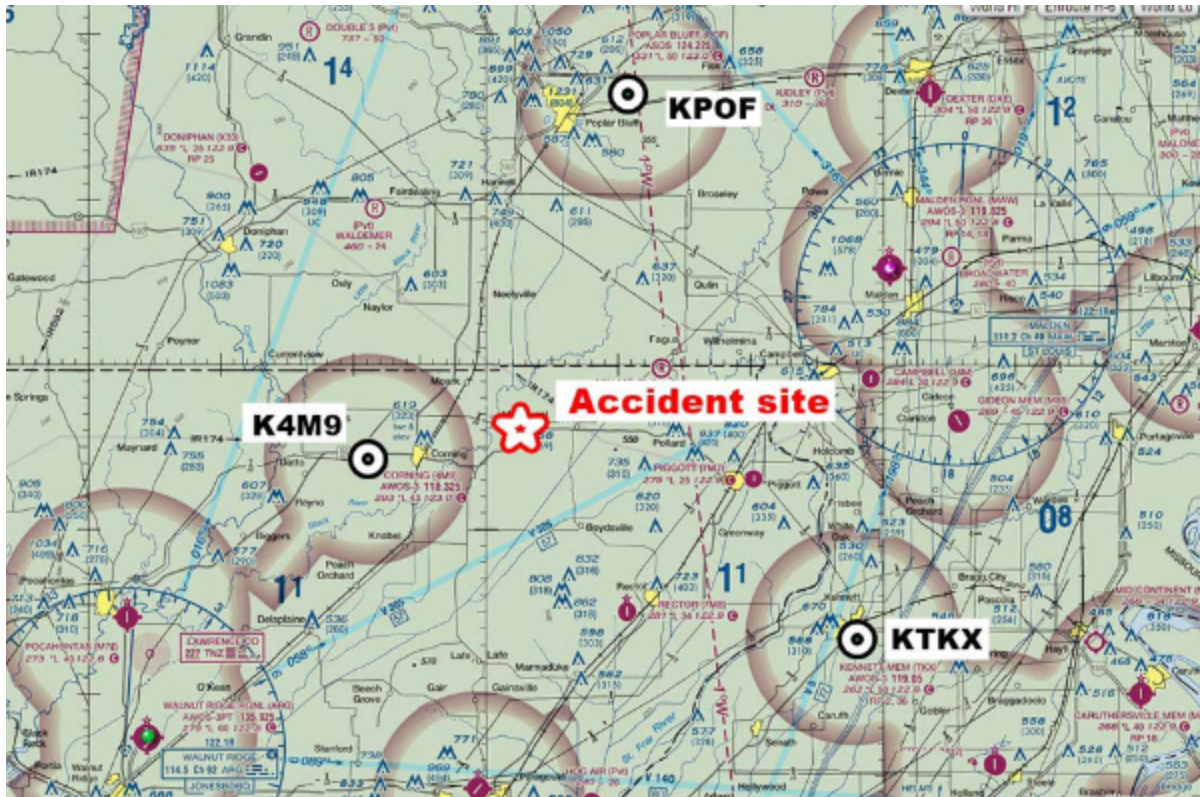
Figure 5: Sectional chart of accident area with the location of the accident site and the closest surface observation site.

Observations from the two closest airports to the accident site, around the accident time, indicated visual flight rules conditions; however, the winds increased in magnitude with gusts to 19 knots out of the southwest.

At K4M9, weather at 1315 CDT, automated, wind from 250° at 12 knots. At 1335 CDT, automated weather at K4M9 was wind from 240° at 10 knots with gusts to 17 knots. At KPOF weather at 1253 CDT, automated, wind from 220° at 11 knots. At 1353 CDT, automated weather at KPOF was wind from 220° at 14 knots with gusts to 19 knots.

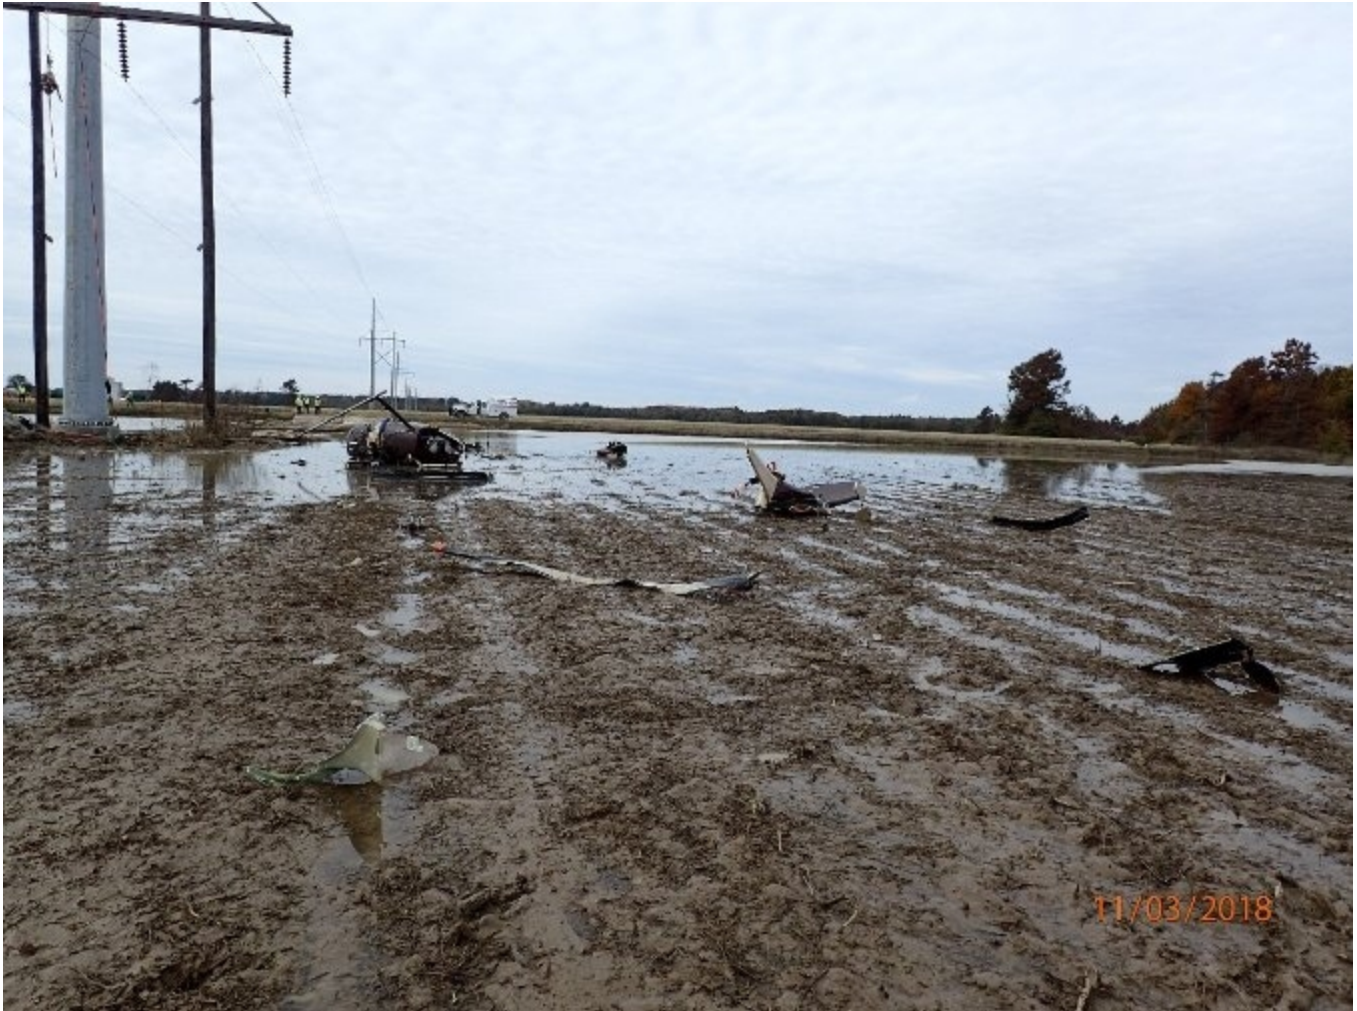
Figure 2: Main Wreckage

The main wreckage came to rest on the north side of wooden and steel utility pole structures in a muddy soybean field. This area of the field was flooded with about 2 ft of water at the time of the accident due to heavy rains prior to the accident. The helicopter impacted the ground on the right side; the damage was consistent with nearly vertical forces. The main wreckage included the fuselage, left skid and rear strut, right rear strut, main rotor drive shaft, and engine. All five main rotor blades, the tail rotor section, tail boom, and right skid were found in the area surrounding the main wreckage.

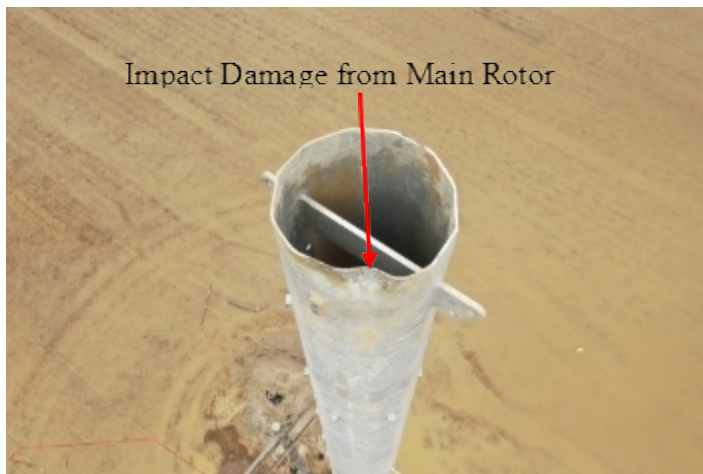
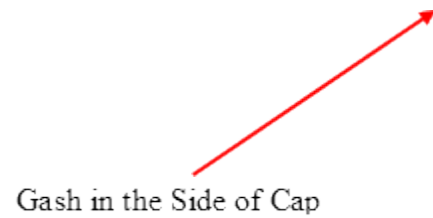
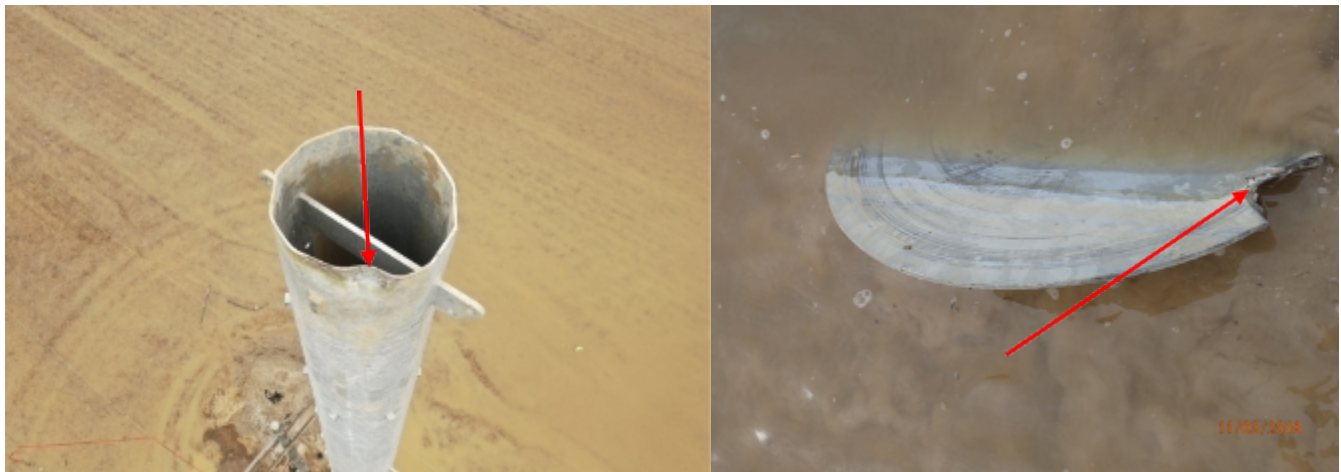
Figures 3 and 4: Photograph of Impact of Top of Steel Utility Pole and Cap Plate with Impact Mark

A postaccident examination of the helicopter revealed no mechanical anomalies that would have precluded normal operation. The power line structure displayed an indentation consistent with impact with the top of the new steel utility pole. There was also a gouge mark to the side of the upper cap plate of the structure, consistent in shape with the indentation mark to the pole. Therefore, it is likely that the pilot failed to maintain clearance from the power line structure while hovering, resulting in contact with the structure.

Before impacting the ground, the helicopter's main rotor blades impacted the top of the steel utility pole. A drone was used to observe the impact damage and showed an inward indentation in the top of the pole, as shown in Figure 3. The tower cap plate was separated and about 3/4 of the plate was submerged in water. There was a gash in the side of the plate, as shown in Figure 4.
