Aviation Investigation Final Report

Location:	Galliano, Louisiana	Accident Number:	CEN19FA095
Date & Time:	March 10, 2019, 12:03 Local	Registration:	N577AL
Aircraft:	Bell 407	Aircraft Damage:	Destroyed
Defining Event:	Loss of control in flight	Injuries:	2 Fatal
Flight Conducted Under:	Part 135: Air taxi & commuter - Non-scheduled

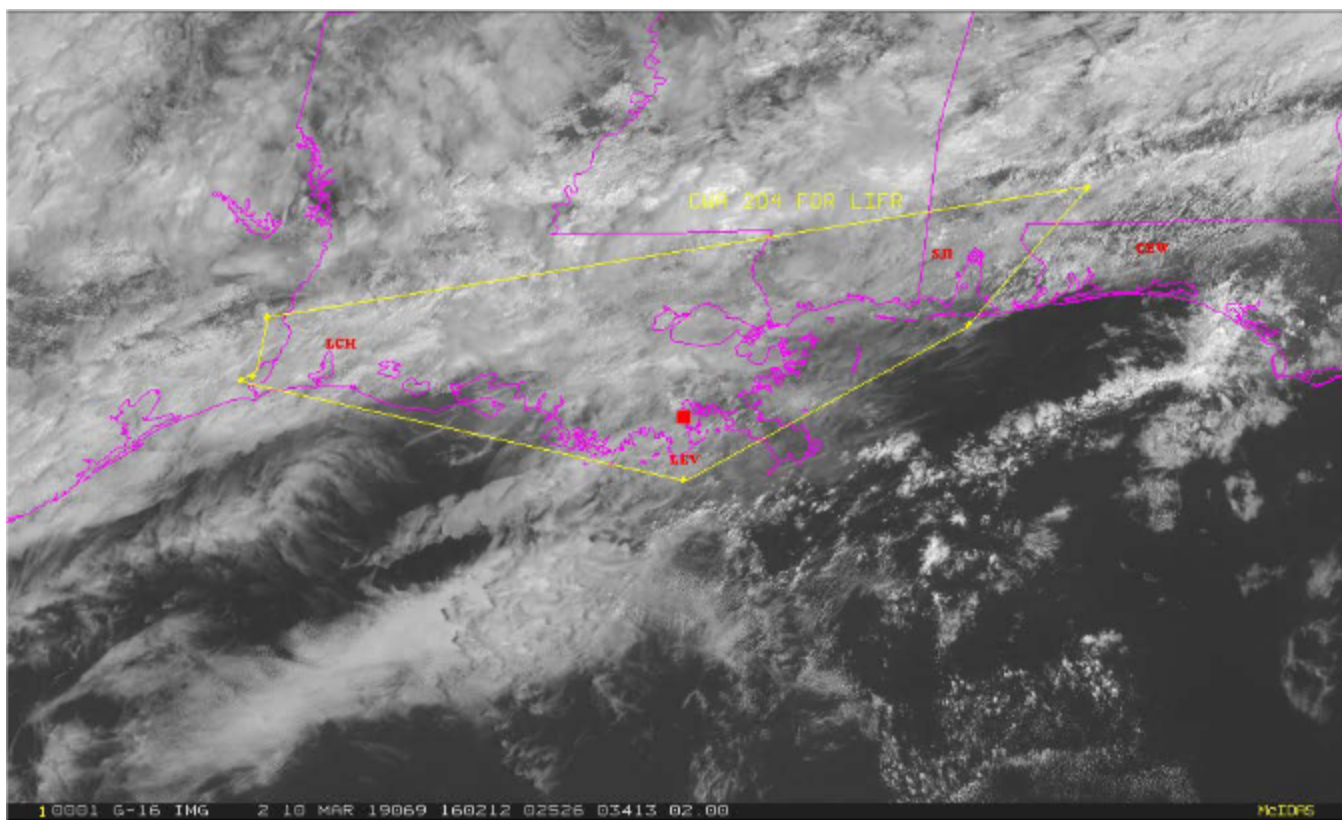
The Houston, Texas, Center Weather Service Unit issued several center weather advisories (CWA) during the period between 0904 through 1300 warning of low instrument flight rules (IFR) conditions over the region. The GOES-16 visible satellite image with the CWA advisory for low IFR conditions were plotted with reference to the accident site, depicted in Figure 1.

Figure 1: GOES-16 visible satellite image at about 1100 with CWA 204 for LIFR conditions.
