# Aviation Investigation Final Report

<b>Location:</b>	Italy, Texas	<b>Accident Number:</b>	DCA16FA199
<b>Date &amp; Time:</b>	July 6, 2016, 11:48 Local	<b>Registration:</b>	N525TA
<b>Aircraft:</b>	Bell 525	<b>Aircraft Damage:</b>	Destroyed
<b>Defining Event:</b>	Aircraft structural failure	<b>Injuries:</b>	2 Fatal
<b>Flight Conducted Under:</b>	Part 91: General aviation - Flight test

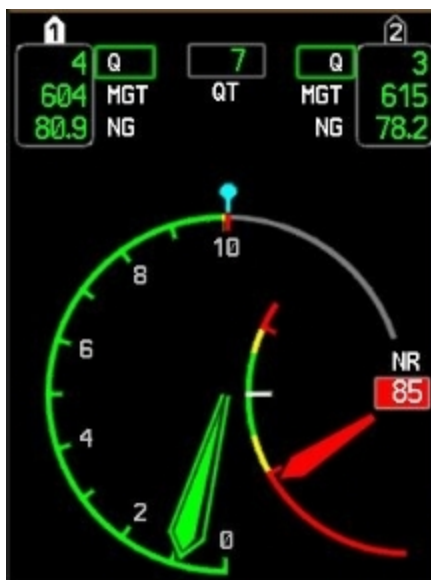
The PSI displayed Nr as a vertical scale (center bar in lower right indicator) when Nr was above 90%, as shown in figure 3. If Nr dropped below 90%, the display changed to an analog needle that displayed a green arc for Nr between 100 and 90%, a yellow arc for Nr between 86 and 89% Nr, and a red arc below 86% Nr (see figure 4). (Overtorquing limits appear above 100%.)

**Figure 4.** PSI displaying Nr as an arc.

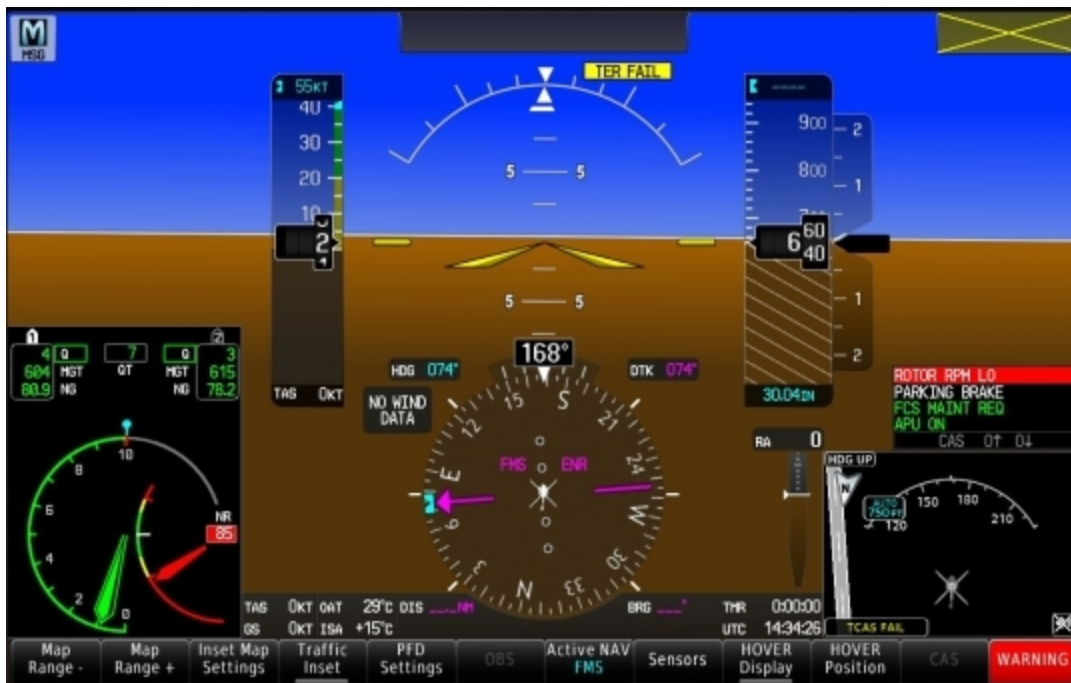
**Figure 6.** Example of PFD during "ROTOR RPM LO" warning.

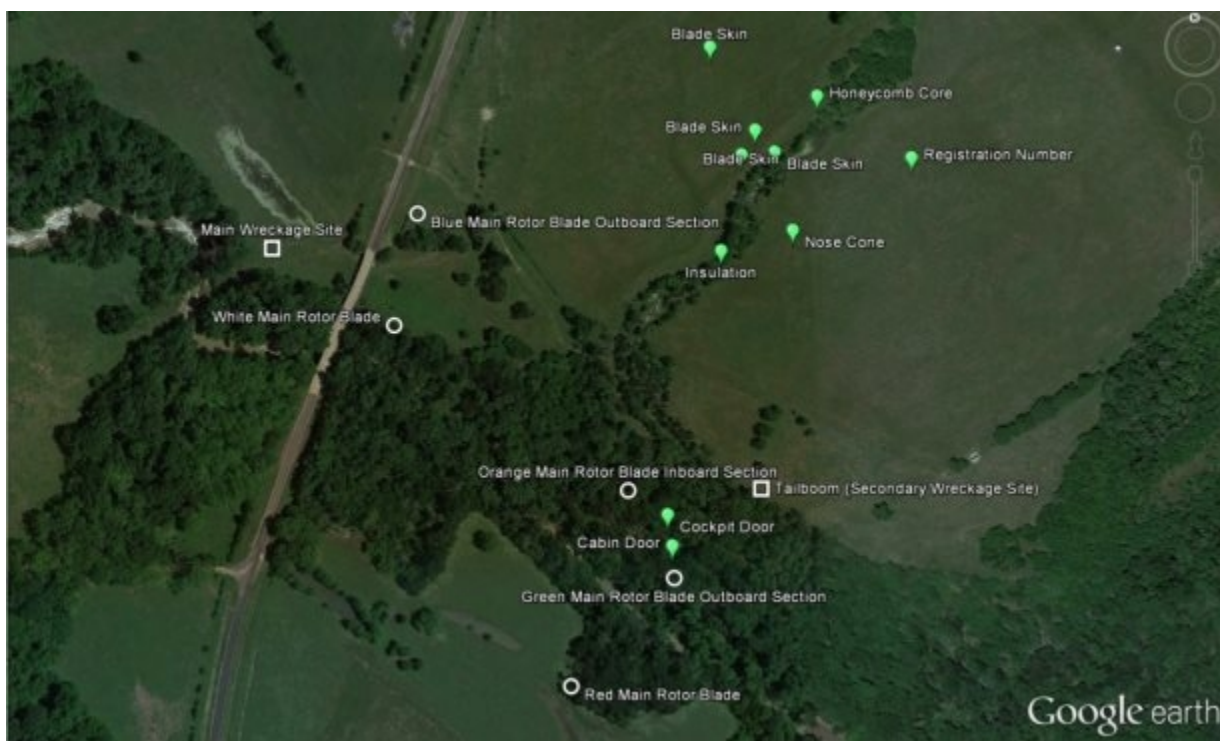
The main wreckage field was 2,200 ft from the last transmitted GPS point, along the flightpath heading of 320°. The main wreckage site included an impact crater, remnants of the main fuselage, cockpit, main transmission and main rotor hub, two of the five main rotor blades (blue and green), the forward portion of the tail boom, and both engines. There was evidence of a postcrash fire at the main wreckage site. The wreckage debris path at the main wreckage site was about 200 ft in length and was oriented about 315° magnetic.

The secondary wreckage site was about 1,300 ft southeast of the main wreckage site and comprised the aft portion of the tail boom, which contained the tail rotor drive system, intermediate gearbox, tail rotor gearbox (TRGB), and tail rotor. A debris field extended between the last data point and the main wreckage covering about 4,000 ft (north to south) by 1,700 ft (east to west). Three of the five main rotor blades (orange, white, and red) and various pieces of forward cowlings, cockpit frames, and cabin doors were found separate from the main and secondary wreckage sites in the debris field. Additionally, lightweight debris, such as insulation and main rotor blade skin pieces, was found scattered to the northeast of the debris path between the main and secondary wreckage sites, with the farthest piece being found about 1,520 ft away from the debris path between the main and secondary wreckage sites (see figure 7).

**Figure 7.** The location of the main wreckage site, secondary wreckage site, and selected items from the wreckage debris field.

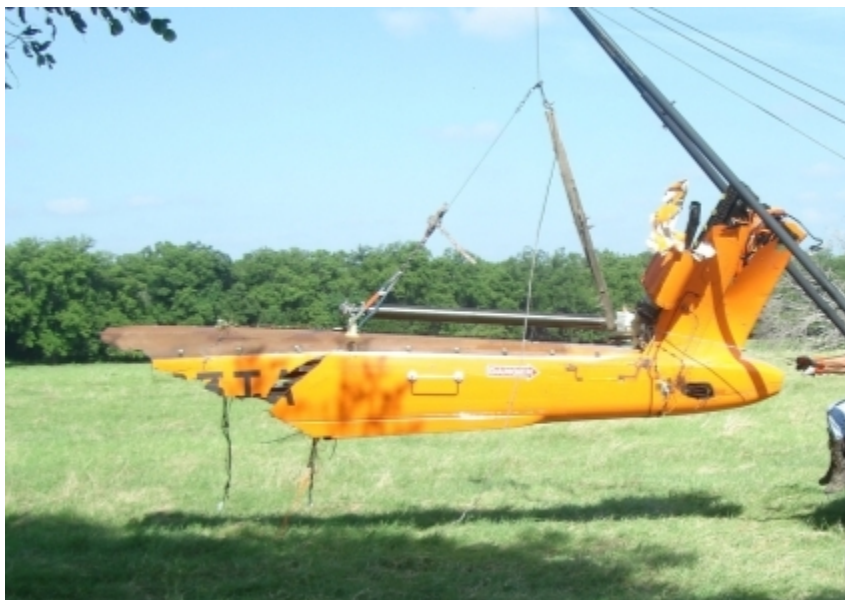
The main fuselage was highly fragmented and exhibited evidence of thermal damage. The cockpit wreckage did not sustain significant thermal damage. Fractured pieces of the cyclic and collective side sticks were observed within the cockpit wreckage. The lateral push-pull tubes were retained in the cockpit wreckage but exhibited fractures consistent with overload. Both engines remained installed on the engine deck and exhibited thermal distress from exposure to the postcrash fire. The forward portion of the tail boom exhibited an angled fracture line at its aft end consistent with main rotor blade contact. The tail boom attachment points to the main fuselage exhibited fractures near the upper left corner and lower right corner. The aft portion of the tail boom was found resting partially inverted, with the tail rotor head and one tail rotor blade wholly embedded into the ground and exhibited an angled cut line at

its forward end consistent with main rotor blade contact (see figure 8).

**Figure 8.** Angled cut line at the forward end of the aft section of the tail boom.

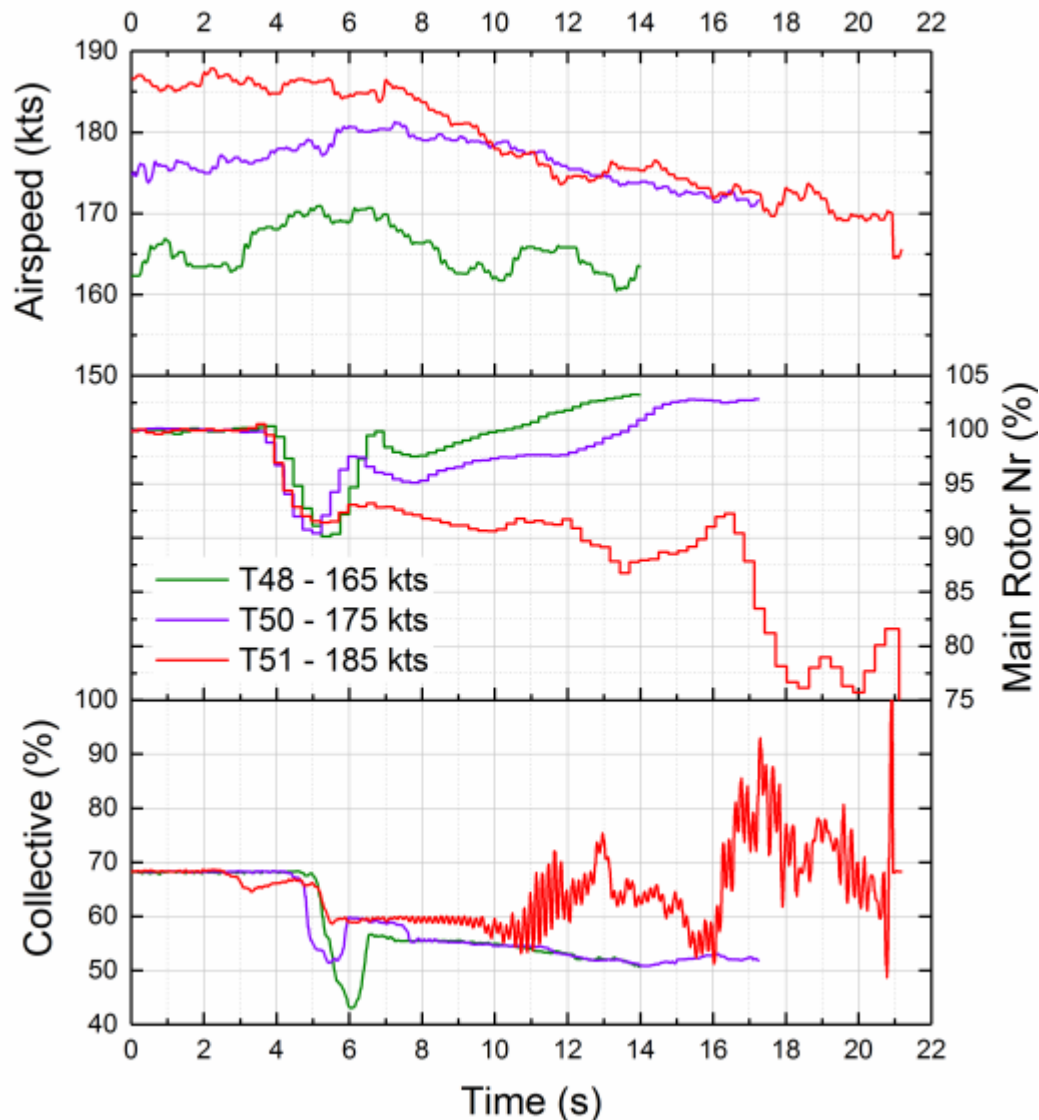
In two prior successful OEI tests at 175 knots airspeed (record 50) and 165 knots airspeed (record 48), Nr decayed from 100% within about 3.5 to 4 seconds, consistent with initiation of the OEI test. Collective was reduced to 51% for test 50 and 43% for test 48. Nr stopped decreasing around 90% before recovering to 97% for test 50 and nearly 100% for test 48. The time from Nr decay to initial Nr recovery for both tests was between 2 and 3 seconds (see figure 9).

**Figure 9.** Plot comparing tests 48, 50, and 51.

For test 51, Nr began to decay about 3.5 seconds after test initiation, similar to the prior tests. Collective was reduced to 58%, and Nr stabilized near 92% but did not return to 97% or higher as in the previous tests. After 6 seconds, a vibration near 6 Hz was seen in the collective and longitudinal cyclic inputs that was not present in the earlier tests. After 7 seconds, Nr stopped recovering. When collective was increased between 10 and 13 seconds and again between 16 and 17.5 seconds, Nr slowed, and, by 18 seconds, it had decreased to below 80%. After 10 seconds, cyclic input activity increased, as did the roll response. The helicopter's roll and pitch responded to cyclic input throughout the accident flight.
