Aviation Investigation Final Report

Location:	Chauvin, Louisiana	Accident Number:	CEN17FA112
Date & Time:	February 27, 2017, 10:33 Local	Registration:	N1371
Aircraft:	Bell 407	Aircraft Damage:	Destroyed
Defining Event:	Controlled flight into terr/obj (CFIT)	Injuries:	1 Fatal
Flight Conducted Under:	Part 91: General aviation - Positioning

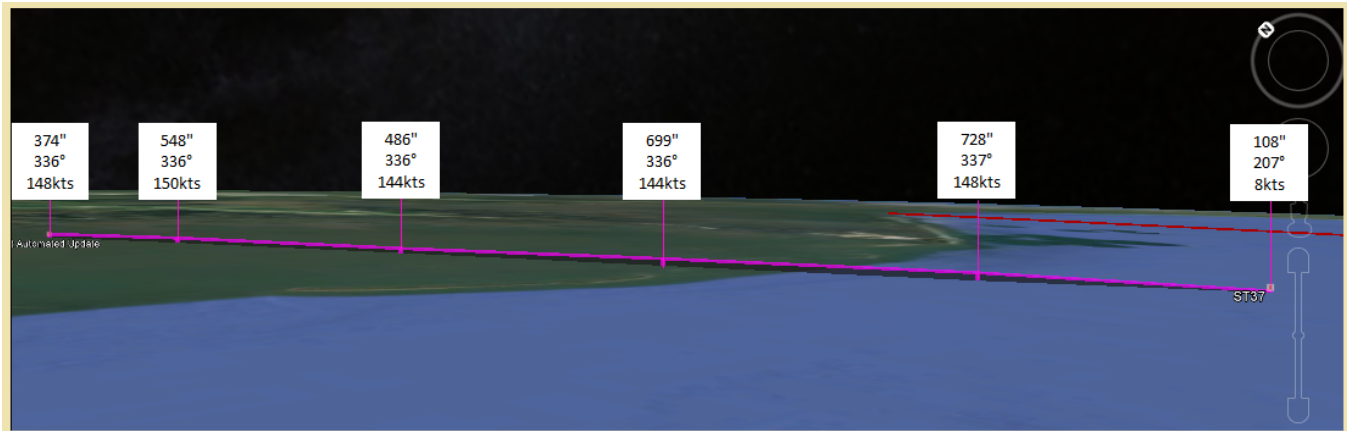
Figure. Sky Connect Flight Path

The helicopter was equipped with an on-board flight tracking system (Sky Connect). After takeoff from ST37, six flight path data points were recorded at 2-minute intervals and showed the helicopter on a northwest heading. Sky Connect data showed the flight path of the helicopter flying direct toward HUM on a northwest heading. Sky Connect Flight Path Data Points:

The figure shows the helicopter's altitude, heading, and ground speed; ST37 is located at the right of the figure. The last Sky Connect data point was at 1024, indicating an altitude of 374 ft and ground speed of 148 knots. Sky Connect issued an "Overdue" alarm at 1033. At 1103, company flight monitoring personnel dispatched a search helicopter, and the wreckage was found at 1135 about 15 miles south-southeast of HUM.
