Aviation Investigation Final Report

Location:	Audubon, Iowa	Accident Number:	CEN20LA136
Date & Time:	March 31, 2020, 16:26 Local	Registration:	N107EH
Aircraft:	ROBINSON HELICOPTER COMPANY R44 II	Aircraft Damage:	Destroyed
Defining Event:	Controlled flight into terr/obj (CFIT)	Injuries:	2 Fatal
Flight Conducted Under:	Part 91: General aviation - Aerial observation

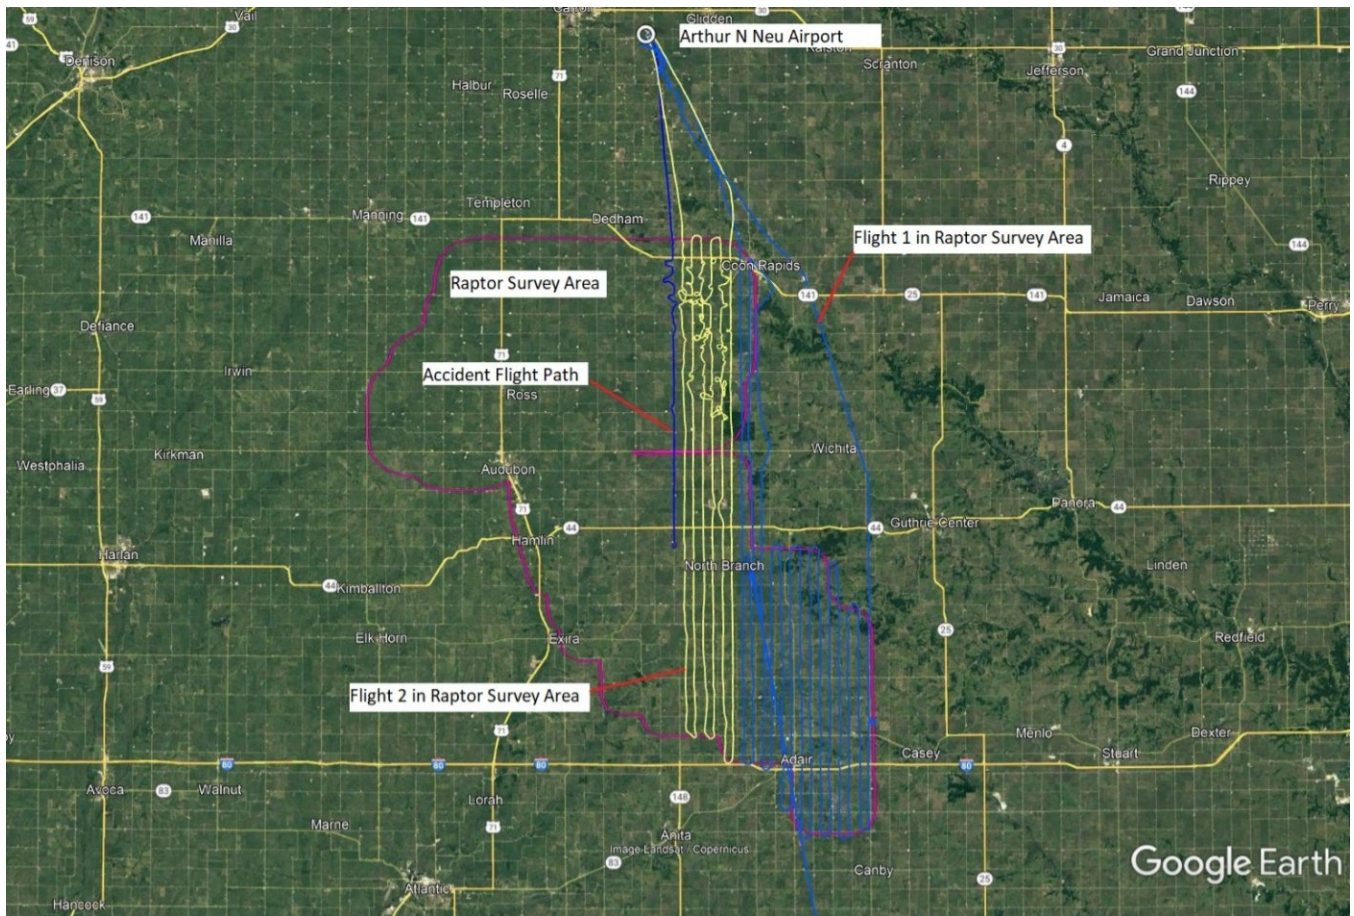
Automatic dependent surveillance- broadcast (ADS-B) data showed that during the final moments of the accident flight, the helicopter was travelling south over Robin Avenue, approaching 240th Street, at an ADS-B-reported geometric altitude of 1,475 ft, with a ground speed of about 85 kts. The final recorded data point was about 160 ft north of the wires that were struck. There were no deviations in heading or altitude before the end of the data. The ground elevation at the accident site was about 1,460 ft. The flights within the survey area were conducted at altitudes about 100 ft above the ground. Examination of the flight track data for the previous flight showed that the helicopter had crossed the power lines on at least two occasions during the previous flight. (See Figure 1.)

Figure 1: Plot of the survey area and the helicopter flight path on the day of the accident.

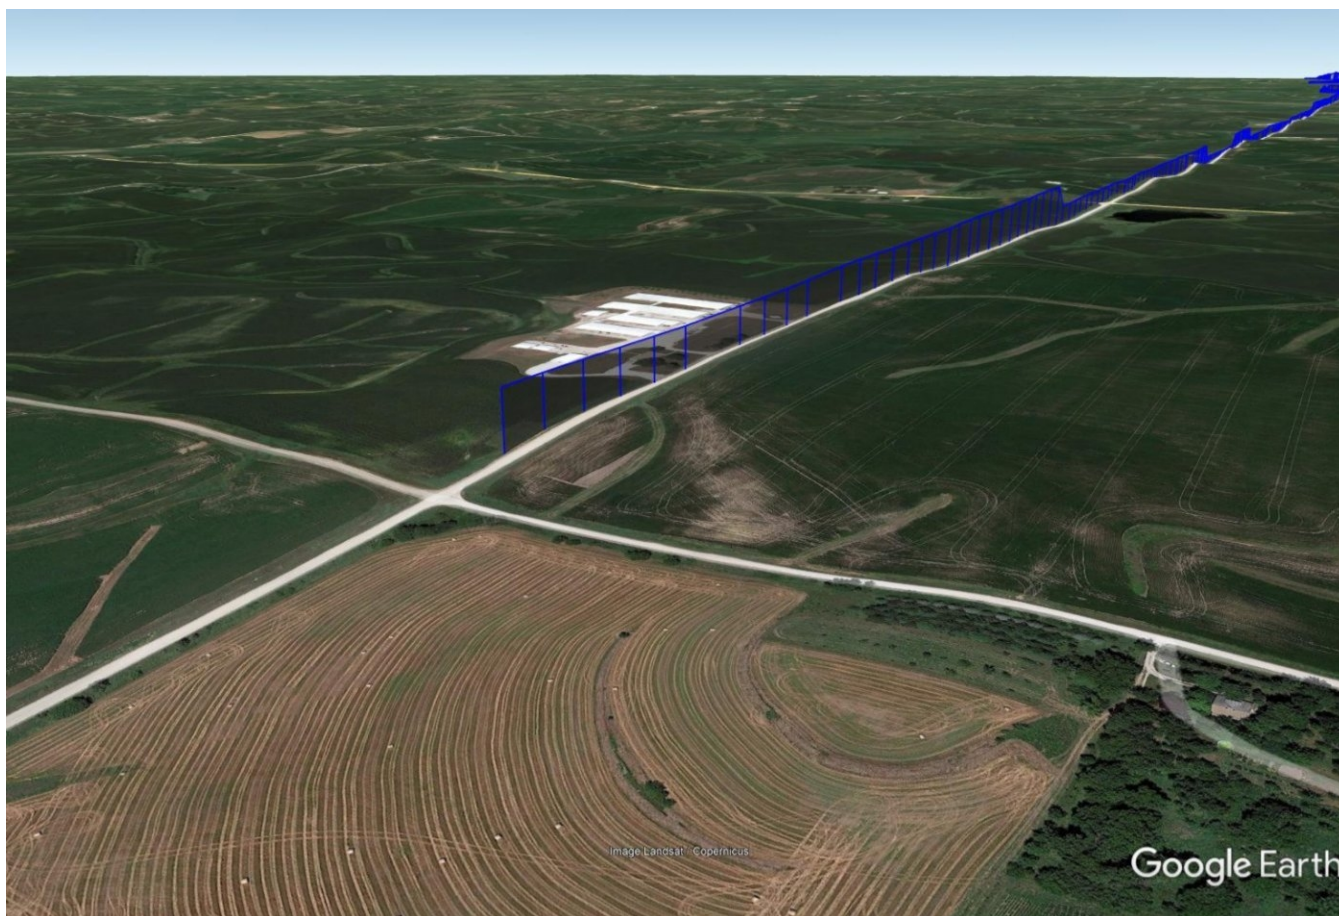
Figure 2: 3-dimensional view of the final portion of the accident flight path.

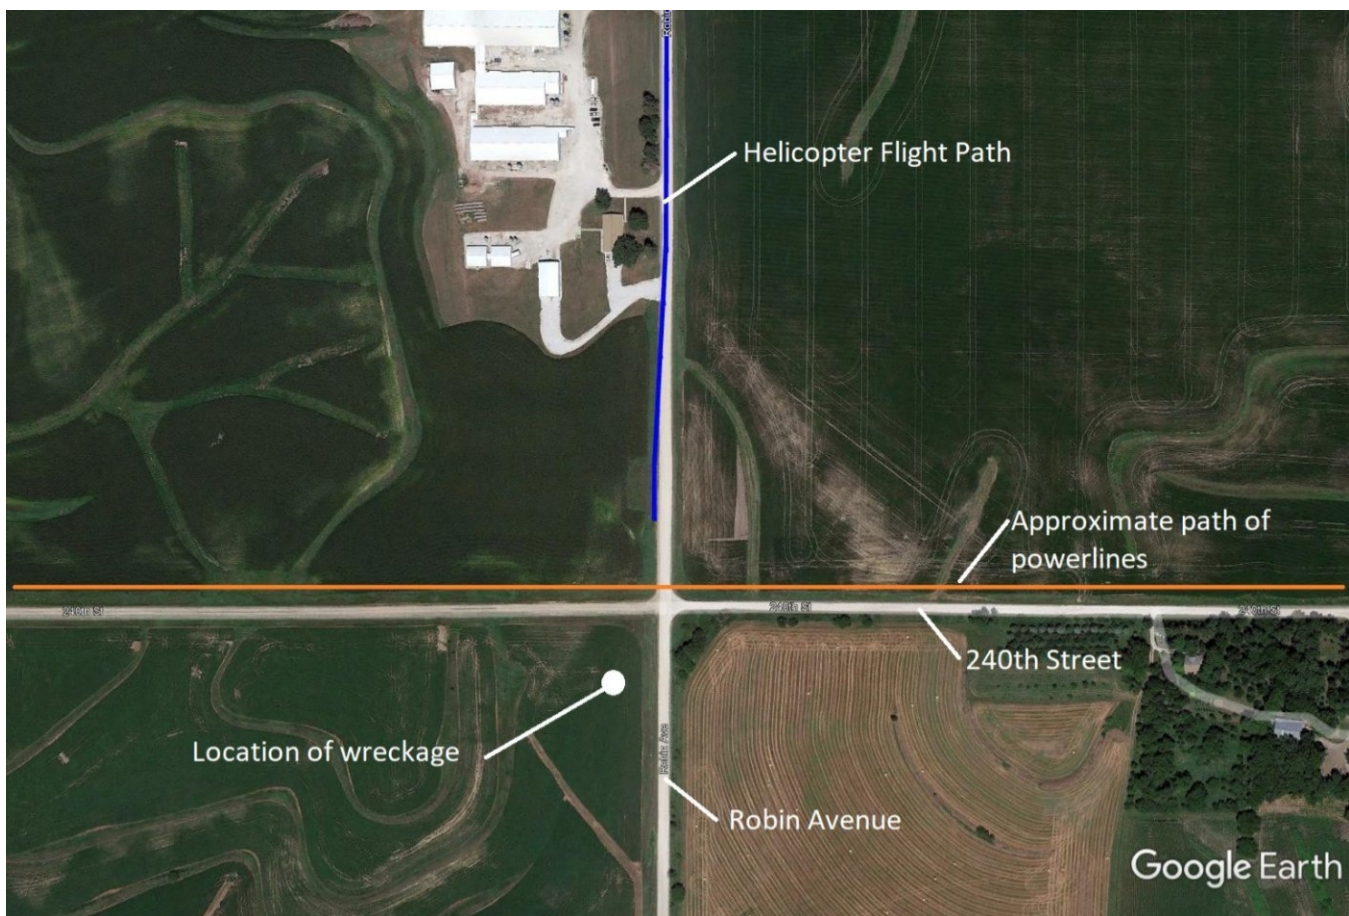
The helicopter came to rest in a field next to the west side of Robin Avenue and south of 240th Street. The wires that were struck ran along the north edge of 240th Street, strung between poles that were about 100 ft. tall. The estimated height of the wires struck was about 85 ft. above the ground.

Figure 3. Location of powerlines, helicopter flight path, and wreckage.

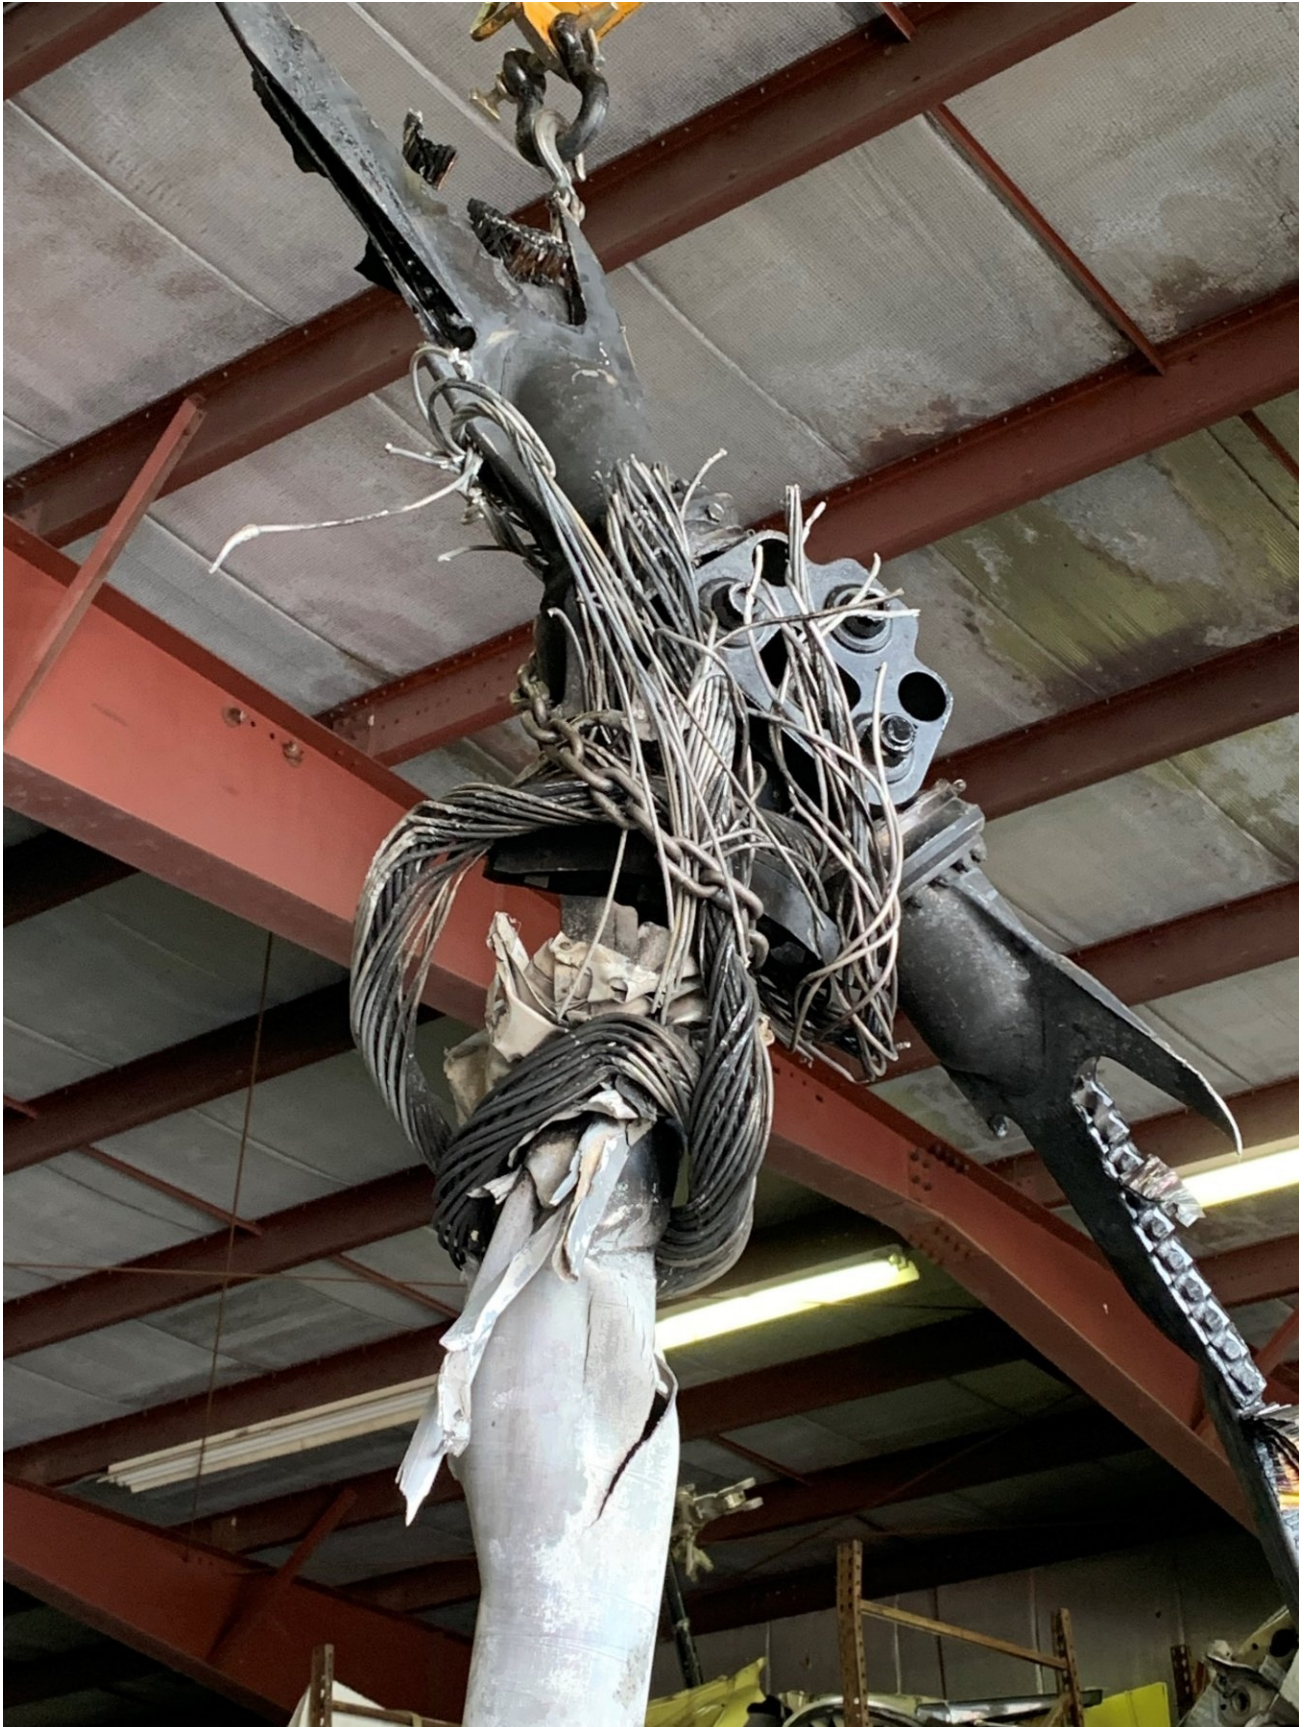
A post-impact fire consumed most of the cabin section of the helicopter. A postaccident examination of the helicopter after it was removed from the site revealed no preimpact anomalies. A large wire was found wrapped around the rotor mast just below the main rotors.

Figure 4: Powerline wires wrapped around main rotor mast.
