# Aviation Investigation Final Report

<b>Location:</b>	Pikeville, North Carolina	<b>Accident Number:</b>	ERA20LA220
<b>Date &amp; Time:</b>	June 18, 2020, 17:00 Local	<b>Registration:</b>	N4QW
<b>Aircraft:</b>	Robinson R66	<b>Aircraft Damage:</b>	Substantial
<b>Defining Event:</b>	Collision with terr/obj (non-CFIT)	<b>Injuries:</b>	1 Fatal
<b>Flight Conducted Under:</b>	Part 137: Agricultural

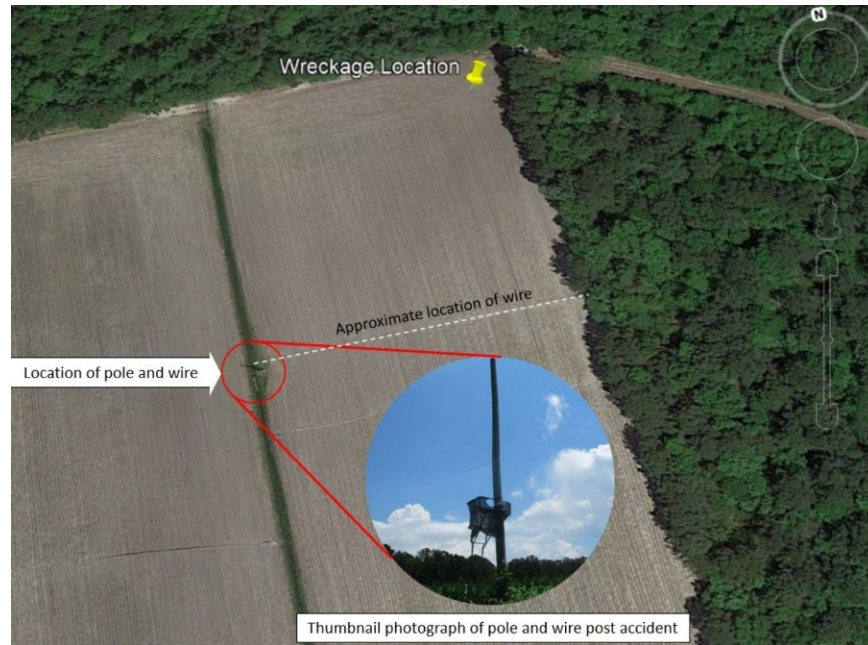
Clear daylight conditions existed at the time of the accident. The sun was at 39.85° above the horizon at an azimuth of 272.39° and was very close to being directly in line with the wire. It is possible that the sun's position relative to the wire would have made the 5/16-inch wire more difficult to see as the shadow of the wire and pole would have been nearly directly under the wire rather than offset.

The pilot's failure to see and avoid a small diameter wire during low altitude agricultural spraying operations. Contributing to the accident was the pilot's insufficient property survey.

The helicopter impacted a non-energized wire, also known as a "dove wire" that was used for hunting. The wire was mounted about 30 feet up a 40 ft pole that also contained a hunting stand and was stretched across the width of the corn field (250 ft) from west to east (See figure 1). The wire was connected to a tree on the east side of field, perpendicular to the helicopter's flightpath. The wire had no markings and was 5/16 inch thick. According to the farmer, the wire was installed at least 20 years earlier and was installed high enough for a tractor or combine to get underneath it during harvest.

*Figure 1 - Accident site overview of pole, wire, and wreckage location.*

The wreckage path was oriented on a heading of about 030° magnetic, and the distance from the wire impact to the final wreckage location was about 275 ft. The tail rotor empennage separated about 2 ft aft of the rotating beacon light and was found in a nearby irrigation ditch. The tail rotor assembly and blades separated from the empennage. All major components of the helicopter were accounted for at the accident site. Both main rotor blades remained attached to the hub. About 20 ft of 5/16 inch diameter braided steel wire was wrapped around the blade pitch change horns, swashplate, pitch links, rotor hub, and both rotor blades.
