Aviation Investigation Final Report

Location:	Hertford, North Carolina	Accident Number:	ERA17MA316
Date & Time:	September 8, 2017, 11:20 Local	Registration:	N146DU
Aircraft:	EUROCOPTER DEUTSCHLAND GMBH MBB BK 117	Aircraft Damage:	Destroyed
Defining Event:	Loss of engine power (partial)	Injuries:	4 Fatal
Flight Conducted Under:	Part 135: Air taxi & commuter - Non-scheduled - Air Medical (Discretionary)

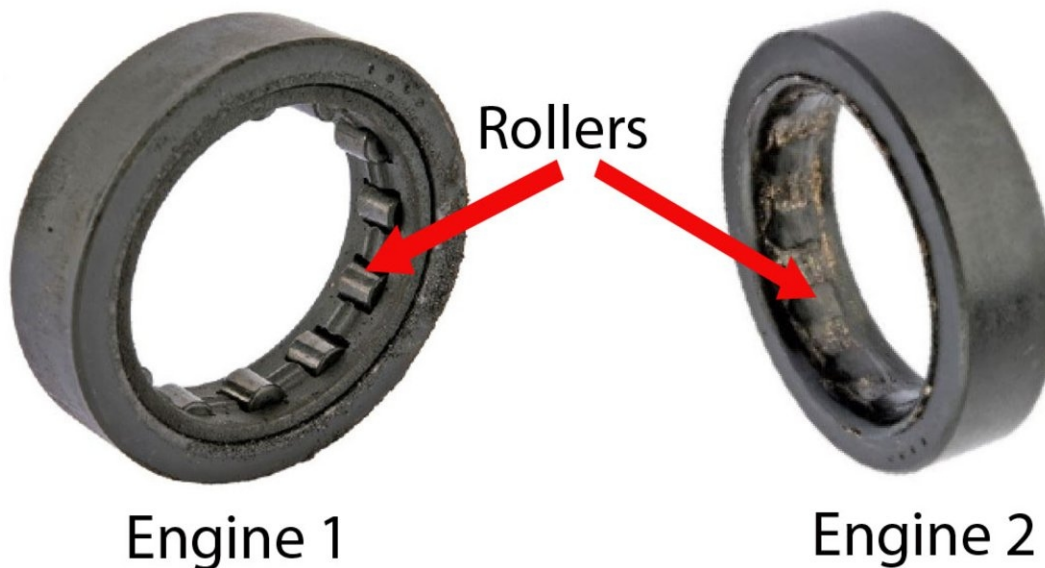
Detailed examination of the No. 2 engine revealed that its gas generator shaft rear bearing was seized and damaged. Specifically, all the roller elements were flattened and none of the roller elements would rotate. Several bearing components showed damage consistent with friction between the seized rollers and the inner race and ensuing overheating. These signatures were not observed in the No. 1 engine gas generator shaft rear bearing. The lack of rotation of the roller pins and the damage to the gas generator spool indicated that the No. 2 engine's rear bearing had failed during the accident flight.

The No. 2 engine disassembly revealed that the gas generator shaft rear bearing was mechanically damaged. A detailed examination of the bearing at the engine manufacturer's laboratory revealed that all of the bearing roller elements were found seized (that is, none of the roller elements would rotate), with the outer bearing race, and had rubbed against the inner rotating bearing race. The roller elements appeared ground down (flattened) and overheated.

Figure 2 compares the No. 2 engine rear bearing with the undamaged No. 1 engine rear bearing. Turbine components and the end of the No. 2 engine gas generator shaft exhibited rotational non-uniform damage. This damage was consistent with some continued rotation of the gas generator spool after the bearing had seized. (The turbine shaft supported by the rear bearing rotates at speeds up to 53,500 rpm.)

Figure 2 - Gas generator shaft rear bearings.
