Aviation Investigation Final Report

Location:	New Salem, North Carolina	Accident Number:	ERA20FA012
Date & Time:	October 17, 2019, 15:38 Local	Registration:	N167AG
Aircraft:	Bell 206	Aircraft Damage:	Substantial
Defining Event:	Collision with terr/obj (non-CFIT)	Injuries:	1 Fatal
Flight Conducted Under:	Part 137: Agricultural

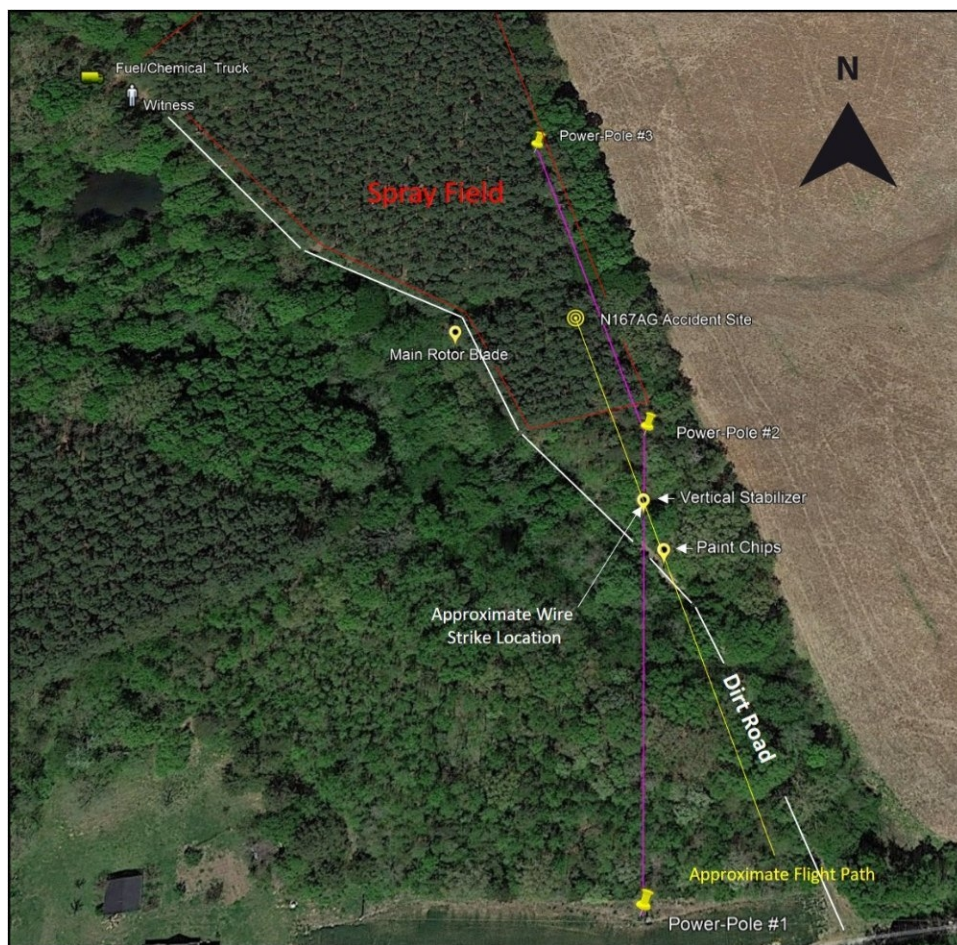
Figure 1 – Accident location.

Examination of the accident site area revealed damage to powerlines that were oriented south to north. (see Figure 1.) The helicopter was on a north-northwest heading when it struck the wire between poles 1 and 2, near pole 2.
