Aviation Investigation Final Report

Location:	Honolulu, Hawaii	Accident Number:	WPR16FA072
Date & Time:	February 18, 2016, 10:20 Local	Registration:	N80918
Aircraft:	Bell 206B	Aircraft Damage:	Substantial
Defining Event:	Sys/Comp malf/fail (non-power)	Injuries:	1 Fatal, 3 Serious, 1 Minor
Flight Conducted Under:	Part 91: General aviation - Aerial observation

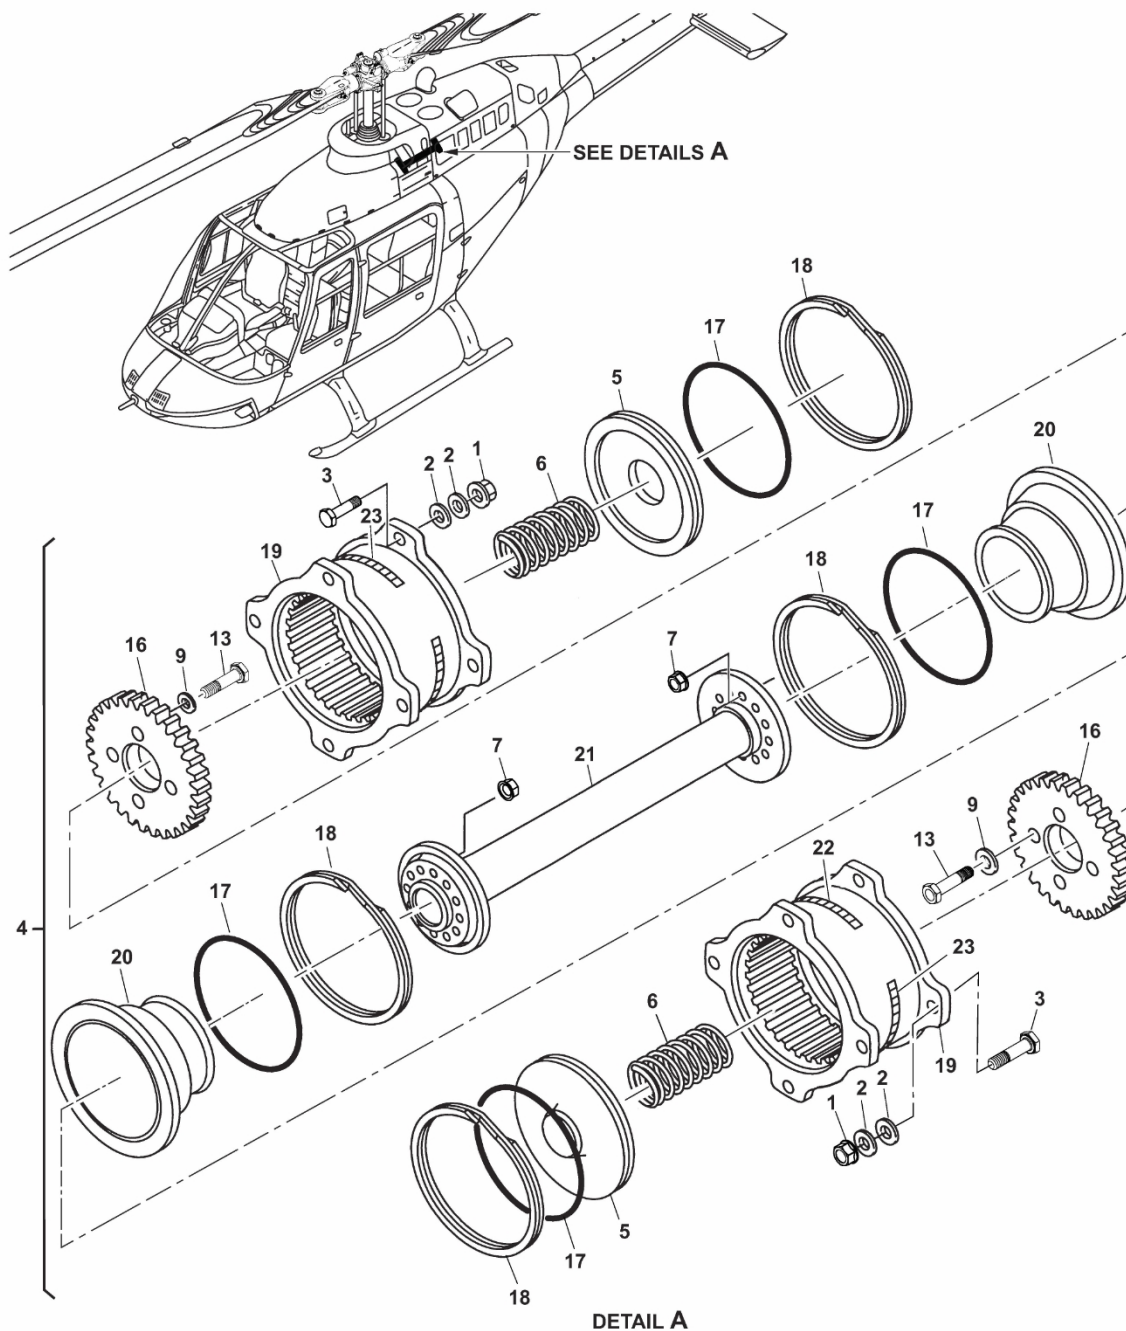
Figure 2: Engine-to-transmission-driveshaft diagram.

The drive shaft contains a gear sprocket affixed to the shaft flange via 4 bolts (bolt heads positioned on the inside of the coupling). The donut-shaped gear has a hollow area in the middle that aligns with the hollow tube situated between the couplings; a slight lip surrounds the hollow area. The outer coupling gear surrounds the drive gear where it is splined, and torque is transmitted. Inside the coupling, the assembly is equipped with a shaft centering spring. The spring (item 6 in figure 2) is positioned between

the lip and the end cap of the coupling (grease retainer plate). A retainer ring and packing seal rest against the back plate.

The spline teeth on the forward (transmission side) spherical coupling were worn down to the bottom landings. Two of the attachment bolts had fractured at the transition from the bolt shank to the bolt head. The forward compression spring and forward cover plate were both fractured into multiple pieces and the spring pieces were deformed from their original shape. A comparison of the spring and cover plate fragments with their respective aft counterparts indicated that only a portion of each item was recovered. The spring and cover plate fragment fracture surfaces were examined visually with the aid of a stereomicroscope and all fractures exhibited features consistent with either overstress or rubbing/smearing due to post-separation damage.

The forward outer coupling had a dark tint consistent with exposure to elevated temperatures, and the temperature plates, which were supposed to be on the forward outer coupling, were missing. The forward end of the forward outer coupling exhibited mechanical damage around the perimeter of the forward opening. The internal spline profile exhibited comparatively minor wear marks near the middle of the spline teeth when compared to the wear on the forward spherical coupling.

Neither the forward spherical coupling nor the forward outer coupling exhibited indications of residual grease lubrication. By comparison, the aft outer coupling and spherical coupling were covered by a lubricant that was brown/black in color and viscous. The aft coupling did not exhibit any notable wear features.

The attachment bolt head fractures were examined in detail and determined to be consistent with cadmium-induced embrittlement of the steel at elevated temperature. The bolts were type NAS 1304-10 and were made of a low alloy steel with a cadmium-plated coating. Both bolt heads were examined using a scanning electron microscope (SEM). The fracture surface had a faceted appearance, consistent with intergranular fracture. Energy dispersive x-ray spectroscopy (EDS) of the fracture surface and a portion of the bolt indicated the presence of oxygen and cadmium in addition to the elements associated with the base metal.

The BHT maintenance manual recommends that, before reassembly, the engine-to-transmission drive shaft couplings be hand-packed with lubricant (C-015 grease) over the top of the internal spline teeth to a depth of 0.2-0.3 inch.
