Aviation Investigation Final Report

Location:	Viroqua, Wisconsin	Accident Number:	CEN19FA276
Date & Time:	August 19, 2019, 18:34 Local	Registration:	N634SC
Aircraft:	SHIRLEY CARL SPORTCOPTER VORTEX	Aircraft Damage:	Destroyed
Defining Event:	Loss of engine power (total)	Injuries:	1 Fatal
Flight Conducted Under:	Part 91: General aviation - Personal

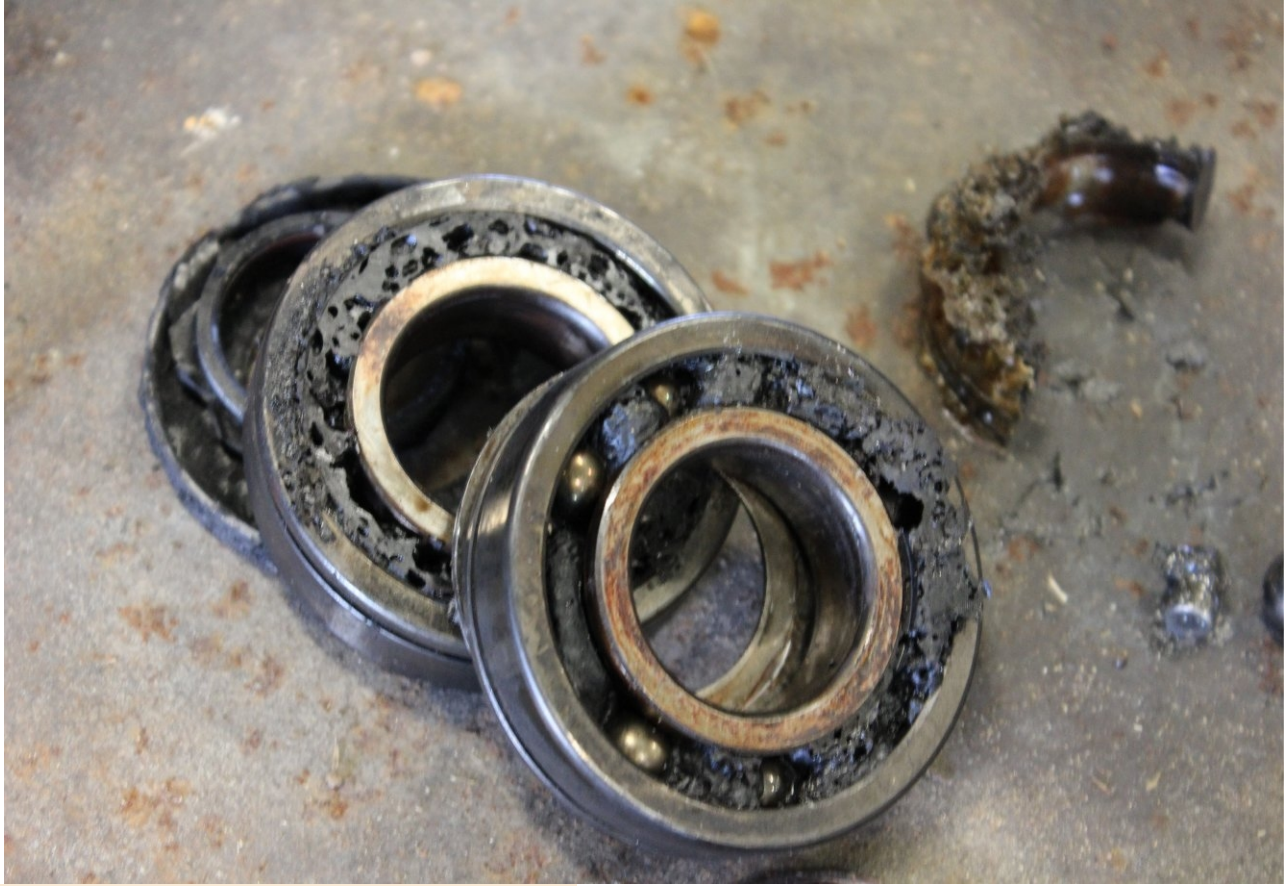
The noncertificated pilot's loss of control of the gyrocopter after a total loss of engine power due to seizure of the crankshaft bearings. Contributing to the accident were the insufficient maintenance of the engine and the pilot's lack of gyrocopter flight experience.

When the engine case was separated, circumferential scarring was present on both sides of the engine case corresponding to the No.1 (most forward) bearing.

The substance in all bearings was congealed, consistent with exposure to high heat. See figure 1.

Figure 1: Congealed substance in each bearing
