Aviation Investigation Final Report

Location:	McFarland, California	Accident Number:	WPR16FA037
Date & Time:	December 10, 2015, 19:03 Local	Registration:	N408FC
Aircraft:	Bell 407	Aircraft Damage:	Destroyed
Defining Event:	Loss of control in flight	Injuries:	4 Fatal
Flight Conducted Under:	Part 135: Air taxi & commuter - Non-scheduled - Air Medical (Discretionary)

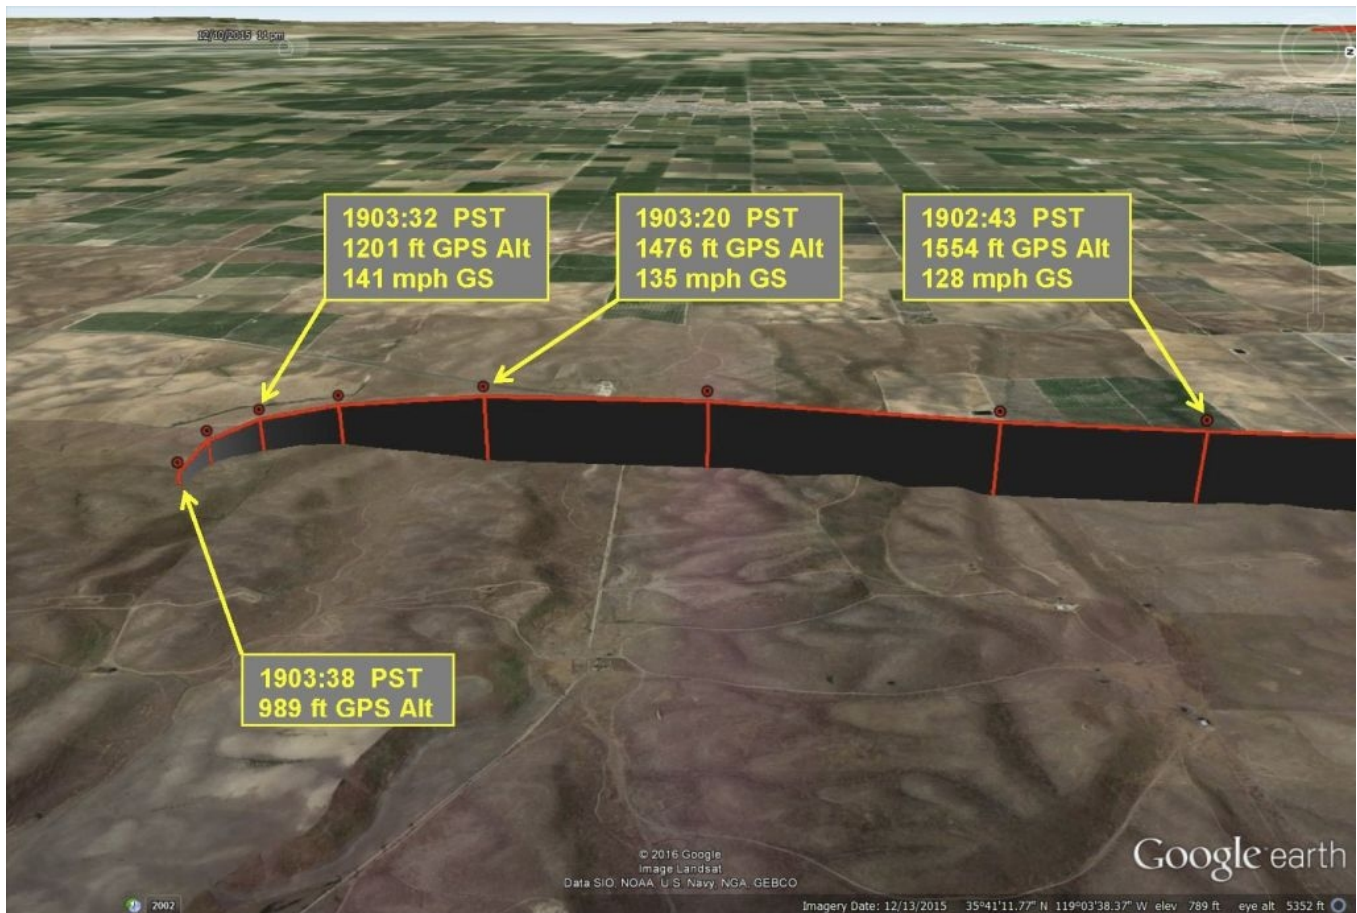
Between 1903:08 and 1903:20, the helicopter's GPS altitude decreased from 1,535 to 1,476 ft, and the groundspeed increased from 135 to 138 mph, while the helicopter flew along a magnetic heading of 185°. At 1903:28, the helicopter began a left turn while descending through 1,300 ft at a groundspeed of 141 mph. The last three recorded data points—at 1903:32, 1903:35, and 1903:38—showed that the

helicopter continued to descend; the GPS did not indicate a groundspeed for the last data point, which was recorded when the helicopter was about 590 ft southwest of the accident site. The calculated rate of descent for the last three data points was 2,210 ft per minute. Figure 1 shows the GPS-derived data points between 1902:43 and 1903:38.

Figure 1. Final eight GPS-recorded data points.

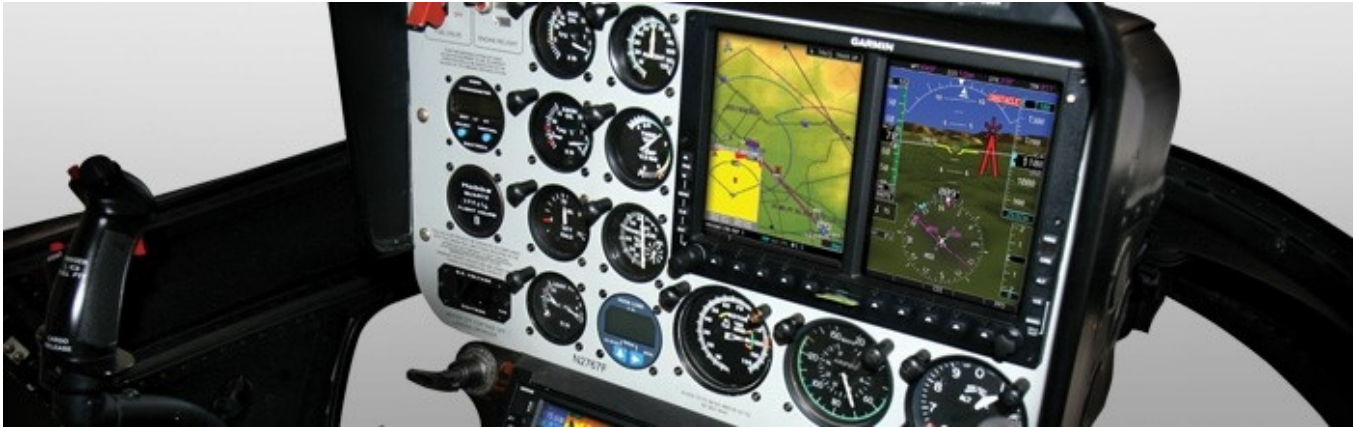
Figure 2. Garmin G500H system similar to that installed in N408FC (the accident helicopter) , Obtained from Garmin.Com.

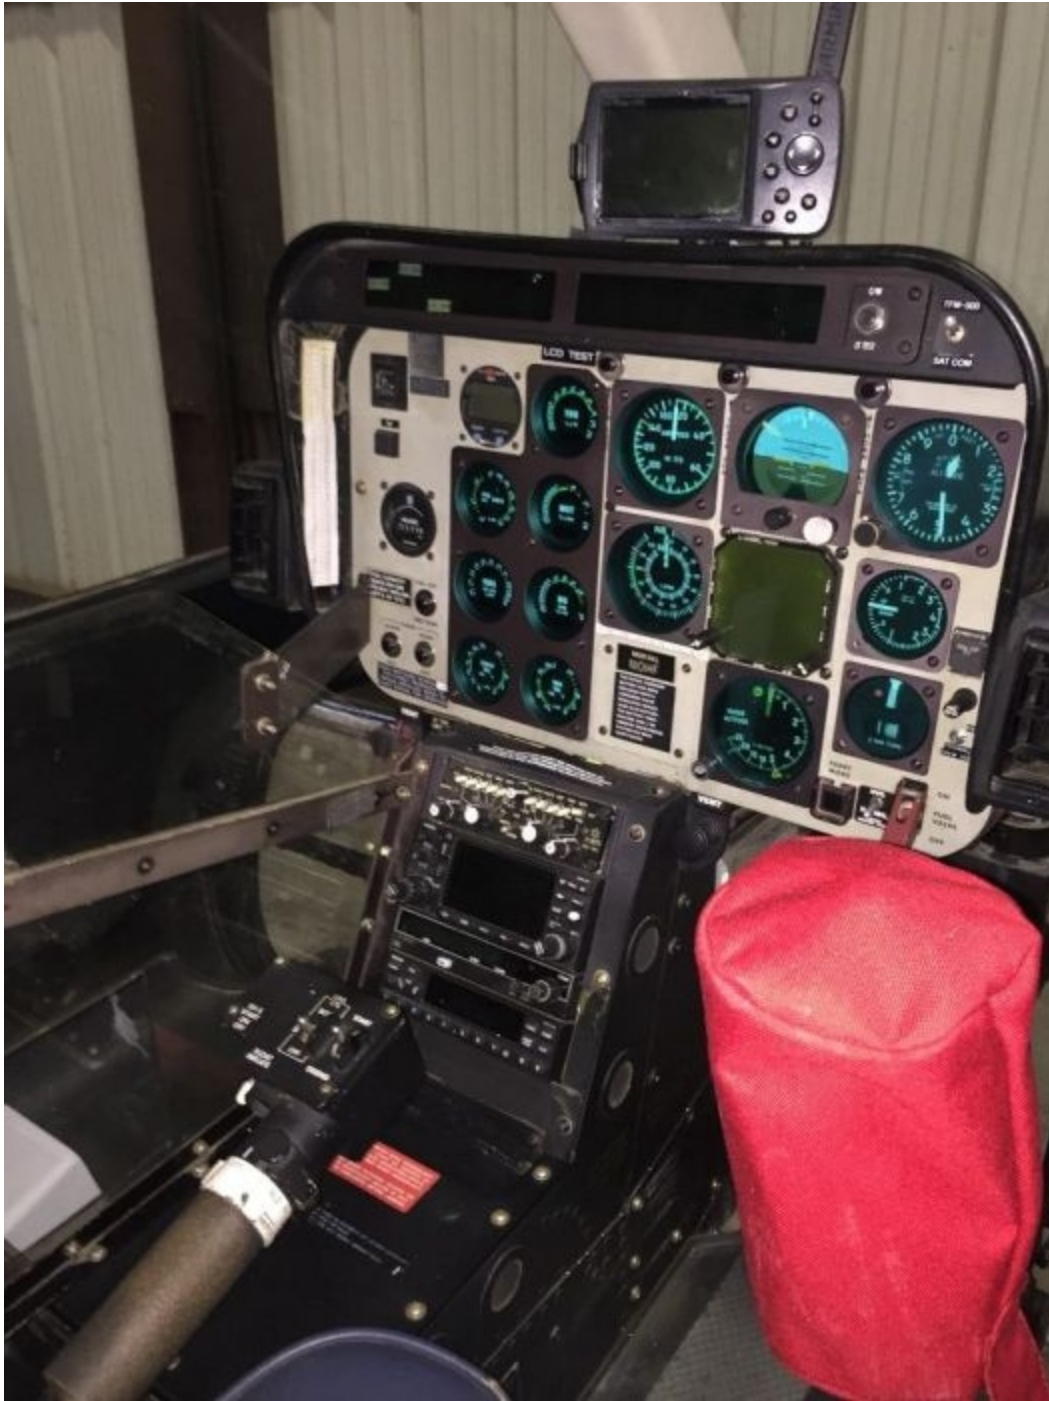
The pilot primarily flew another company Bell 407 helicopter, N101HF, that was also configured for HAA operations. As shown in figure 3, this helicopter had analog instruments and not the advanced avionics installed in the accident helicopter.

Figure 3. Analog instruments installed in N101HF.

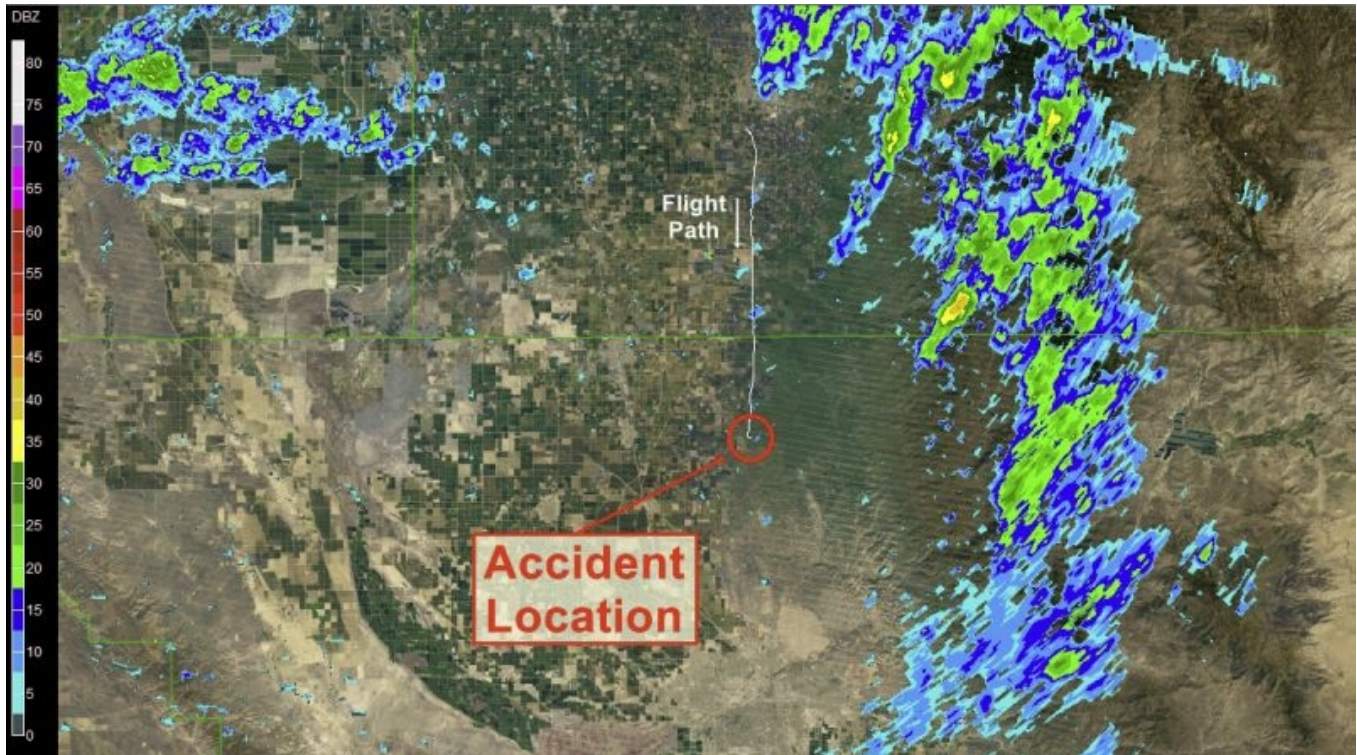
The closest National Weather Service Weather (NWS) Surveillance Radar-1988, Doppler (WSR-88D) was located in the San Joaquin Valley, California, about 47 nm northwest of the accident site. The WSR-88D captured base reflectivity imagery at 1902, as shown in figure 4, which mainly depicted light to moderate values of reflectivity to the east, northeast, north, and northwest of the accident site.

Figure 4. WSR-88D base reflectivity imagery.
