Aviation Investigation Final Report

Location:	Erie, Colorado	Accident Number:	CEN15FA126
Date & Time:	January 26, 2015, 12:02 Local	Registration:	N86235
Aircraft:	Enstrom 280FX	Aircraft Damage:	Destroyed
Defining Event:	Inflight upset	Injuries:	2 Fatal
Flight Conducted Under:	Part 91: General aviation - Instructional

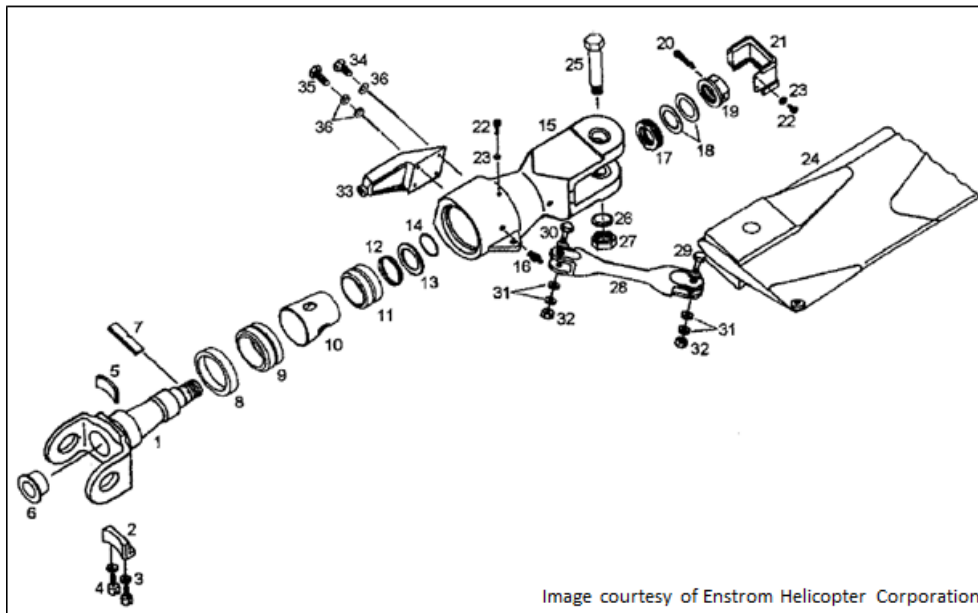
Figure 1: Enstrom spindle and grip assembly

The inboard end of each main rotor blade is attached to its respective grip and drag link. Each rotor blade is attached to the outboard side of its respective grip via a retention bolt. At the inboard side of each grip, a pitch arm and drag link are attached to the leading and trailing sides, respectively, of the grip. Two feather bearings, which accommodate rotor blade pitch change motion, a bearing spacer, and a spindle are installed within the grip. A Lamiflex bearing, a spindle retention nut, and a cover are installed at the threaded outboard end of the spindle. Two flanges at the inboard end of the spindle attach to a universal block, the latter of which is attached to the main rotor hub, that accommodate rotor blade flapping and lead-lag motions. See figure 1.
