Aviation Investigation Final Report

Location:	Gulf of Mexico, Gulf of Mexico	Accident Number:	CEN20FA035
Date & Time:	December 7, 2019, 09:18 Local	Registration:	N79LP
Aircraft:	Bell 407	Aircraft Damage:	Destroyed
Defining Event:	Powerplant sys/comp malf/fail	Injuries:	2 Fatal
Flight Conducted Under:	Part 135: Air taxi & commuter - Non-scheduled

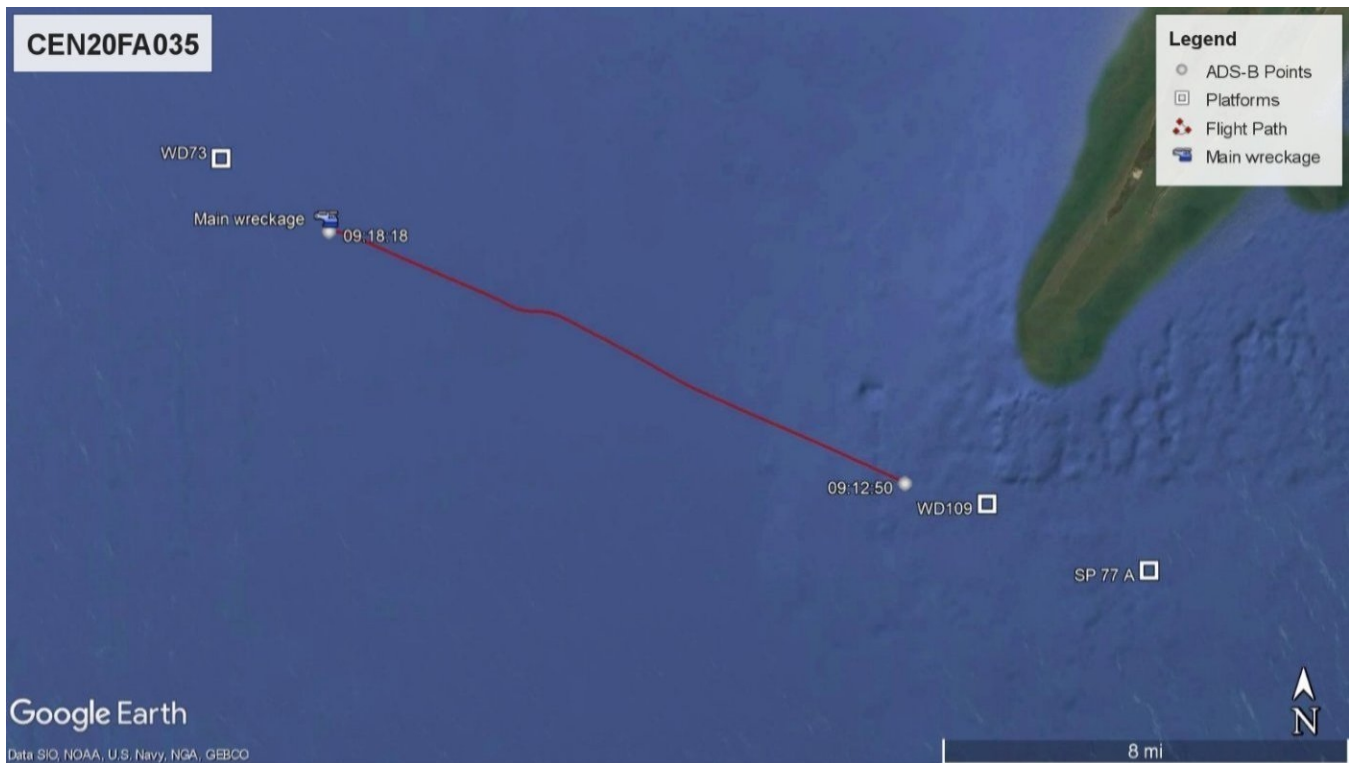
Recorded ADS-B data revealed that the helicopter’s flight track began at 0912:50 about 1.5 miles west-northwest of platform WD109 at 700 ft mean sea level (msl) and 115 knots groundspeed. The helicopter continued northwest for about 10.5 miles and gradually descended to 375 ft msl. At 0918:10, the helicopter’s heading was 292° at a groundspeed of 114 knots and altitude of 375 ft msl. The final recorded point, at 0918:18, showed that the helicopter made a left course deviation to 270°, descended to 150 ft msl, and slowed to 72 knots. Figure 1 shows the platforms, recorded ADS-B flight path, and initial main wreckage location.

Figure 1 – Main wreckage location, flight track and platforms.

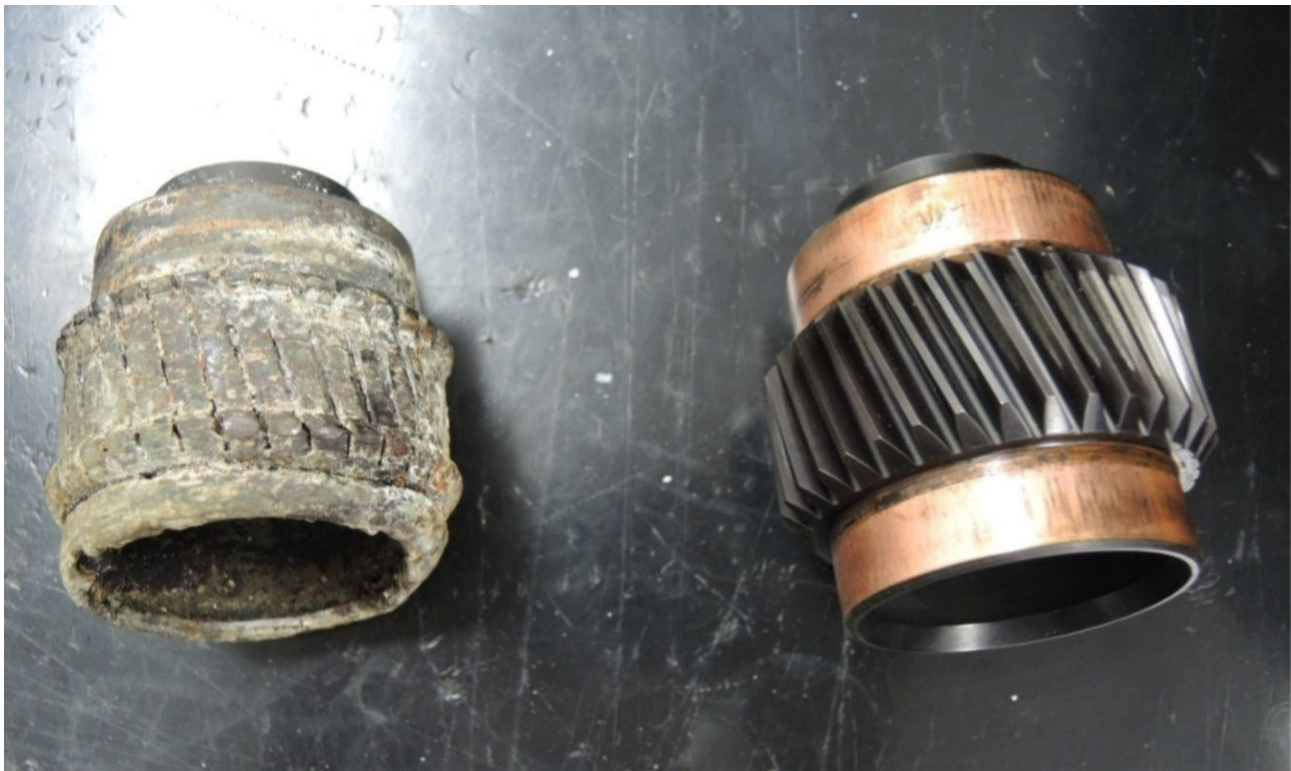
Examination of the engine revealed that the power turbine pinion gear teeth were significantly worn and smeared, which ultimately resulted in the engine's inability to provide power to the rotor system. While the majority of the No. 3 bearing was not recovered, the significant thermal damage and loss of material of the power turbine pinion gear shoulder, to which the No. 3 bearing inner race was installed, indicated that the bearing likely failed first, but the cause of the No. 3 bearing failure could not be determined because the bearing was not recovered. The failure of the No. 3 bearing could result in misalignment of the gear mesh between the power turbine pinion gear and the torque meter gear, which likely caused the pinion gear teeth to rapidly degrade and/or fracture. The initial failure of the No. 3 bearing would have resulted in the failure of the No. 4 bearing and the power turbine pinion gear. The reasons why damage to the Nos. 3 and 4 bearings and the power turbine pinion gear did not result in an engine chip light or oil filter contamination, leading to a filter bypass indication, could not be determined based on the available evidence.

Several gears and engine accessories from the accessory gearbox were recovered separated from the engine assembly. The power turbine pinion gear, part of the power turbine-to-pinion (N2) gear train, was found loose in the accessory gearbox and exhibited severe wear and smearing damage on its gear teeth and bearing shoulders. Figure 2 shows a comparison of the accident power turbine pinion gear (left) to an exemplar power turbine pinion gear (right).

Figure 2 – Accident power turbine pinion gear (left) and an exemplar power turbine pinion gear (right).

Rolls-Royce completed a metallographic examination of the retained engine components. The power turbine pinion gear exhibited evidence of fatigue fractures on six consecutive gear teeth. The fatigue fractures originated on the drive side tooth root fillets and exhibited multiple origins. The fatigue fractures progressed toward the coast side (the non-drive and non-contact side) of the gear tooth. No dimensional anomalies were observed at the fracture origins or the gear tooth root surfaces adjacent to the origins. All pinion gear teeth exhibited circumferential rubbing and smearing. The Nos. 3 and 4 bearing journals on the power turbine pinion gear also exhibited circumferential rubbing damage and thermal distress, with the No. 3 bearing journal
