Aviation Investigation Final Report

Location:	The Woodlands, Texas	Accident Number:	CEN15LA104
Date & Time:	January 16, 2015, 12:30 Local	Registration:	N416JB
Aircraft:	BAKER BOBBY J SAFARI	Aircraft Damage:	Substantial
Defining Event:	Aircraft structural failure	Injuries:	1 Fatal
Flight Conducted Under:	Part 91: General aviation - Personal

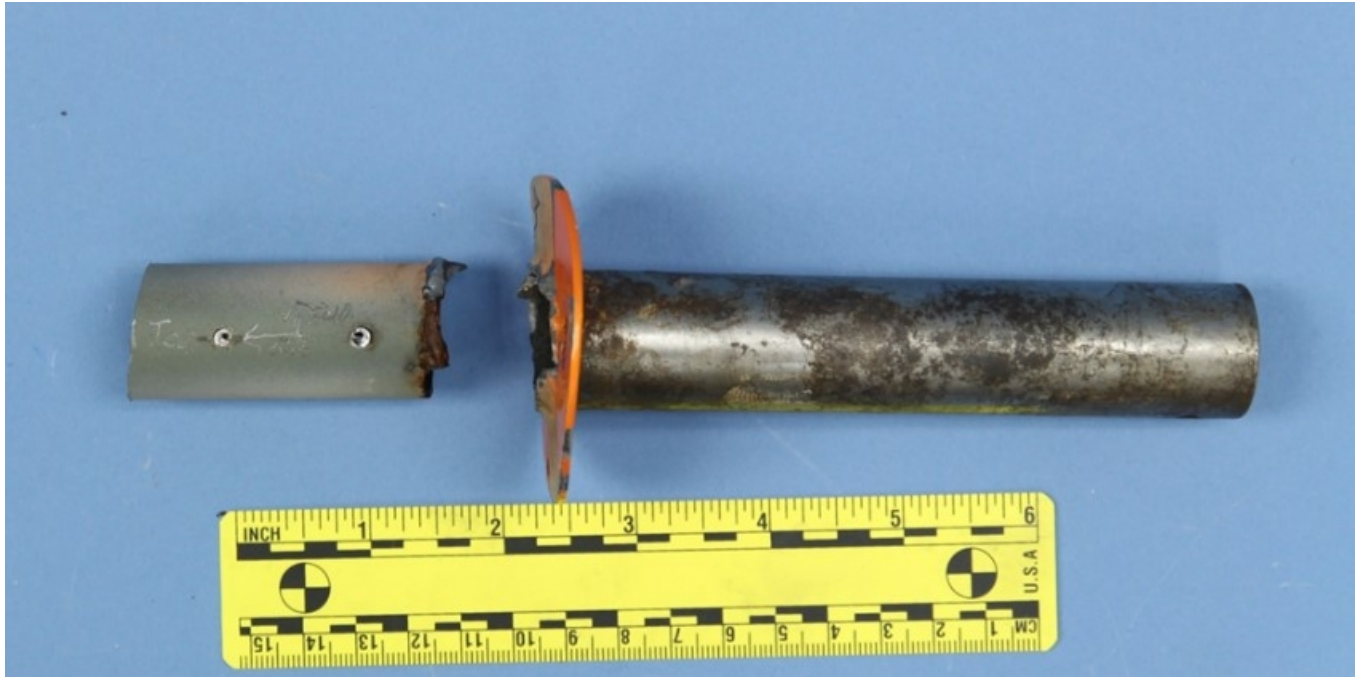
Figure 1: Photograph of fractured spar tube from horizontal stabilizer

The spar tube of the horizontal stabilizer was fractured just outboard of the mounting flange and adjacent to the inboard edge of the airfoil section. The forward side of the end plate was bent slightly outboard but no impact damage was apparent on either the end plate or the airfoil skin of the stabilizer.

As manufactured, the mounting flange of the spar is welded (on the outboard side) to the spar tube and positioned immediately adjacent to the inboard edge of the airfoil skin. As assembled, the fracture location and weld are partially hidden by the airfoil skin and not directly visible.

Most of the fracture followed the outboard edge of the mounting flange weld. As initially received, large areas of both fracture faces were obscured by red and brown corrosion products. These surfaces were cleaned for a more detailed examination. Magnified optical examinations of the fracture surfaces identified features consistent with fatigue cracking. Three fatigue origins were found on the outer surface of the spar tube at the outboard toe (edge) of the assembly weld. The fatigue propagated generally radially through the wall thickness with some circumferential spreading. The fatigue cracking progressed through about half of the total spar cross section. The fatigue origins and propagation were

all on the aft portion of the spar. No corrosion or other obvious damage was apparent at any of the origins.

Examinations also uncovered a rust-covered crack slightly inboard of and undercutting the main fracture plain. The undercutting crack intersected the outboard fatigue and formed part of the overall fracture. Magnified examinations of the crack faces without opening revealed fatigue features with at least one fatigue origin on the outer surface of the spar. The crack morphology was consistent with additional fatigue origins in the unopened portion of the crack.

The remaining fracture surface displayed separation features and deformation patterns consistent with overstress separation. The deformation pattern was consistent with forces associated with the stabilizer tip moving forward and outboard.

Visually, the weld exhibited good workmanship with no apparent undercutting, weld cracking, or surface discontinuities. A small pore and a single area of lack of fusion were uncovered by the weld fracturing in the overstress regions.

The inboard fracture face was viewed using a scanning electron microscope (SEM) after it was cleaned and the corrosion removed. The fracture area near one fatigue origin point displayed a corrosion-damaged surface, while fracture two other surfaces were much less damaged by corrosion and displayed features consistent with fatigue cracking in alloy steels.

The bulletin stated that, if cracking was found on the horizontal stabilizer spar, it must be replaced with a new spar. If no cracking was found during LPI inspection, Safari indicated that a steel tube insert must be installed into the end of the stabilizer to extend the "full length of the tail boom mount."
