# Aviation Investigation Final Report

<b>Location:</b>	Forkston, Pennsylvania	<b>Accident Number:</b>	ERA21LA191
<b>Date &amp; Time:</b>	April 22, 2021, 21:04 Local	<b>Registration:</b>	N4055N
<b>Aircraft:</b>	ROBINSON HELICOPTER R44	<b>Aircraft Damage:</b>	Destroyed
<b>Defining Event:</b>	VFR encounter with IMC	<b>Injuries:</b>	1 Fatal
<b>Flight Conducted Under:</b>	Part 91: General aviation - Personal

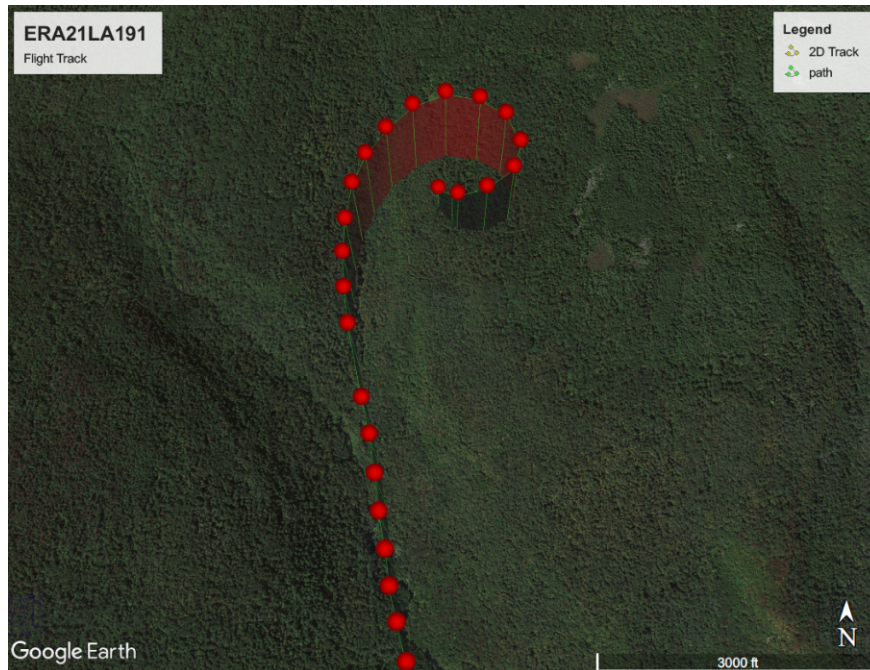
Figure 1 - Helicopter's flight track during the final moments of the flight.
