# Aviation Investigation Final Report

<b>Location:</b>	Pigeon Forge, Tennessee	<b>Accident Number:</b>	ERA16FA144
<b>Date &amp; Time:</b>	April 4, 2016, 16:10 Local	<b>Registration:</b>	N16760
<b>Aircraft:</b>	Bell 206	<b>Aircraft Damage:</b>	Destroyed
<b>Defining Event:</b>	Loss of engine power (total)	<b>Injuries:</b>	5 Fatal
<b>Flight Conducted Under:</b>	Part 91: General aviation - Aerial observation

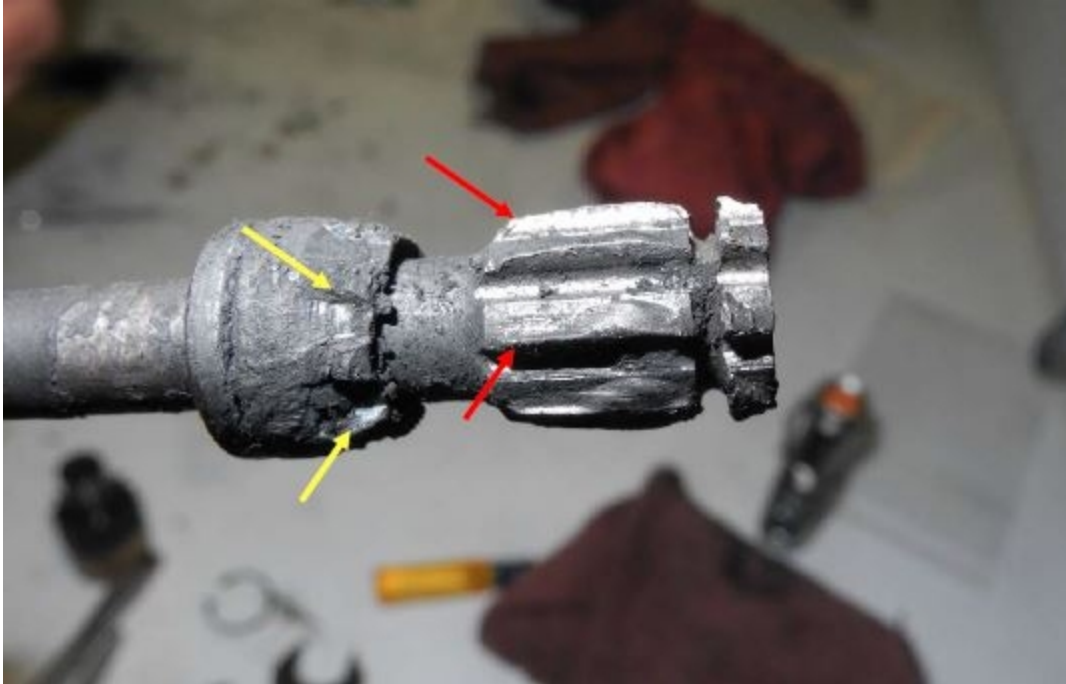
The wear on the splines was likely accelerated due to a lack of grease. Remnant material on the fuel pump splines was consistent with grease being present at some time on the drive gear and drive shaft splined connection, but it could not be determined if it was from the last overhaul which was performed about 8 years and 1,078 flight hours before the accident or from an earlier overhaul. Drive gear spline impressions on the drive shaft spacer were consistent with an erroneously selected spacer. The incorrectly-sized spacer could have resulted in a gap between the spacer and drive gear that provided a path for grease that was applied on the splines to escape. According to records from the most recent fuel pump overhaul and the overhaul facility, the spacer was not replaced during the last overhaul. Because overhaul records preceding the most recent fuel pump overhaul were not available, it could not be determined when the incorrectly-sized spacer was introduced into the fuel pump assembly.

The National Transportation Safety Board determines the probable cause(s) of this accident to be: An inflight loss of engine power due to a failure of the engine fuel pump, which resulted in a collision with trees and terrain during the subsequent autorotation. The failure of the engine fuel pump resulted from the absence of adequate grease leading to accelerated spline wear within the fuel pump.

The engine fuel pump was removed from the engine accessory gearbox and disassembled. Removal of the drive shaft revealed that its small splines, which are normally mated to the internal splines of the fuel pump drive gear, exhibited evidence of severe damage, with significant portions of the spline teeth missing material. The drive shaft spacer exhibited thermal distress and indentations consistent with contact with the internal splines of the drive gear (see Figure 1).

Figure 1. Anomalous spline damage observed on the small splines of the drive shaft (red arrows) and indentations observed on the drive shaft spacer (yellow arrows).

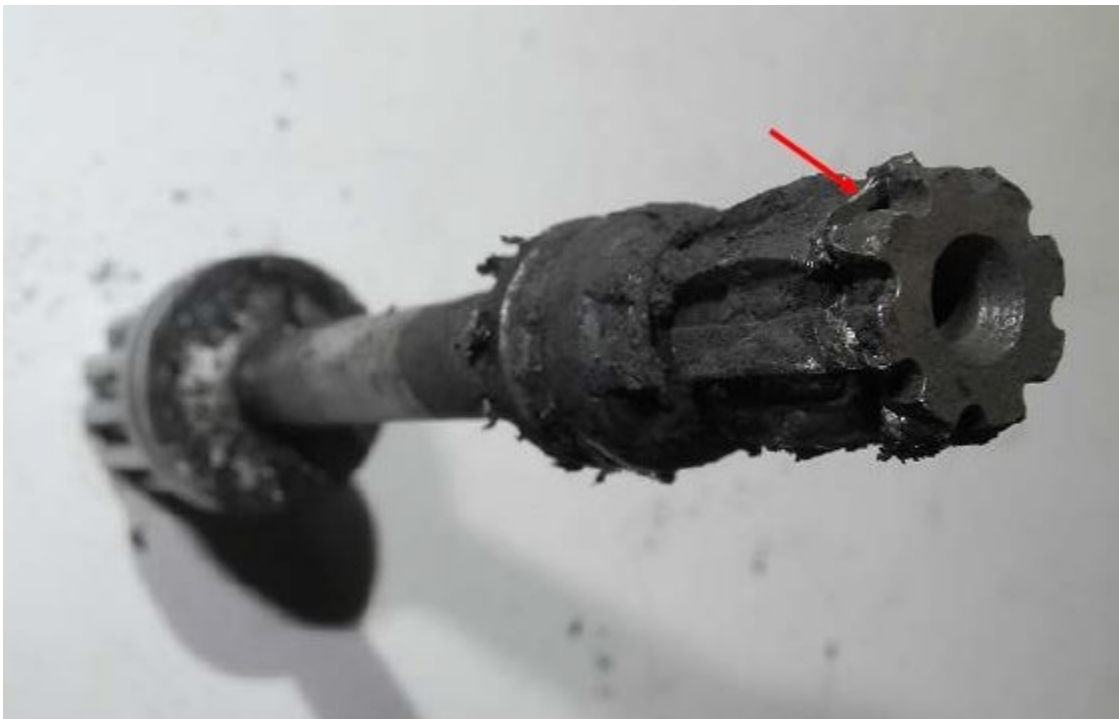
Remnant pieces consistent with the retaining clip, which is normally installed on the spline relief on the drive shaft small splines, were not observed during disassembly but were later identified via photographs taken during the examination (see Figure 2).

Figure 2. Remnant pieces consistent with the retaining clip (red arrow).

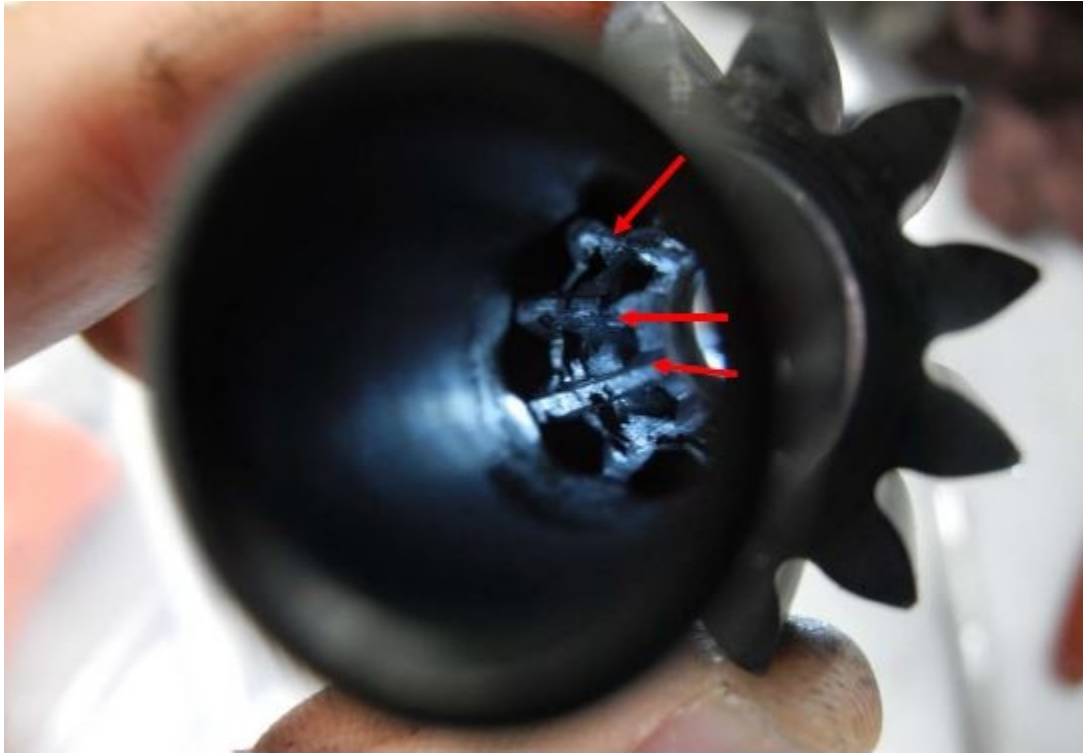
The internal splines of the drive gear also exhibited evidence of severe damage, with significant portions of the spline teeth missing material (see Figure 3).

Figure 3. Anomalous spline damage observed on the internal splines (red arrows).

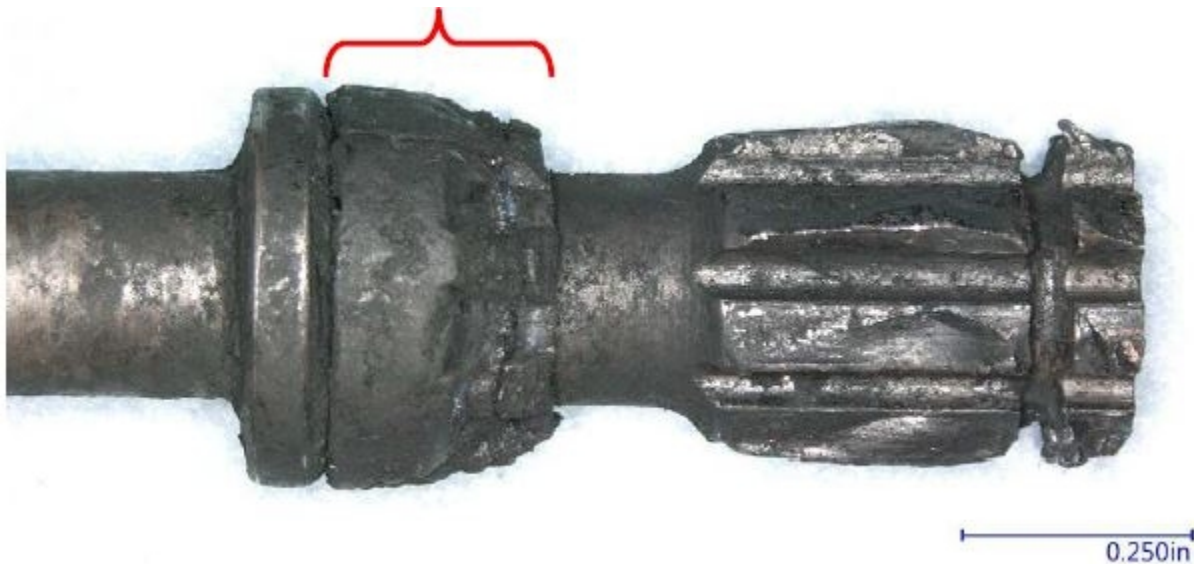
The illustrated parts list for the fuel pump found in the CMM allowed for 11 different drive shaft spacers of different sizing. According to the CMM, measurements taken during assembly of the drive shaft to the pump assembly are used to select proper drive shaft spacer thickness. The drive shaft spacer installed on the accident fuel pump drive shaft was consistent with a P/N 215981-8 spacer, about 0.240 inches thick (see Figure 4). According to the original build record from the manufacture of the fuel pump, dated September 1985, a spacer with a thickness of 0.120 inches was originally installed. Records of fuel pump overhaul preceding the last overhaul were not available, and it could not be determined whether other spacer sizes were used throughout the operational history of the accident fuel pump. In addition, it could not be determined whether the drive shaft, drive gear, and driven gear were original to the fuel pump or, if previously replaced, when the replacement occurred.

Figure 4. The drive shaft spacer installed on the drive shaft (red bracket).
