Aviation Investigation Final Report

Location:	New Castle, Delaware	Accident Number:	ERA17FA190
Date & Time:	May 25, 2017, 11:53 Local	Registration:	N62UP
Aircraft:	EUROCOPTER DEUTSCHLAND GMBH EC 135	Aircraft Damage:	Destroyed
Defining Event:	Loss of control in flight	Injuries:	1 Fatal
Flight Conducted Under:	Part 91: General aviation - Personal

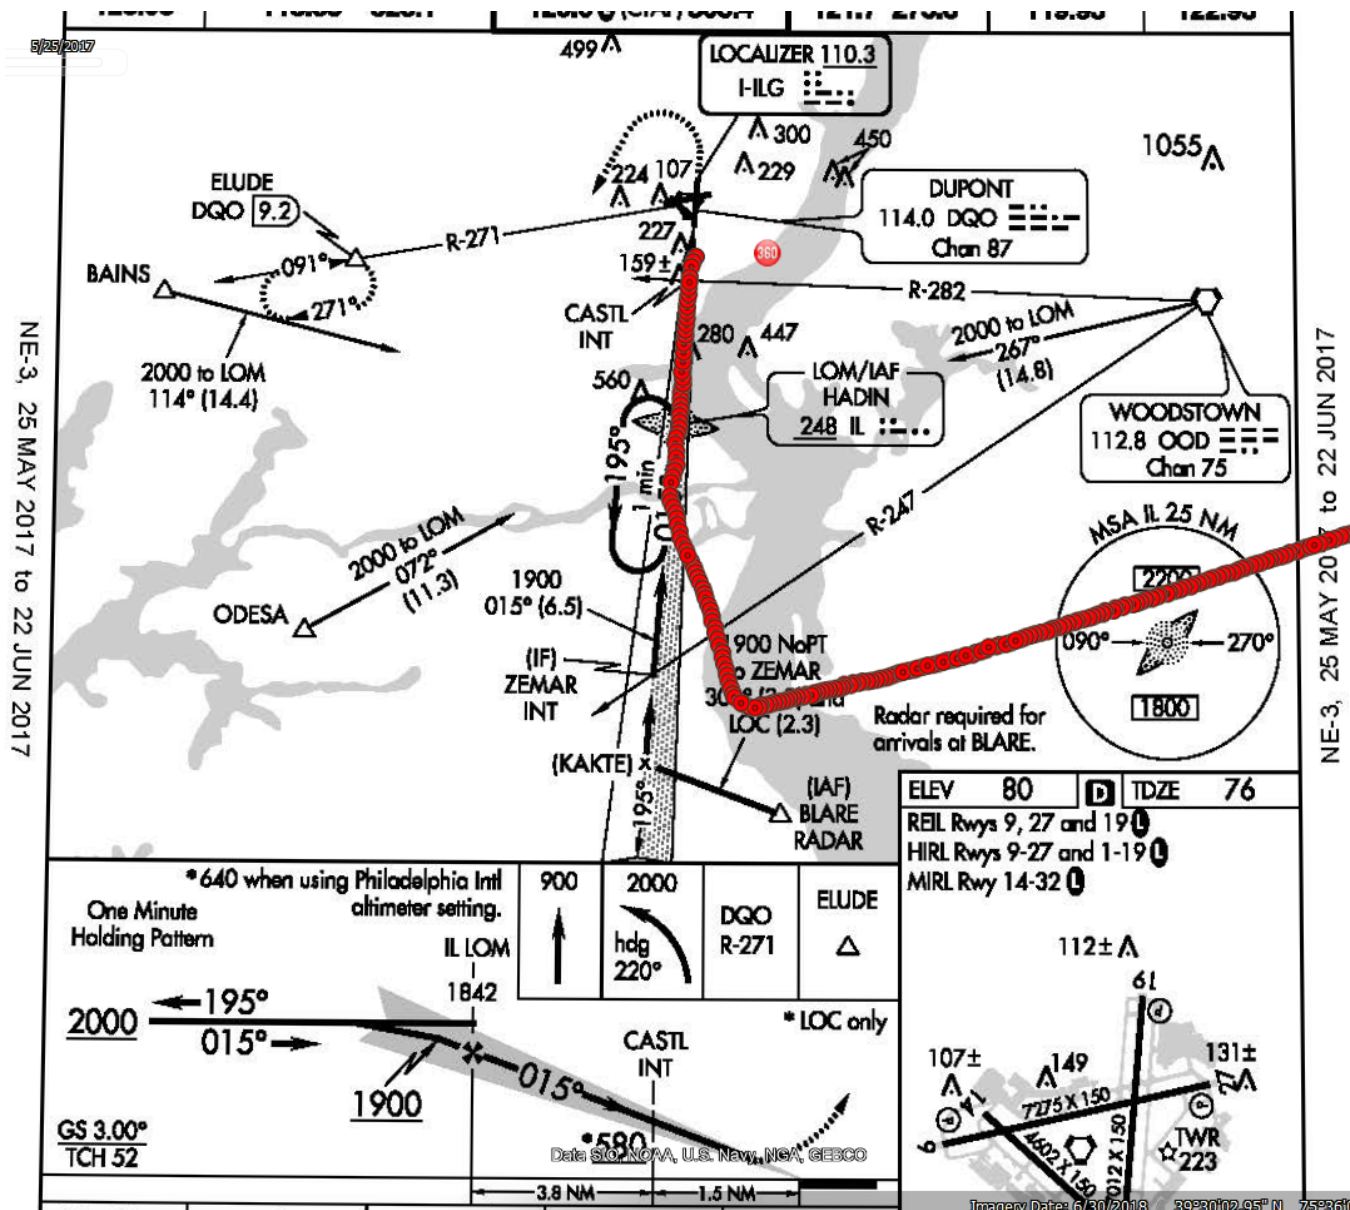
Figure 1. Overhead view of helicopter's radar ground track (red) overlaid onto the ILS Rwy 1 instrument approach procedure plan view.

The helicopter continued on course toward the runway; when it was about 3 miles, and about 2 minutes and 15 seconds beyond HADIN and still at an altitude of 2,000 ft msl, the pilot declared a missed approach. The controller advised the pilot to fly the published missed approach procedure. (The published procedure was a straight ahead climb to 900 ft, then left climbing turn to 2,000 ft to a heading of 220° to the ELUDE fix). Following the instruction, the helicopter climbed on course to 2,525 ft msl before it turned right and started a descent to 2,225 ft msl 4 seconds later. Subsequently, radar contact was lost when the helicopter was at 1,625 ft msl, and no additional communications were received from the pilot.
