# Aviation Investigation Final Report

<b>Location:</b>	Argyle, New York	<b>Accident Number:</b>	ERA21FA317
<b>Date &amp; Time:</b>	August 7, 2021, 18:00 Local	<b>Registration:</b>	N162KJ
<b>Aircraft:</b>	Rotorway Exec 162F	<b>Aircraft Damage:</b>	Destroyed
<b>Defining Event:</b>	Abrupt maneuver	<b>Injuries:</b>	2 Fatal
<b>Flight Conducted Under:</b>	Part 91: General aviation - Personal

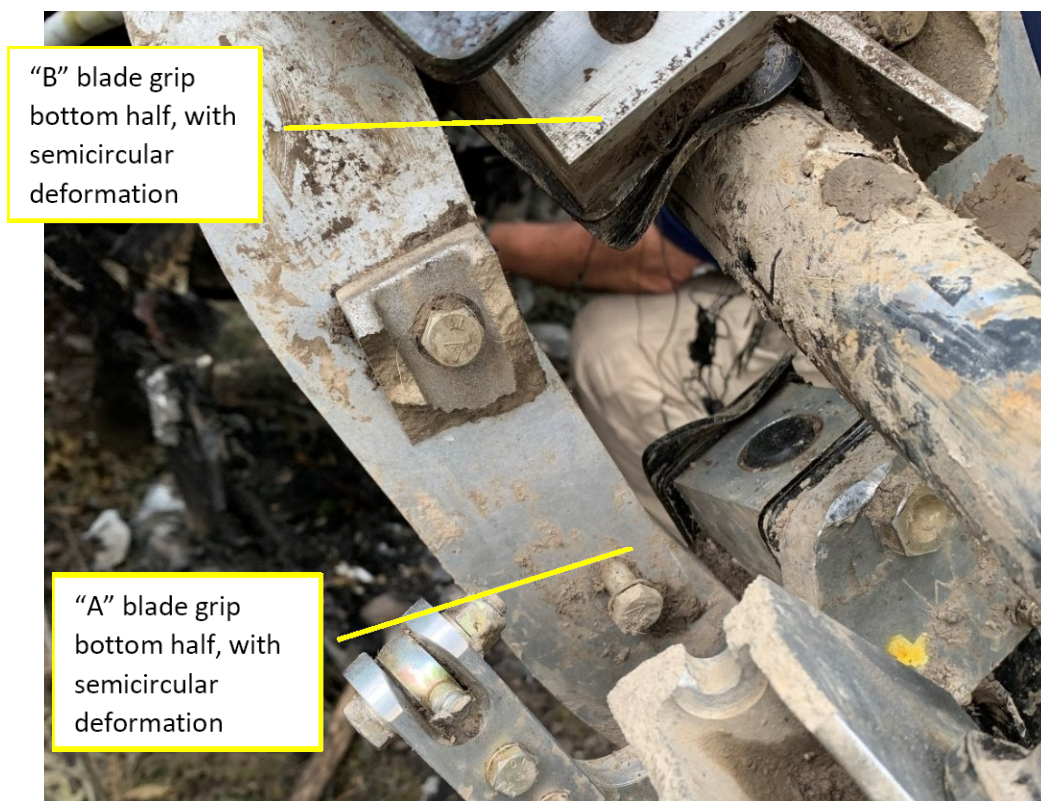
Figure 1 - Damage to blade grips.

Examination of the wreckage revealed that the lower inboard ends of the main rotor blade grips were bent upward and that both had semicircular indentations with the same diameter as the rotor mast. This damage was consistent with the blade grips contacting the mast, commonly referred to as mast bumping, which occurs due to excessive flapping motion of rotor blades (specifically, up-and-down motion of the blade tips).

The pilot's abrupt control inputs, which resulted in a low-G condition, main rotor mast bumping, and the subsequent severing of the tail boom by a main rotor blade.

Both main rotor blades were intact and attached to the blade grips, and both blades exhibited downward bending damage in several locations. The teetering hinge attach points were fractured on both sides of the hub plate. One rotor blade had leading-edge damage and gouging about 1 to 2 ft inboard of the blade tip. Both pitch change links were fractured at their upper (blade end) rod ends, and both links remained attached to fractured segments of their lower control horns. The inboard ends of both lower blade grips were bent upward, and each had semicircular deformation consistent with the diameter of the rotor mast, as shown in figure 1.

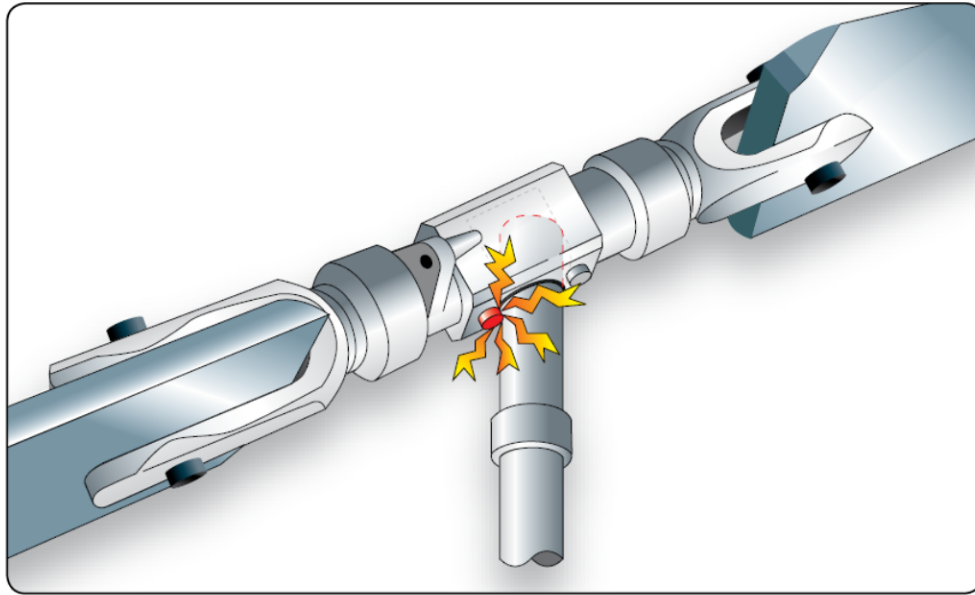
Figure 2. Mast bumping illustration (Source: FAA *Helicopter Flying Handbook*).

*Abrupt forward cyclic input or pushover in a two-bladed helicopter can be dangerous and must be avoided, particularly at higher speeds. During a pushover from moderate or high airspeed, as the helicopter noses over, it enters a low-G condition. Thrust is reduced, and the pilot has lost control of fuselage attitude but may not immediately realize it. Tail rotor thrust or other aerodynamic factors will often induce a roll. The pilot still has control of the rotor disk, and may instinctively try to correct the roll, but the fuselage does not respond due to the lack of thrust. If the fuselage is rolling right, and the pilot puts in left cyclic to correct, the combination of fuselage angle to the right and rotor disk angle to the left becomes quite large and may exceed the clearances built into the rotor hub. This results in the hub contacting the rotor mast, which is known as mast bumping...and the energy and inertia in the rotor system can sever the mast or allow rotor blades to strike the tail or other portions of the helicopter.*

The handbook included an illustration that depicted the hub contacting the rotor mast, as a result of improper corrective action in a low-G condition (figure 2).
