Aviation Investigation Final Report

| Location: | Hayward, California | Accident Number: | WPR19FA188 |
| Date & Time: | July 15, 2019, 14:26 Local | Registration: | N144TG |
| Aircraft: | Robinson R44 | Aircraft Damage: | Substantial |

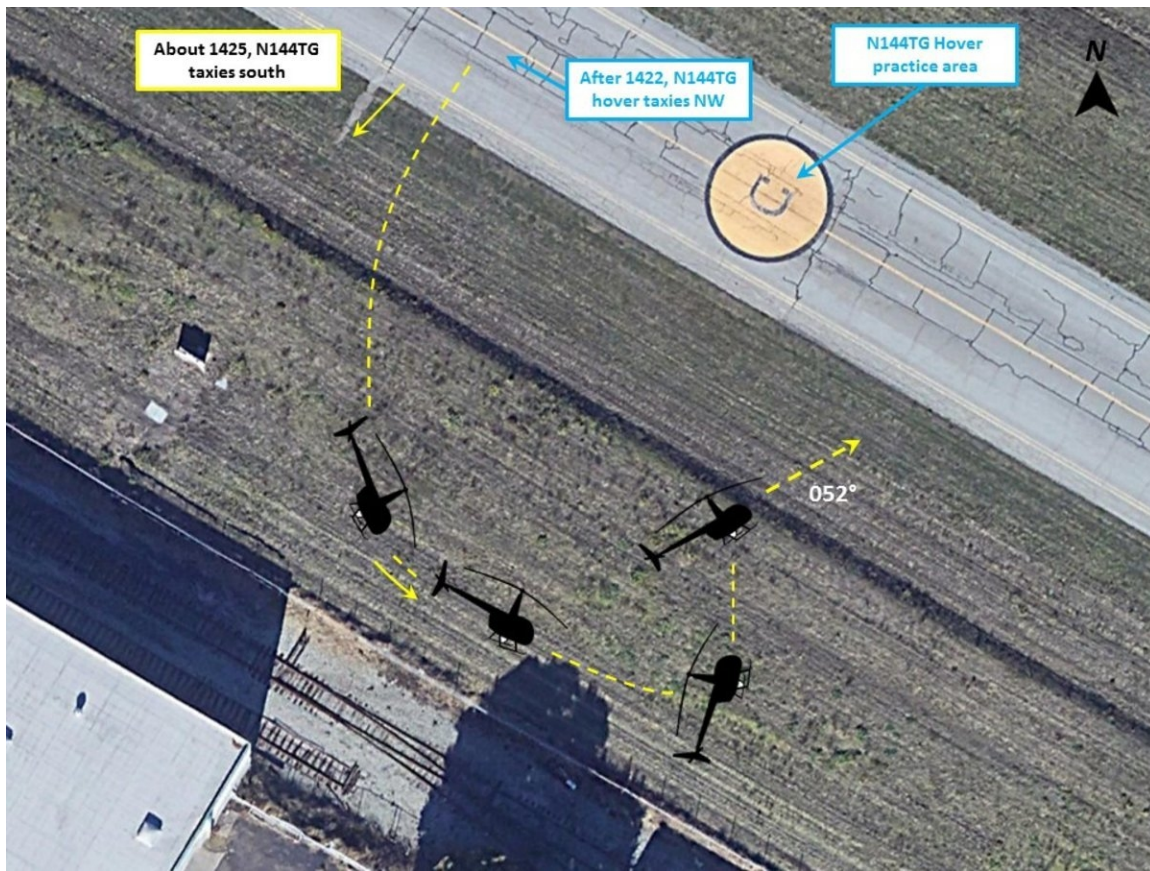
Figure 1: Helicopter Flight Path

GPS flight tracking data showed the helicopter continue to hover for several seconds before slowly maneuvering west and then entering a left turn over a patch of hard dirt and vegetation to the southwest of the taxiway. A surveillance video retrieved from an adjacent building that faced northeast captured the helicopter’s shadow during its final movements. The shadow of the helicopter entered the camera view from the left with its nose facing west. After a brief side hover to the left, in a southern direction, the helicopter performed a rapid turn to the southeast and its speed over the ground increased from about 2.5 mph to about 18 mph. In its final movements, the helicopter made a rapid turn to the north in a high bank angle on its left side and a cloud of dust was observed before the helicopter’s shadow disappeared from the camera view. Figure 1 is a flight path diagram compiled from both tracking data and the surveillance video.

A video study of the surveillance footage conducted by the National Transportation Safety Board (NTSB) showed the roll angle of the helicopter in the last few seconds before the helicopter impacted the ground. The helicopter's actual height above the ground could not be determined. According to the analysis, once over the berm and on a southern heading, the helicopter rolled left about 70° as it neared a fence line. Immediately after, the helicopter's roll angle decreased to about 40° as the helicopter continued to turn left. As the helicopter turned to a northern heading, the left roll angle increased to about 90° . The main rotor blades contacted the ground immediately after and the helicopter came to rest.

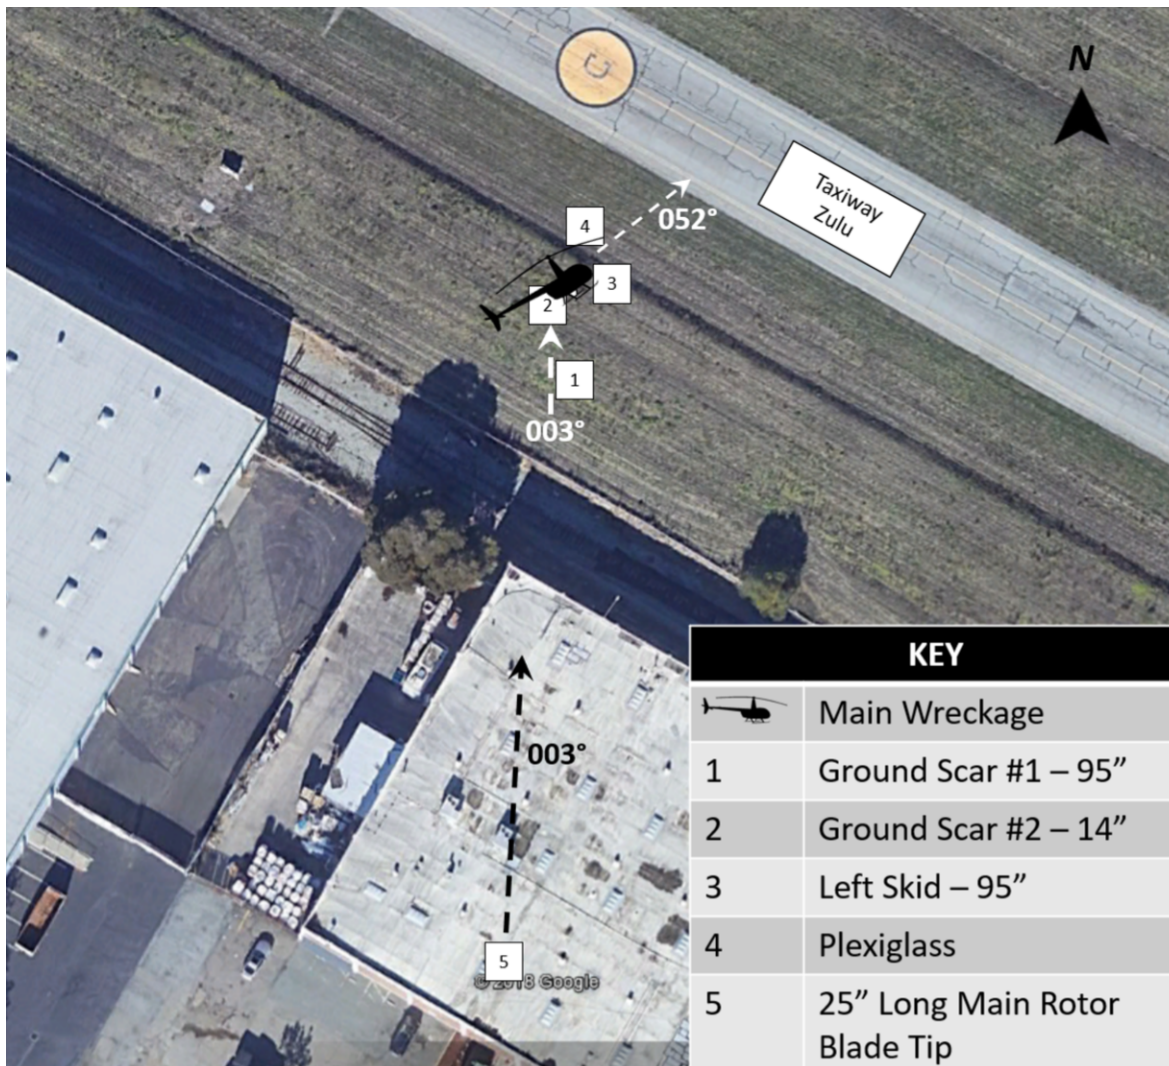
Figure 2: Wreckage Diagram

The helicopter came to rest on its left side, approximately 50 ft from taxiway Zulu at the top of an approximately 3-foot-tall berm. The main wreckage was comprised of most of the major sections of the helicopter and oriented on a heading of 052° magnetic. The first identified point of impact was a ground scar about 95 inches in length located 14 ft south of the main wreckage and was consistent with a main rotor blade impact. Several plexiglass fragments were found several feet forward of the cabin beyond the berm. Two ground scars were adjacent to the main wreckage and another ground scar was collocated with the main wreckage. A 2-foot-long section of main rotor blade tip came to rest about 250 ft southwest of the main wreckage on the roof of a building (see Figure 2).
