Aviation Investigation Final Report

Location:	Uvalde, Texas	Accident Number:	CEN19FA024
Date & Time:	November 3, 2018, 23:47 Local	Registration:	N417WT
Aircraft:	Bell 206	Aircraft Damage:	Destroyed
Defining Event:	Controlled flight into terr/obj (CFIT)	Injuries:	3 Fatal
Flight Conducted Under:	Part 91: General aviation - Personal

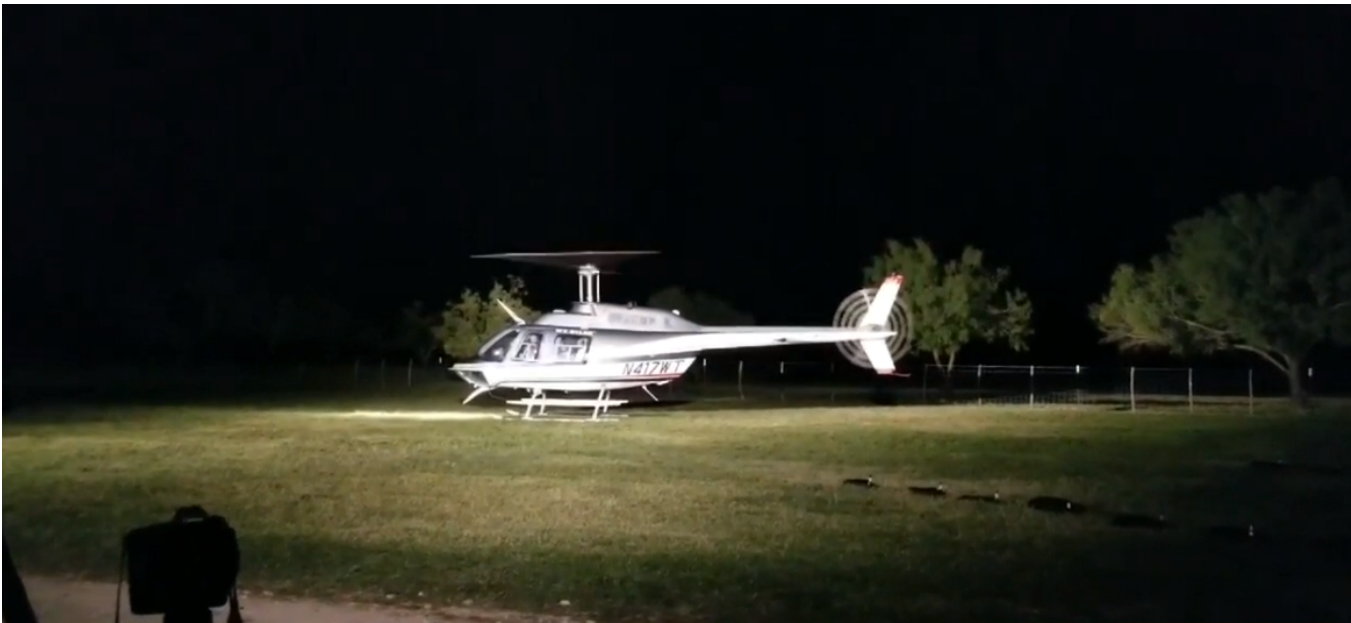
The pilot and two passengers onboard the turboshaft-powered helicopter departed from a private ranch on a night cross-country flight in visual meteorological conditions. Video evidence from witnesses who observed the departure showed that bright flood lights were shown directly at the helicopter during the departure. The helicopter impacted terrain shortly after takeoff about 100 ft below the top of a 1,500-ft hill and about 5 miles east of the departure point.

reported cataracts to the FAA in 2005, and it is possible that they could have increased in severity enough to have compromised his night vision and contributed to his difficulty avoiding the hill. Additionally, the pilot's eyesight may not have adjusted to the night conditions after being exposed to bright lights during departure. However, the severity of his cataracts at the time of the accident is unknown, and whether visual limitations from cataracts or bright lights contributed to the accident, could not be determined.

Figure 1. Helicopter departure with flood lights shining on helicopter (Video screenshot from KSAT and Jason Martinez).

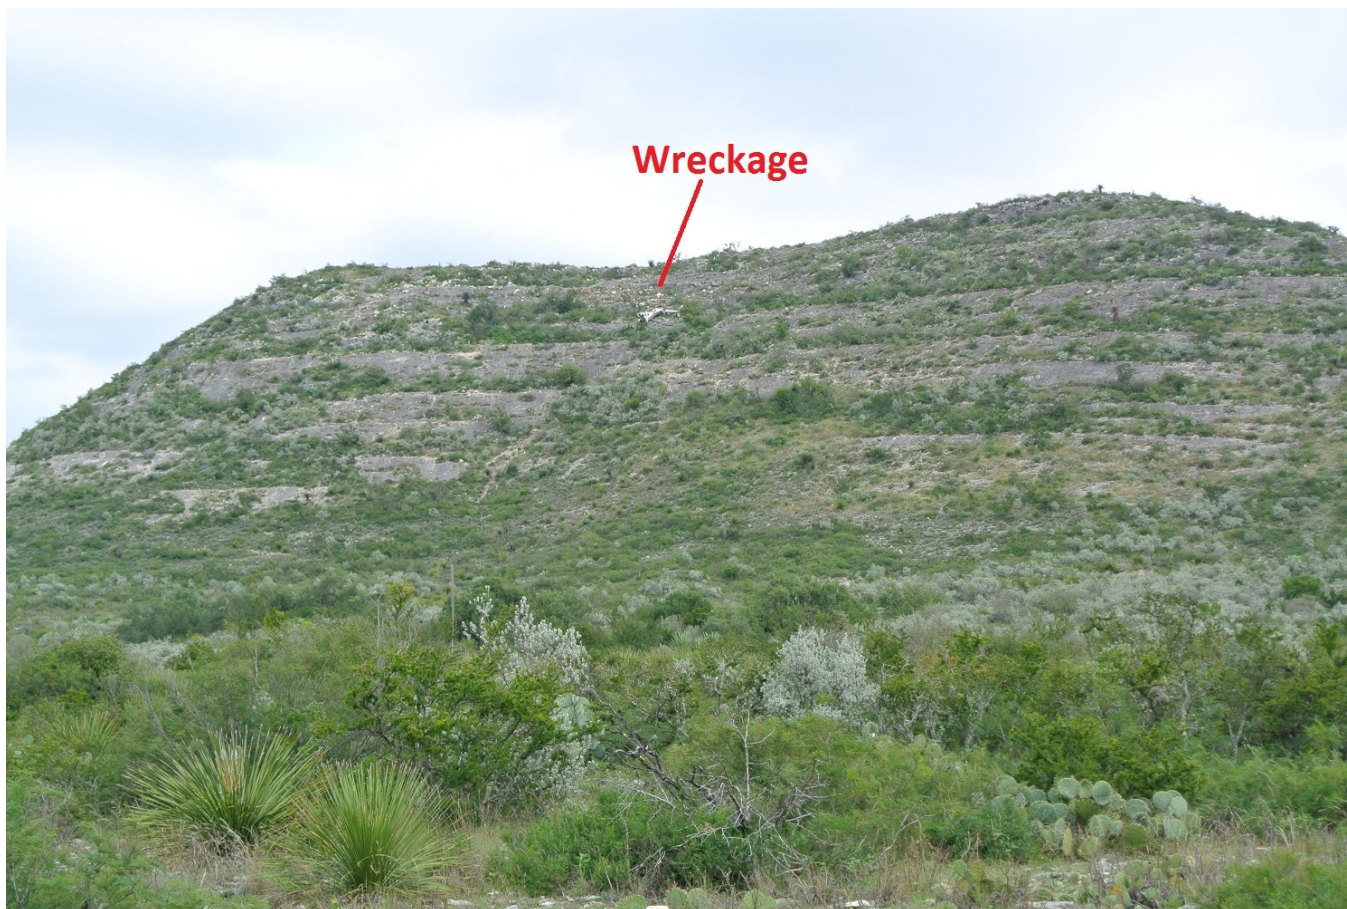
The helicopter impacted about 100 ft below the apex of a hill that measured about 1,500 ft mean sea level (see figure 2). A wreckage path about 75 to 100 yards long was distributed along the hillside leading to the main wreckage. There was no post-crash fire.

Figure 2. Wreckage at the accident site (Courtesy of FAA)
