Aviation Investigation Final Report

Location:	Pukoo, Hawaii	Accident Number:	WPR17FA021
Date & Time:	November 15, 2016, 18:41 Local	Registration:	N81GG
Aircraft:	Hughes 369	Aircraft Damage:	Destroyed
Defining Event:	VFR encounter with IMC	Injuries:	2 Fatal
Flight Conducted Under:	Part 91: General aviation - Personal

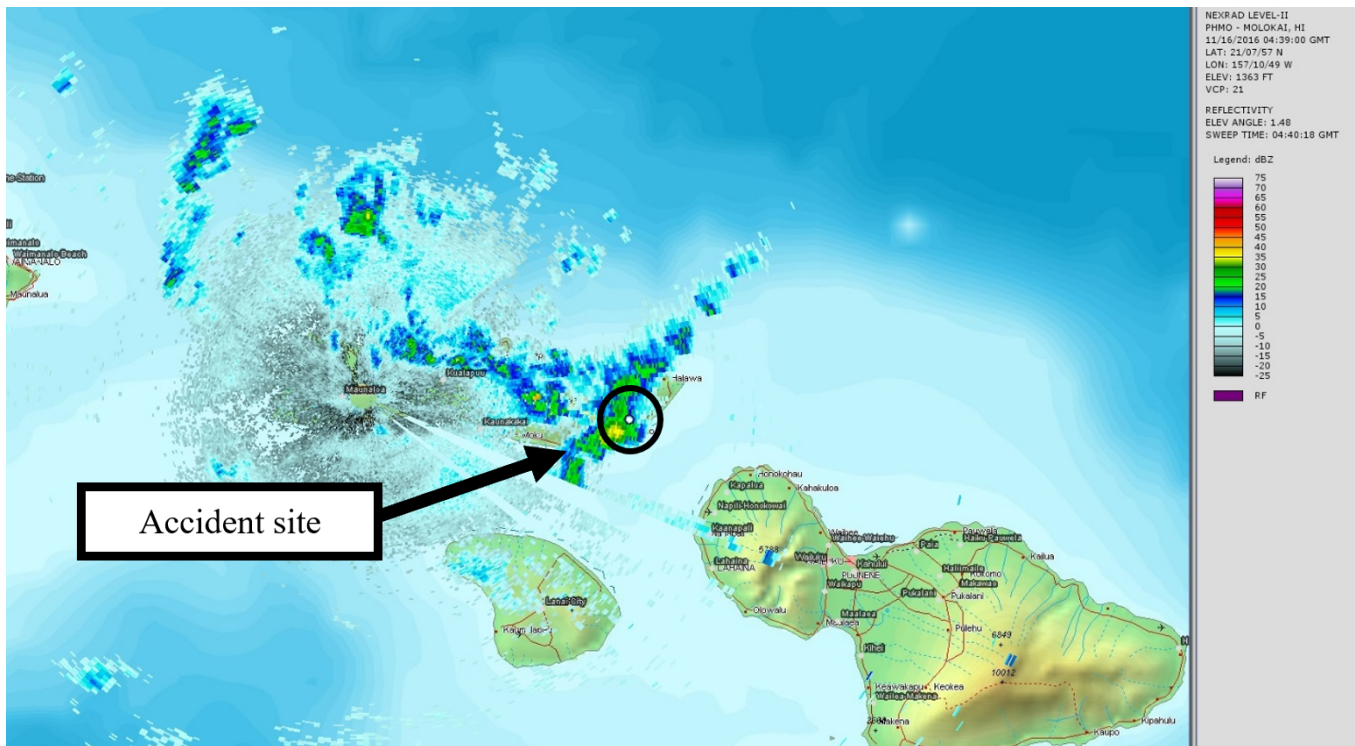
Figure 2. WSR-88D Doppler Radar at 1840.

Meteorological data revealed that a line of rain showers moved over the accident site at the accident time. The reduced visibility and ceiling as the line of rain showers moved east to west over the rising mountain terrain likely resulted in instrument meteorological conditions and mountain obscuration conditions.

A review of archived radar data from the Molokai NWS Weather Surveillance Radar-1988, Doppler (WSR-88D,) which was located 17 miles west of the accident site, showed that, between 1834 and 1845, a line of rain showers moved from east to west over the accident site, likely with reduced visibilities and ceilings.
