Aviation Investigation Final Report

| Location: | North Manchester, Indiana | Accident Number: | CEN20FA098 |
| Date & Time: | February 23, 2020, 23:08 UTC | Registration: | N840GS |
| Aircraft: | INNOVATOR Mosquito | Aircraft Damage: | Substantial |

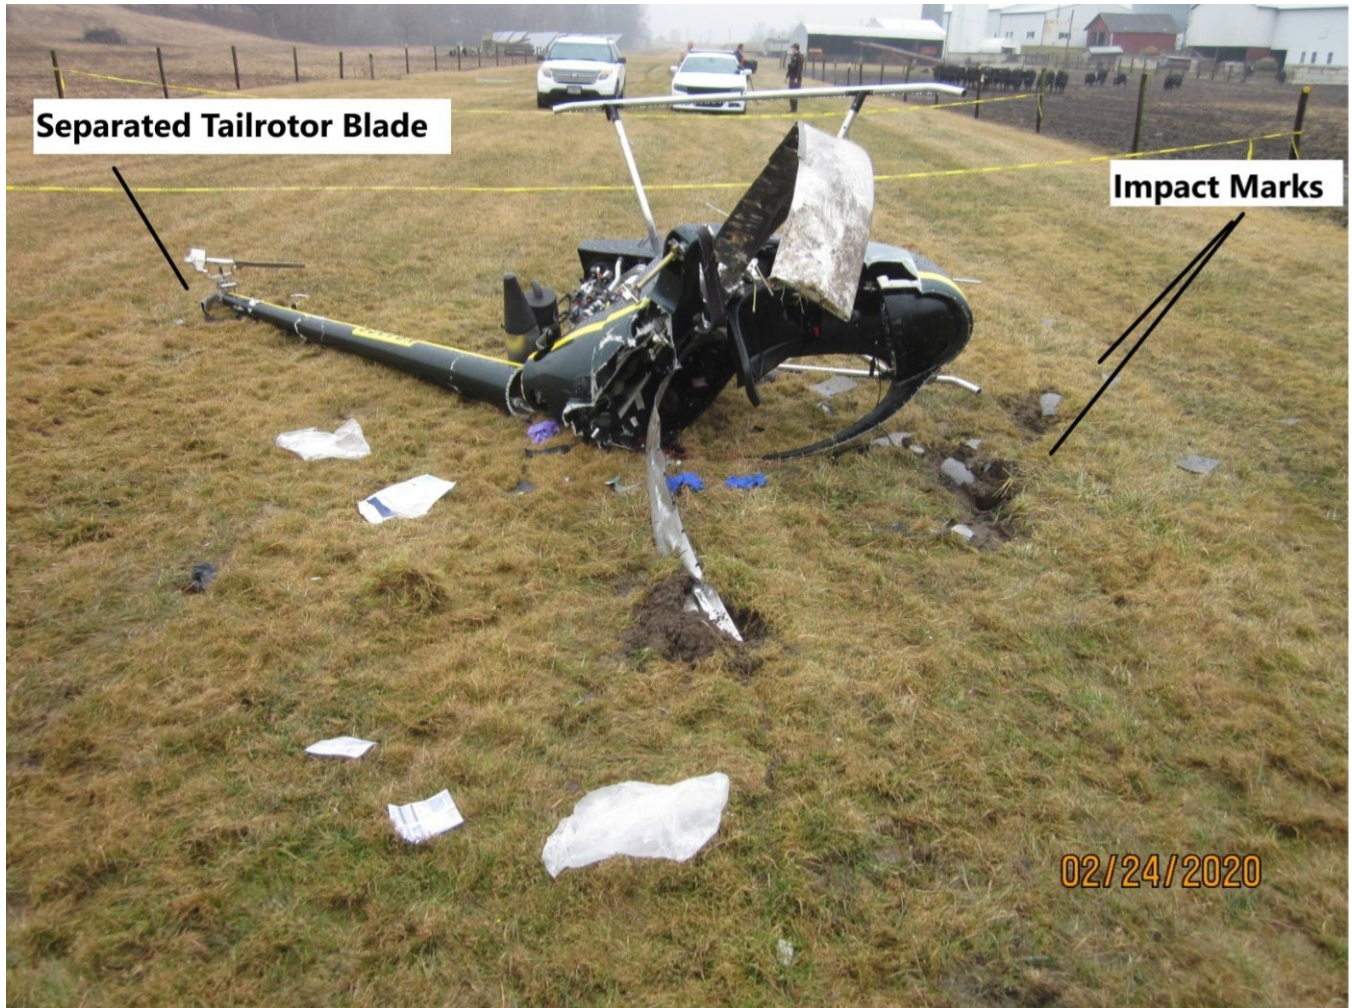
Figure 1. Accident Site.

The accident site was located on the east end of a private grass airstrip located about 3 miles west of North Manchester, Indiana. The helicopter came to rest on its right side. Both aluminum main rotor blades (MRB) remained attached to the rotor mast. One MRB was

partially embedded into the ground and displayed some bending and deformation along its entire length. The second MRB was bent about 70° and exhibited deformation throughout its length. Two impact marks, one of which was linear, were located on the ground within 3 ft of the nose of the helicopter. (see figure 1.)
