Aviation Investigation Final Report

Location:	Cornwall, New York	Accident Number:	ERA22FA010
Date & Time:	October 10, 2021, 13:57 Local	Registration:	N637HP
Aircraft:	ROBINSON HELICOPTER COMPANY R44 II	Aircraft Damage:	Destroyed
Defining Event:	Loss of control in flight	Injuries:	1 Fatal
Flight Conducted Under:	Part 91: General aviation - Personal

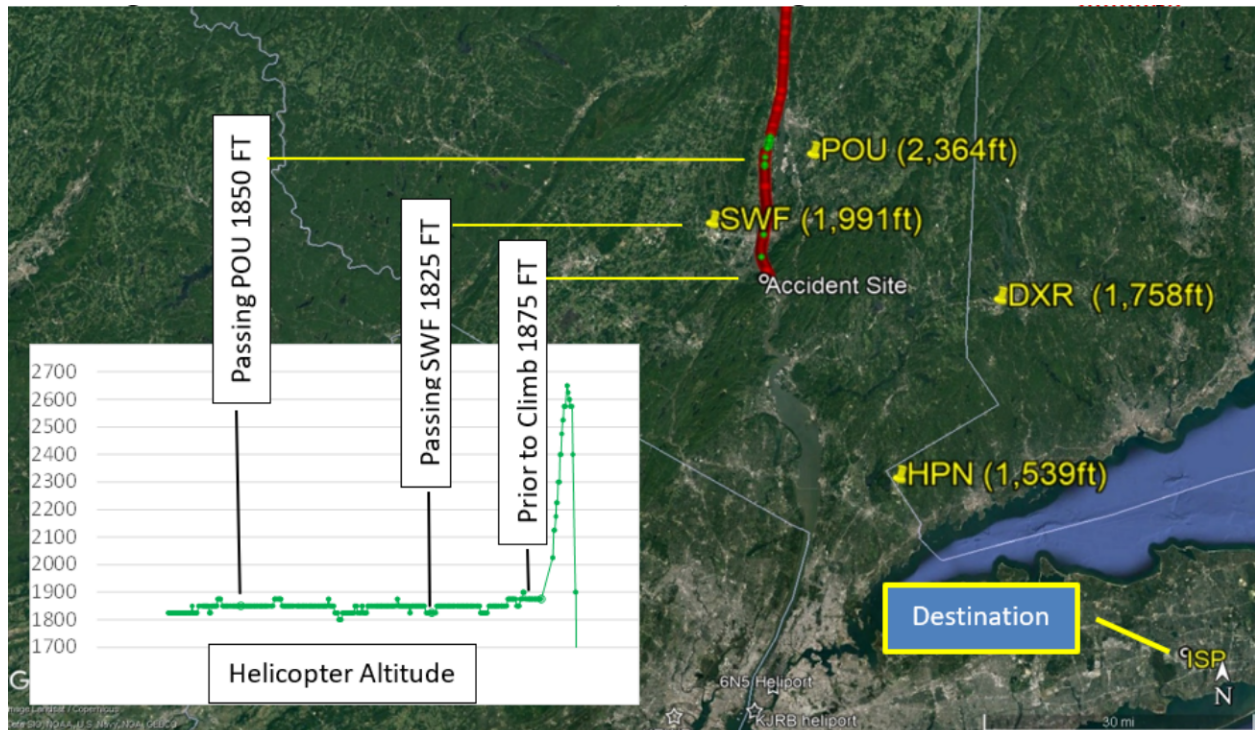
According to ADS-B tracking data and National Weather Service (NWS) records, as the helicopter flew south along the Hudson River at an altitude of 1,800 to 1,900 ft above mean sea level (msl), the overcast cloud ceiling height was decreasing. As it passed by Poughkeepsie, NY (POU) at 1349, the ceiling reported there was about 2,364 ft msl. At 1353, about 7 miles further south, the helicopter passed by the Stewart International Airport (SWF) where the ceiling was reported to be about 1,991 ft msl. At 1356, the helicopter began to climb (see figure 1).

Figure 1 – Helicopter's ADS-B-derived flight track (red/green dots) and cloud heights at nearby airports (yellow text)

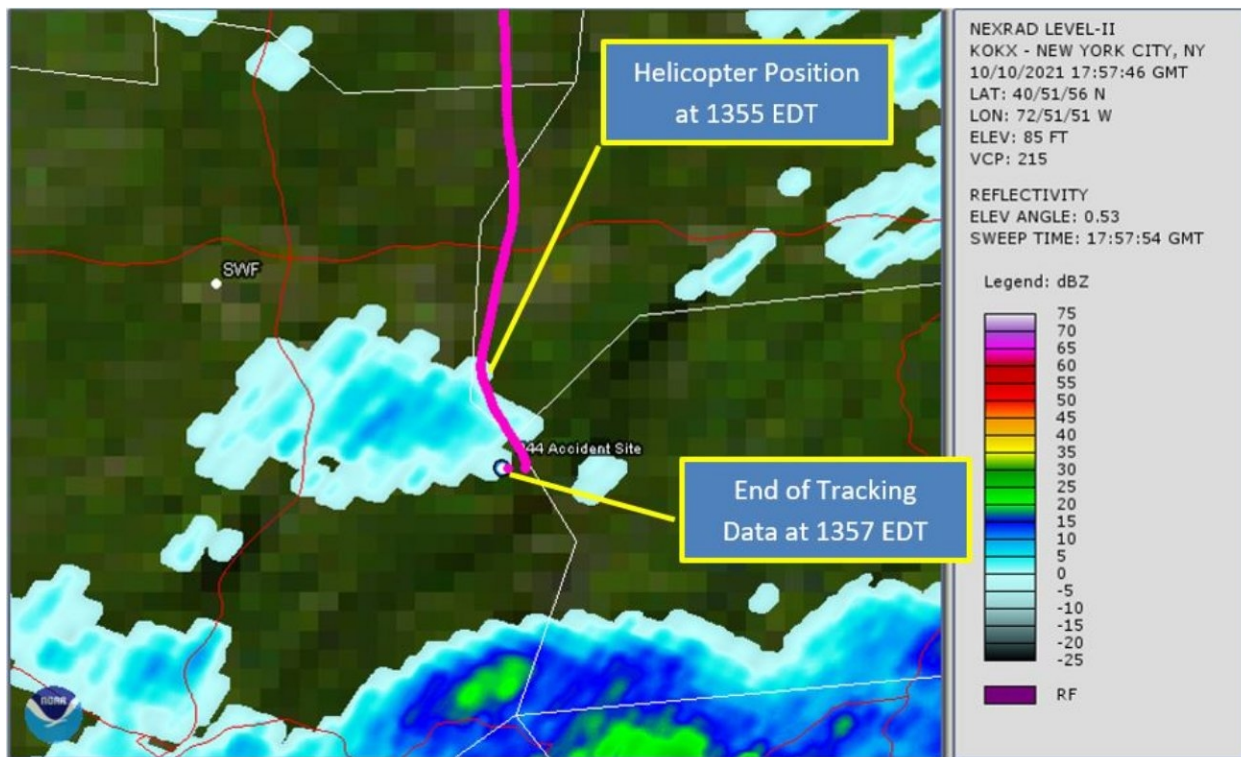
According to NWS weather surveillance radar data, near the time the climb began, the helicopter encountered an area of light intensity echoes that were moving to the north-northwest (see figure 2).

Figure 2 – Helicopter's flight track (magenta) and weather radar base reflectivity at 1357

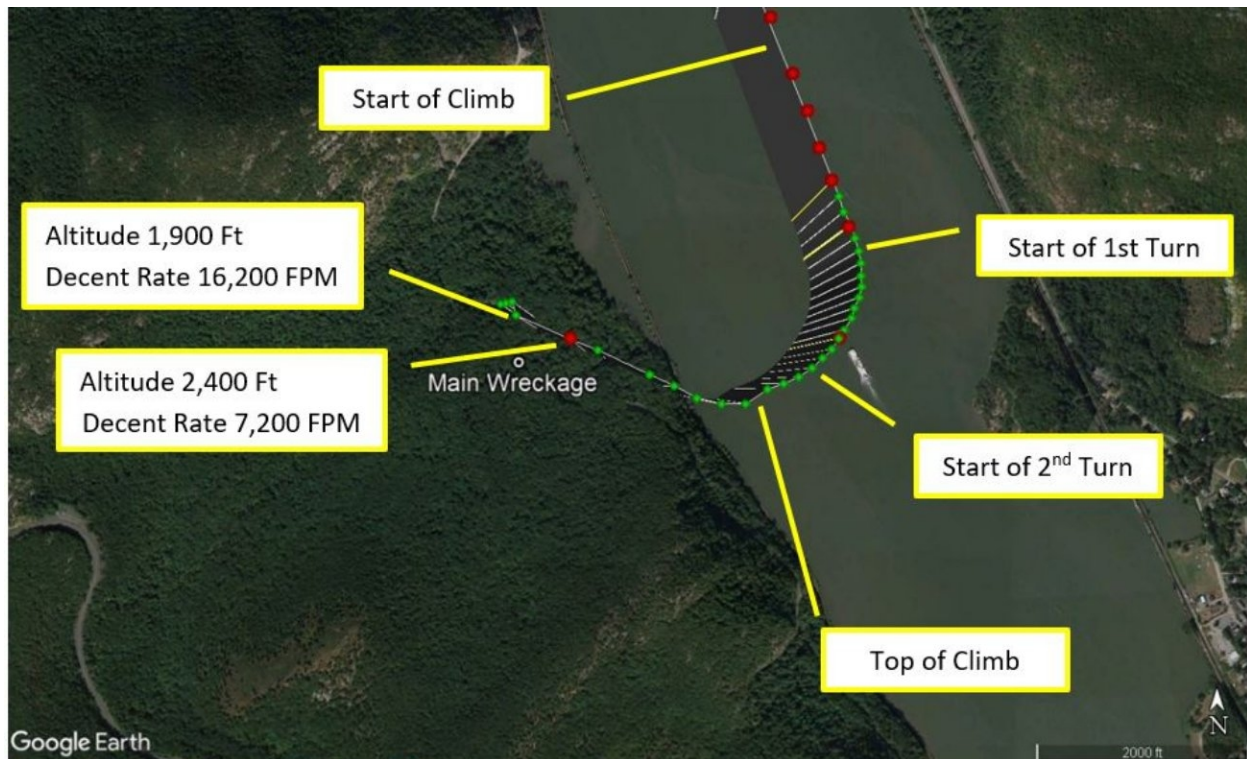
At 1356:03 while at an altitude of 1,875 ft msl, and a ground speed of 101 knots, the helicopter began to climb straight ahead. About 9 seconds later, it reached an altitude of 2,025 ft, which was above the cloud ceiling height reported at SWF (1,991 ft). About 5 seconds later it began the first of two right turns (see figure 3). The first turn lasted about 9 seconds, with an average turn rate of 7 to 11° per second.

Figure 3 – Helicopter's flight track during climbing turn and subsequent descent (red and green dots)

From the start of the climb until about the end of the first right turn, the rate of climb continually increased, and the airspeed continually decreased. At the end of the first turn, the rate of climb plateaued at about 2,400 feet per minute, and the airspeed had decreased to about 45 knots. Just as the rate of climb plateaued, the airspeed trend reversed and began to increase. The helicopter continued to climb for about 10 seconds, as the airspeed increased to about 95 knots. During this time the second right turn began, lasted for about 9 seconds, at an average turn rate of 9-12° per second. At 1356:34, just before the end of the second turn, the helicopter began to descend rapidly from its peak altitude of 2,650 ft. About 6 seconds later, the descent rate reached 7,200 feet per minute. As it descended through 1,900 ft (just below the cloud ceiling height reported at SWF), the descent rate reached 16,200 feet per minute. The tracking data ended about 2 seconds later, about 0.6 nautical miles north of the accident site. The entire flight was about 70 minutes long and the accident site was located about 120 nautical miles south of GFL.
