Aviation Investigation Final Report

Location:	Elgin, Minnesota	Accident Number:	CEN21FA330
Date & Time:	July 19, 2021, 16:00 Local	Registration:	N44BJ
Aircraft:	Robinson R44	Aircraft Damage:	Destroyed
Defining Event:	Low altitude operation/event	Injuries:	1 Fatal
Flight Conducted Under:	Part 137: Agricultural

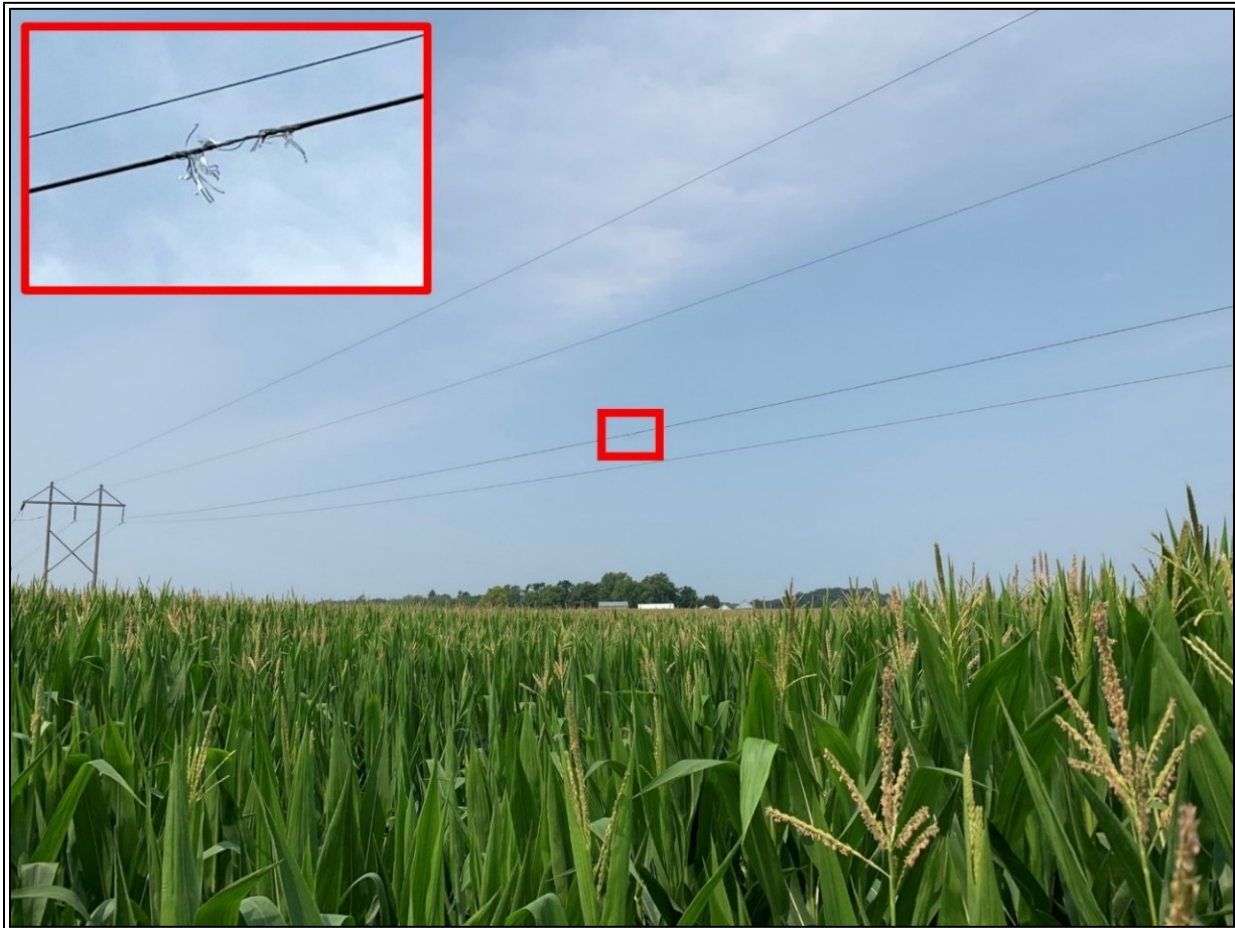
The initial impact location was a multiphase power transmission line, as shown in figure 1. The transmission line consisted of 24 aluminum-conducting strands over 7 steel strands, and three lines were present. The western line remained intact, the center line was frayed, and the eastern line was severed. The frayed transmission line at the point of damage was about 28 ft above the ground. The corn crop under the transmission lines was 8 to 10 ft tall. Portions of

Figure 1. Powerlines above the cornfield with a red rectangle identifying the center powerline (main photograph) and an inset showing the frayed center powerline.

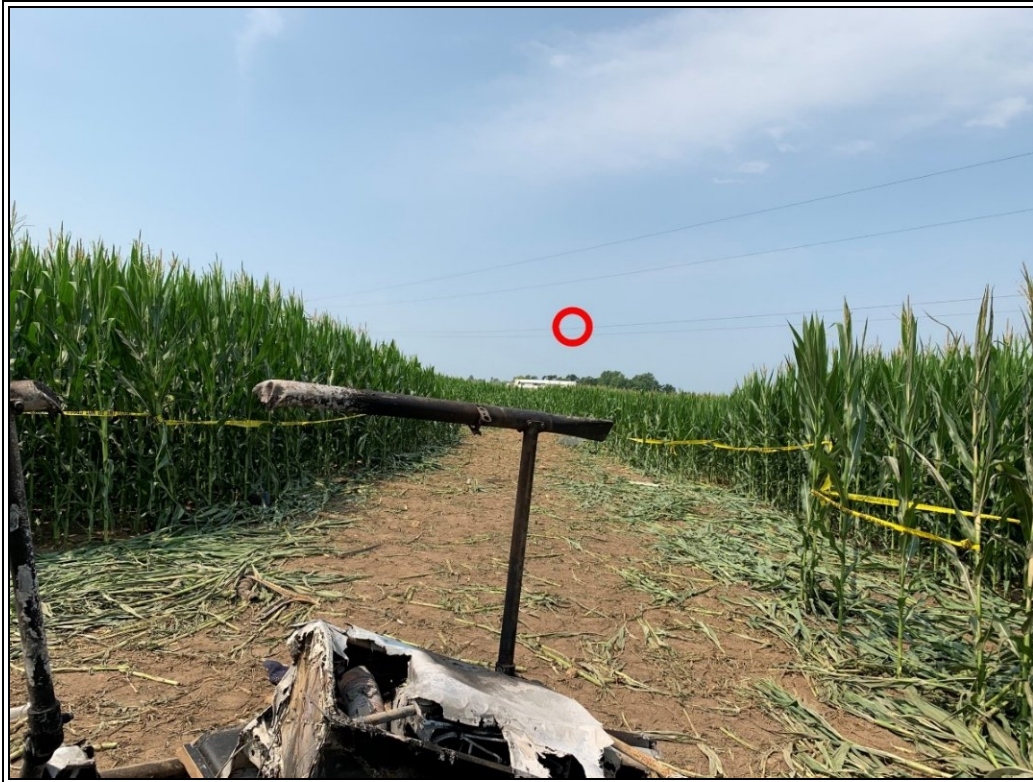
The wreckage debris path, as shown in figure 2, measured 292 ft between the power transmission lines and the main wreckage. The wreckage debris path through the cornfield was on a 090° heading. The helicopter impacted terrain in a 15° descent angle. Fractured portions of the spray booms, cabin door, and plexiglass were scattered along the wreckage debris path.

Figure 2. Wreckage debris path with the red circle showing the location of the wire strike.

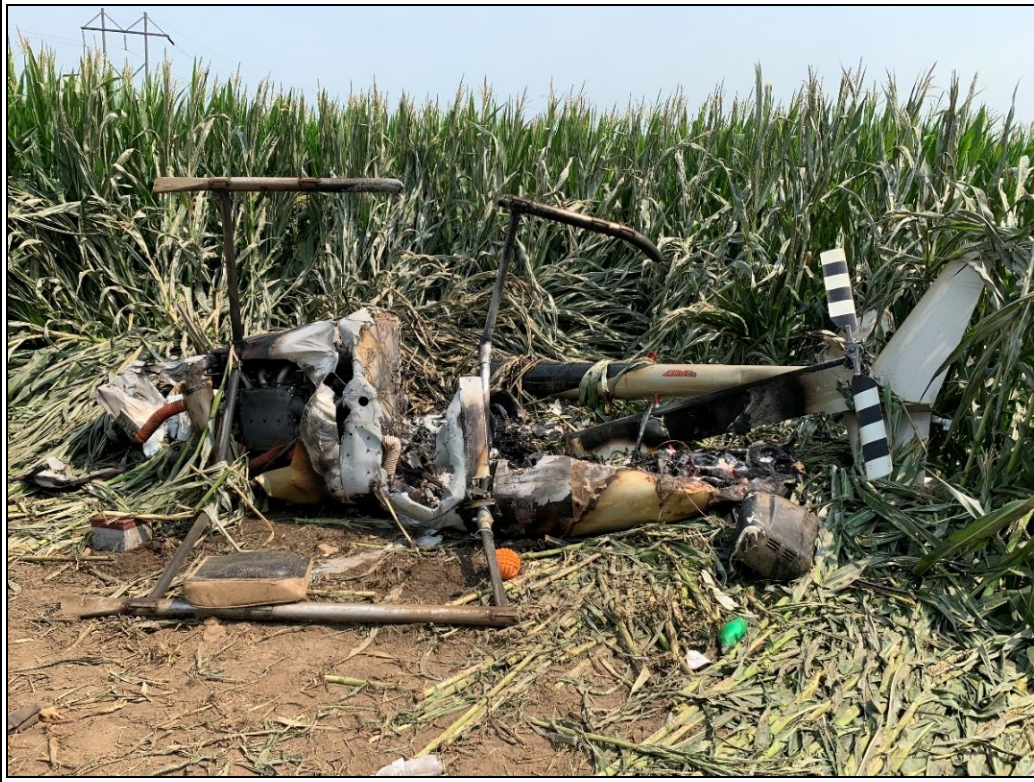
The main wreckage, as shown in figure 3, included remnants of the cabin, landing skids, cockpit, engine, main rotor transmission, main rotor head, main rotor blades, aft fuselage, sheaves, tail rotor driveshaft, tailboom, tail rotor gear box, and tail rotor blades. The product tank was relatively intact, and its support frame was located about 15 ft north of the main wreckage. Most of the cabin and cockpit were destroyed by the postimpact fire. Flight control continuity could not be established due to the extensive damage sustained during the impact and postimpact fire.

Figure 3. Main wreckage at the accident site.

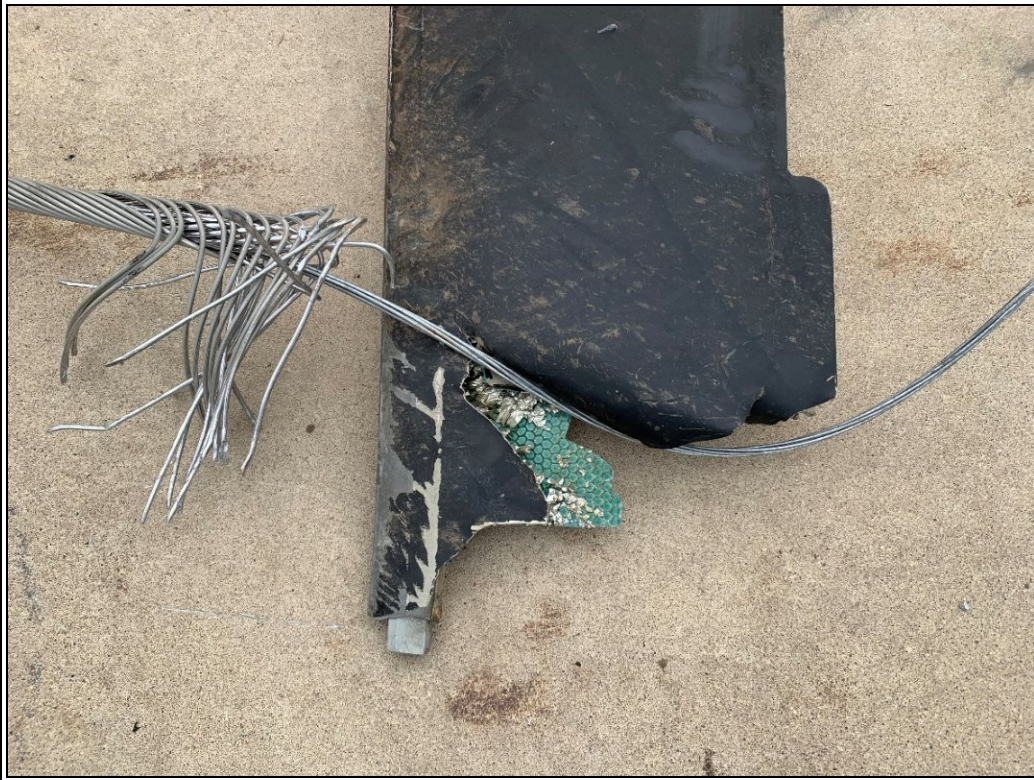
One of the two main rotor blades remained intact but folded in half during impact. The other main rotor blade fractured about 3 ft from the blade tip and exhibited damage consistent with impact with a power transmission line, as shown in figure 4. The outboard 3 ft of the main rotor blade, as shown in figure 5, was located about 465 ft south of where the helicopter impacted the power transmission line.

Figure 4. Main rotor blade fracture with damaged power transmission line.

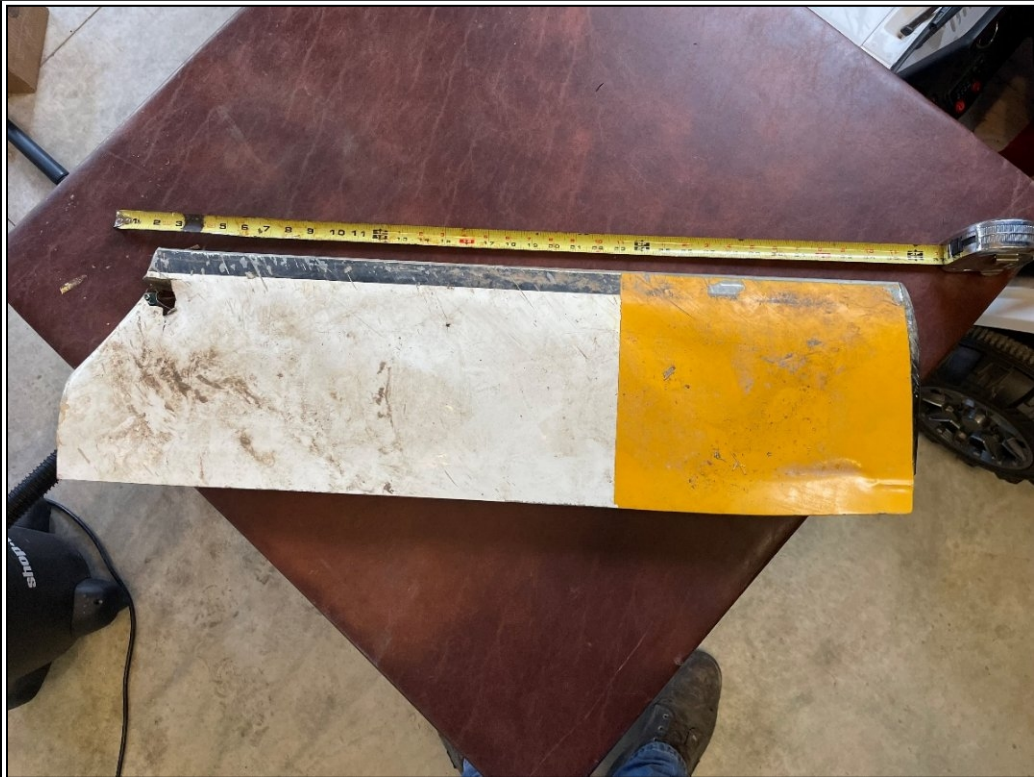
Figure 5. Outboard 3 ft of main rotor blade (Source: Helicopter operator).
