Aviation Investigation Final Report

Location:	Hickory, Kentucky	Accident Number:	ERA16FA248
Date & Time:	July 11, 2016, 11:23 Local	Registration:	N427TV
Aircraft:	BELL HELICOPTER TEXTRON CANADA 407	Aircraft Damage:	Substantial
Defining Event:	Flight control sys malf/fail	Injuries:	1 Fatal
Flight Conducted Under:	Part 91: General aviation

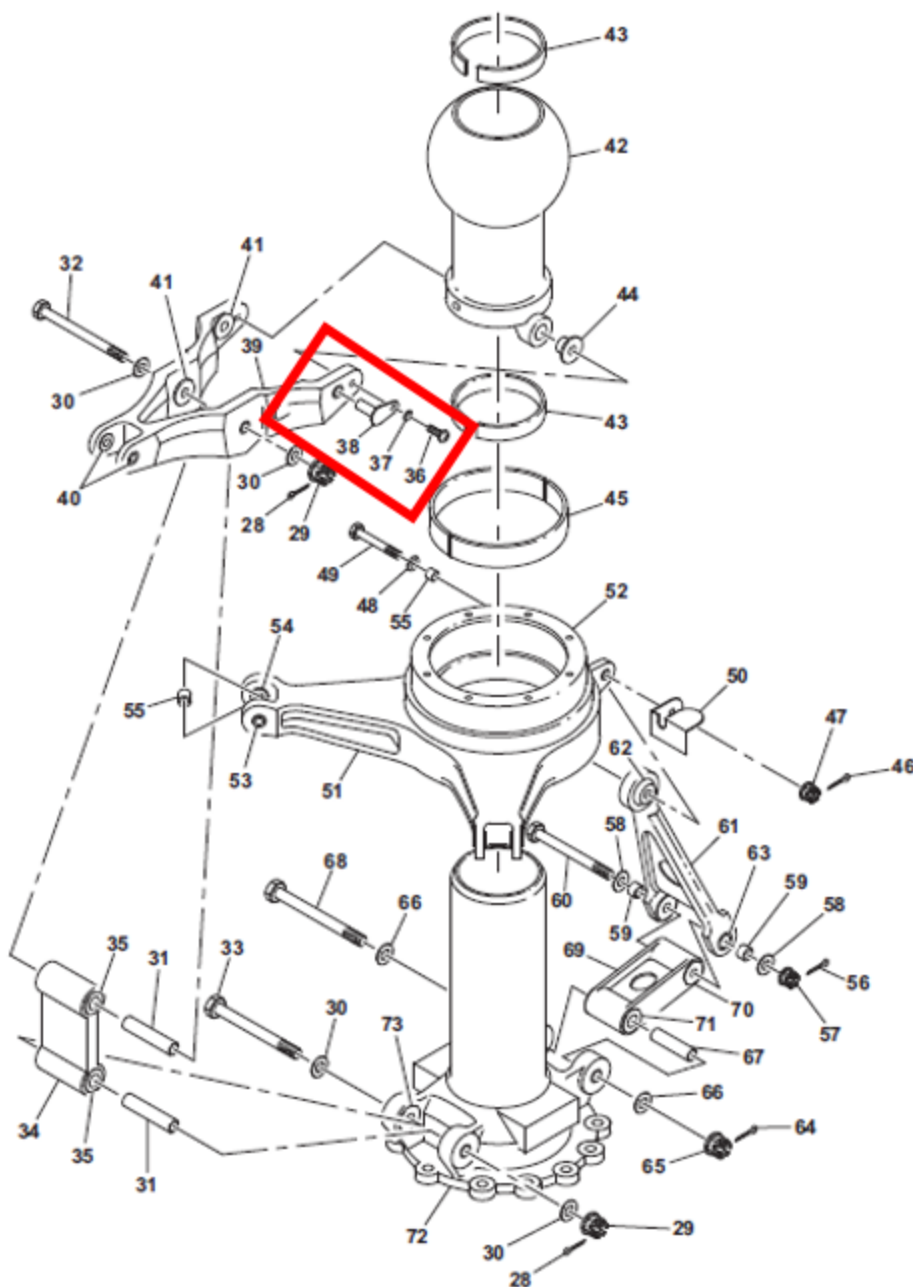
An examination of the wreckage revealed that the collective lever, located at the front and bottom of the swashplate support, was disconnected from the pivot sleeve. The collective lever was designed to move the pivot sleeve vertically on the swashplate support, via direct linkage from the cockpit collective control, to change the pitch on all the main rotor blades simultaneously. The collective lever pins and screws that attached the collective lever to the pivot sleeve were missing; they were later found loose, near the main rotor area. The safety wires intended to secure the screws to the pins were missing. Examination of the hardware at the NTSB Materials Laboratory revealed that the safety wires not present, and the screws backed out over time, resulting in the complete loss of collective control in flight.

Company maintenance personnel's inappropriate removal without replacement of the safety wires on the collective lever pin screws during a recent maintenance inspection, which resulted in the screws backing out and led to a loss of collective control in flight.

The collective lever was located at the front and bottom of the swashplate support. The collective lever and collective control link were designed to move the pivot sleeve vertically on the swashplate support to change the pitch on all the main rotor blades simultaneously. The collective lever was attached to the pivot sleeve with screws, washers, and pivot pins (see figure 1). Once attached, the and the specified torque was applied, locking wire would typically be affixed to the screw.

Figure 1 - Swashplate support assembly, with collective pitch lever attaching hardware outlined in red.

The left collective control was not installed. Collective control continuity was confirmed through the right collective and up through the servo actuators to the disconnected collective lever. The two collective lever pivot pins and screws that attached the collective lever to the pivot sleeve were not installed. The pivot pins and screws were found on the transmission deck and on the ground underneath the right side of the helicopter. The flat washers and lockwire were missing; the washers were later found during a subsequent examination of the wreckage.

The collective lever and attachment hardware were sent to the NTSB Materials Laboratory for further examination. The collective lever, collective lever pins, collective lever pin screws, and washers were examined visually and by optical microscopy. All components were intact. Threads on the collective lever pin screws and the mating threaded holes in the collective lever were intact with no evidence of stripping. Holes for attaching lockwire were present in the

heads of the screws and at an adjacent area on the collective lever, but no lockwire was observed attached at either location. Deformation at the edges of the lockwire holes was noted. Circumferential scoring was present across the entire face on one side of one of the washers. On one of the screws, thread peaks were flattened near the middle of the shank on one side of the screw consistent with contact with the collective lever pin hole bore with the screw partially threaded into place.
