# Aviation Investigation Final Report

<b>Location:</b>	Jordan Valley, Oregon	<b>Accident Number:</b>	WPR20FA016
<b>Date &amp; Time:</b>	October 25, 2019, 15:41 Local	<b>Registration:</b>	N280F
<b>Aircraft:</b>	Enstrom 280F	<b>Aircraft Damage:</b>	Substantial
<b>Defining Event:</b>	Loss of engine power (partial)	<b>Injuries:</b>	1 Fatal, 1 Serious
<b>Flight Conducted Under:</b>	Part 91: General aviation - Personal

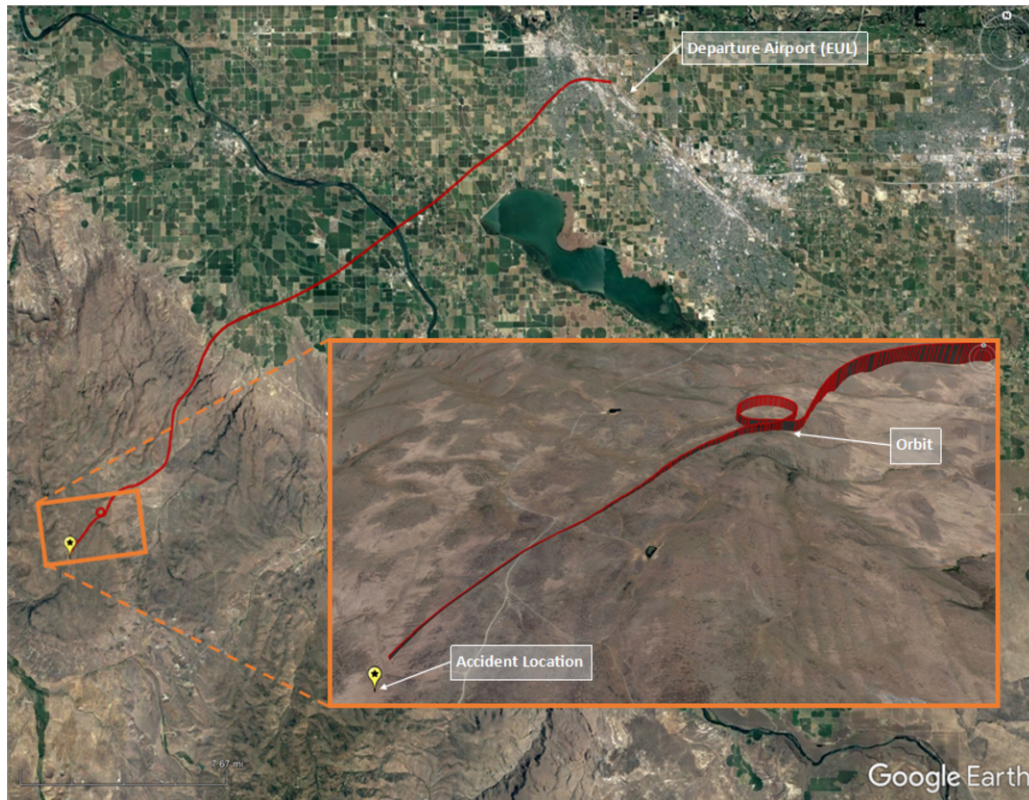
Automatic Dependent Surveillance-Broadcast (ADS-B) flight track data of the entire flight indicated that the helicopter maintained a terrain clearance of between 350 and 900 ft above ground level (agl) after departure as it approached the mountain range, while maintaining a groundspeed of about 100 mph. As it entered the range, the helicopter continued to climb as the ground speed slowed to 85 mph. It started to follow the undulating terrain with clearances varying between 0 and 100 ft agl, until 18 minutes after takeoff and 25 miles southwest of EUL.

It then began an orbit at a GPS altitude of about 4,900 ft, which was between 50 and 200 ft agl over terrain.

After completing the orbit, the helicopter departed to the southwest at an altitude of about 5,000 ft mean sea level (msl), and continued for the remaining 2 miles at the same altitude, which corresponded to terrain clearance of between 0 and 50 ft agl, at a ground speed of about 70 mph.

Figure 1 – ADS-B derived route of flight

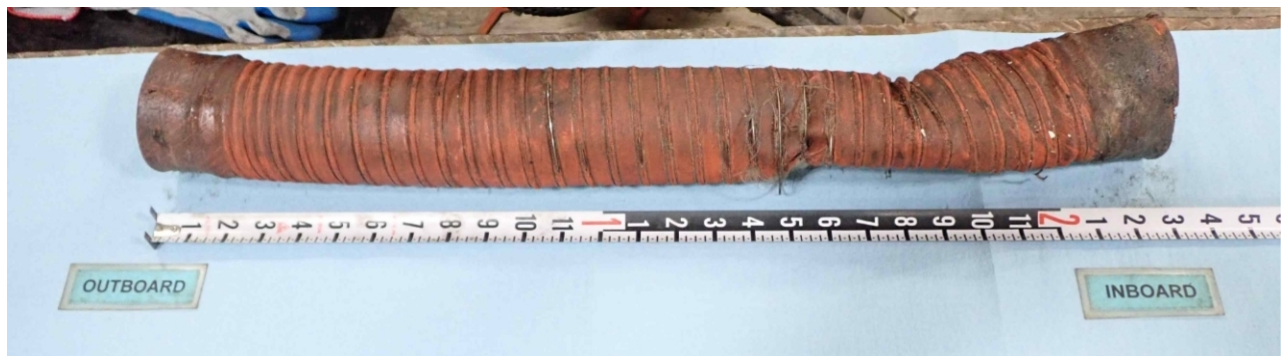
Examination revealed that significant sections of the outer liner of the engine’s air induction hose were abraded, consistent with long-term wear, and had worn away from the supporting structure, allowing the hose liner to collapse and restrict airflow into the engine. Given this condition, the engine would have experienced a partial power loss due to the restricted airflow; damage signatures indicated that the engine was producing some power at the time of impact. The helicopter’s most recent annual inspection was completed about three months before the accident, and the worn hose should have been apparent at the time of the inspection.

A partial loss of engine power due to a worn engine air induction hose, and a subsequent uncontrolled descent into terrain. Contributing to the accident was the failure of maintenance personnel to adequately inspect the hose, and the pilot’s decision to fly the helicopter at a speed and altitude that provided limited time to enter and establish an autorotation following the loss of power.

Detailed examination of the hose revealed that the outer cover and fiberglass cord had abraded, such that the steel helix was visible and protruding over about half of the hose's length. (see Photos 1 and 2.) In some areas, the helix was visible for more than half of the hose circumference, such that the liner and cover were unsupported and could be flexed inward, partially obstructing the flow.

Photo 1 – Engine air induction hose with steel helix visible at multiple locations

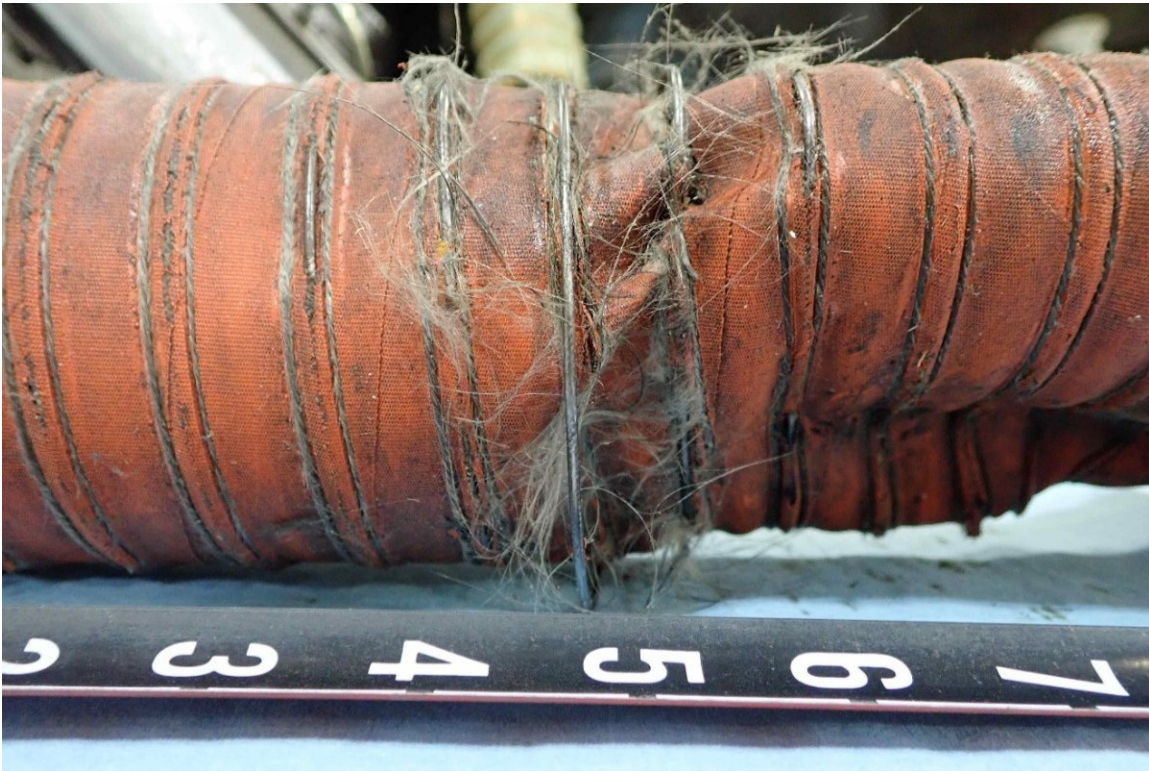
Photo 2 - Engine air induction hose with protruding steel helix

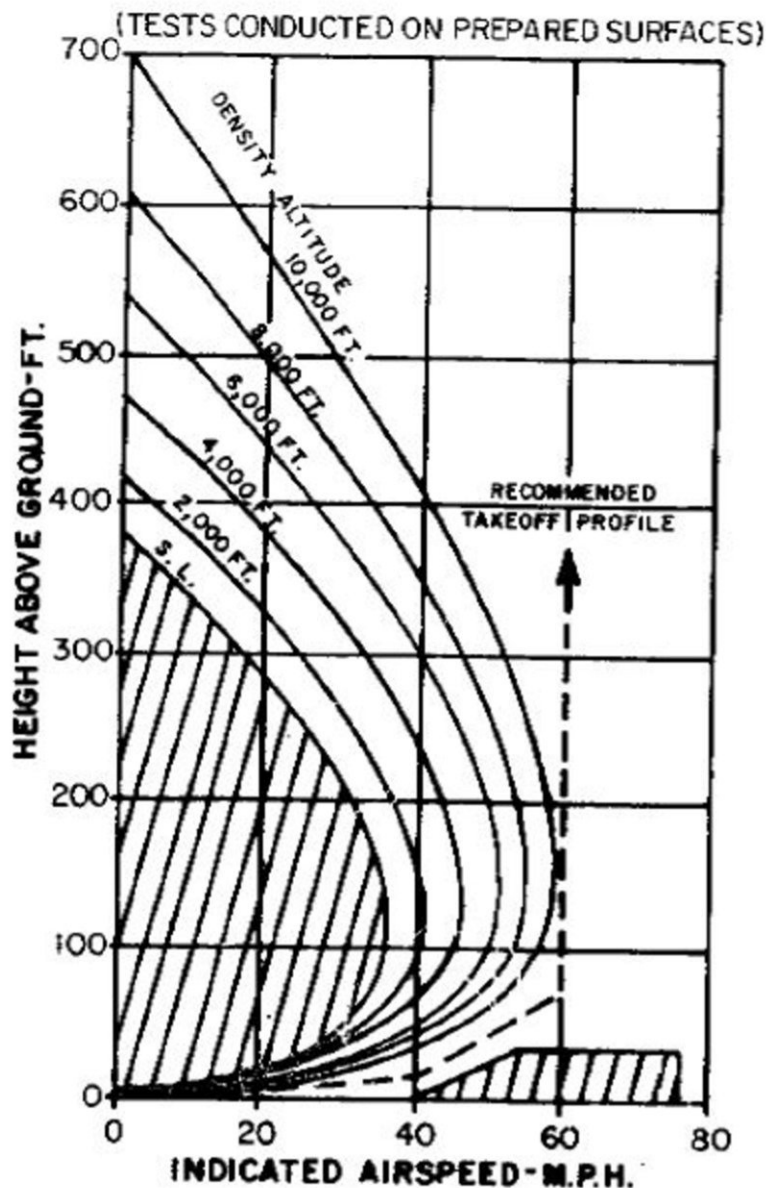
Automatic Dependent Surveillance-Broadcast (ADS-B) data indicated that, before the accident, the helicopter was traveling at a speed and altitude such that, in the event of an engine failure, the pilot would have had limited time to enter and establish a controlled autorotative descent. The helicopter’s operating handbook stated that, at low altitude and low speed, sufficient altitude may not be available to increase rotor rpm following a loss of engine power. Impact damage to the helicopter was consistent with an uncontrolled collision with terrain.

Based on the helicopter's basic empty weight, fuel load, and occupant weight, the gross weight at takeoff was about 2,350 lbs. The height/velocity diagram for 2,350 lbs gross weight, as documented in the helicopter's operator's manual, is represented in Figure 2.

Figure 2 – 2,350-lb gross weight height/velocity diagram
